# **IMPACTS OF 2010/11 FLOODS AND RELATED WEATHER ON POWERLINK'S ELECTRICITY TRANSMISSION GRID**

This report summarises the impacts on Powerlink's grid of the flood events and related torrential rainfall in Queensland in 2010/11. In particular, it addresses the events in South East Queensland in the week commencing 10 January 2011 and flooding in regional Queensland in December 2010. The report does not address weather events occurring post January 2011.

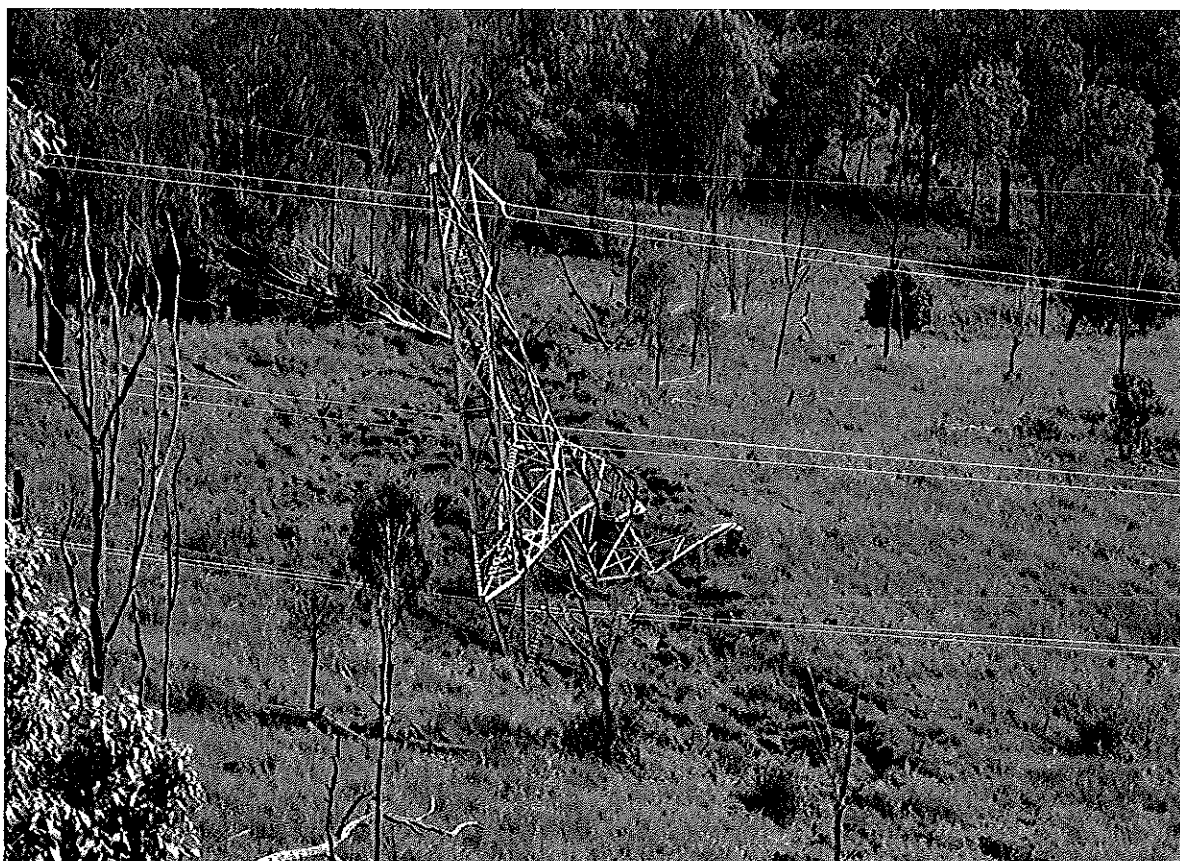
The landslip caused one steel tower on feeder 832 (Tarong to South Pine 275kV) to collapse (*Figure 1*), and caused temporary flexing of adjacent towers. The damage was identified on Friday 14 January following an inspection after the circuit tripped out of service the night before. The tower site was difficult to access due to the D'Aguilar Highway being temporarily closed in the Blackbutt range by landslips, and because the local access tracks were impassable due to boggy conditions.

**Figure 1 - Landslip damages tower on feeder 832**

A permanent bypass using an 'H' frame concrete pole structure (*Figure 2*) was installed by a joint Powerlink/ Ergon Energy team. Feeder 832 was returned to service on Friday 28 January.

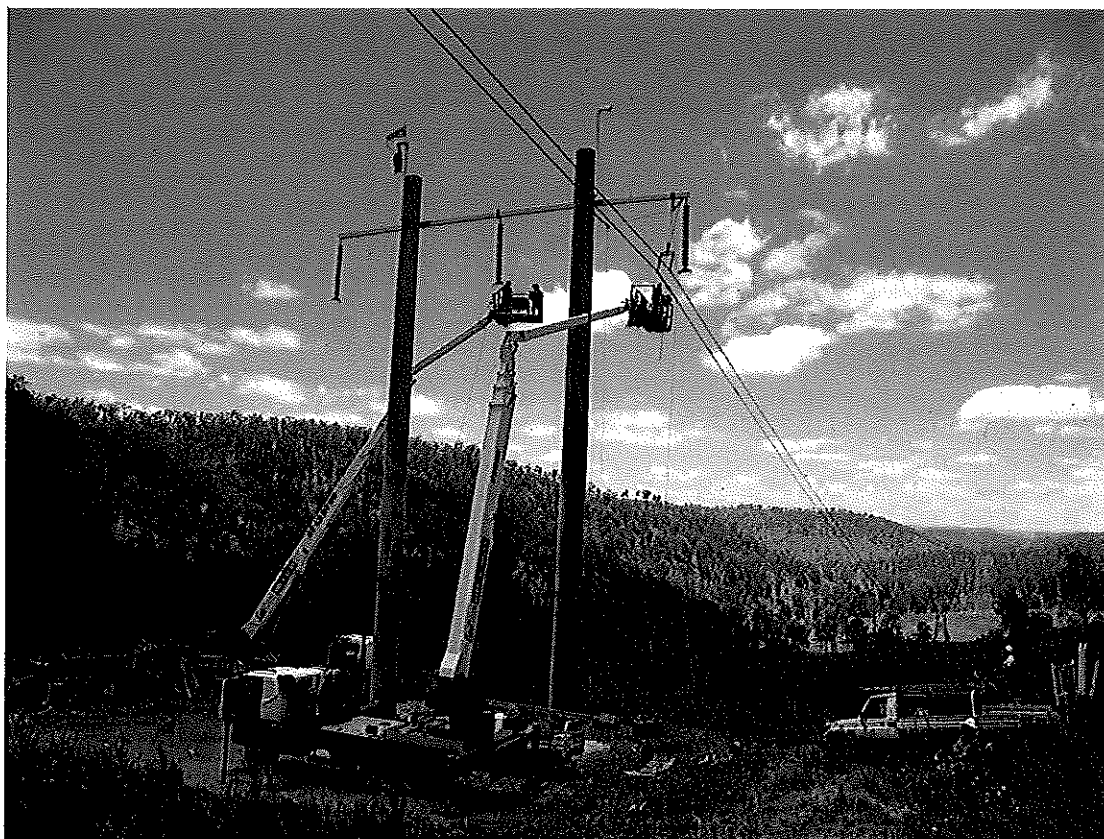
**Figure 2 - Permanent tower replacement using H frame concrete pole structure**

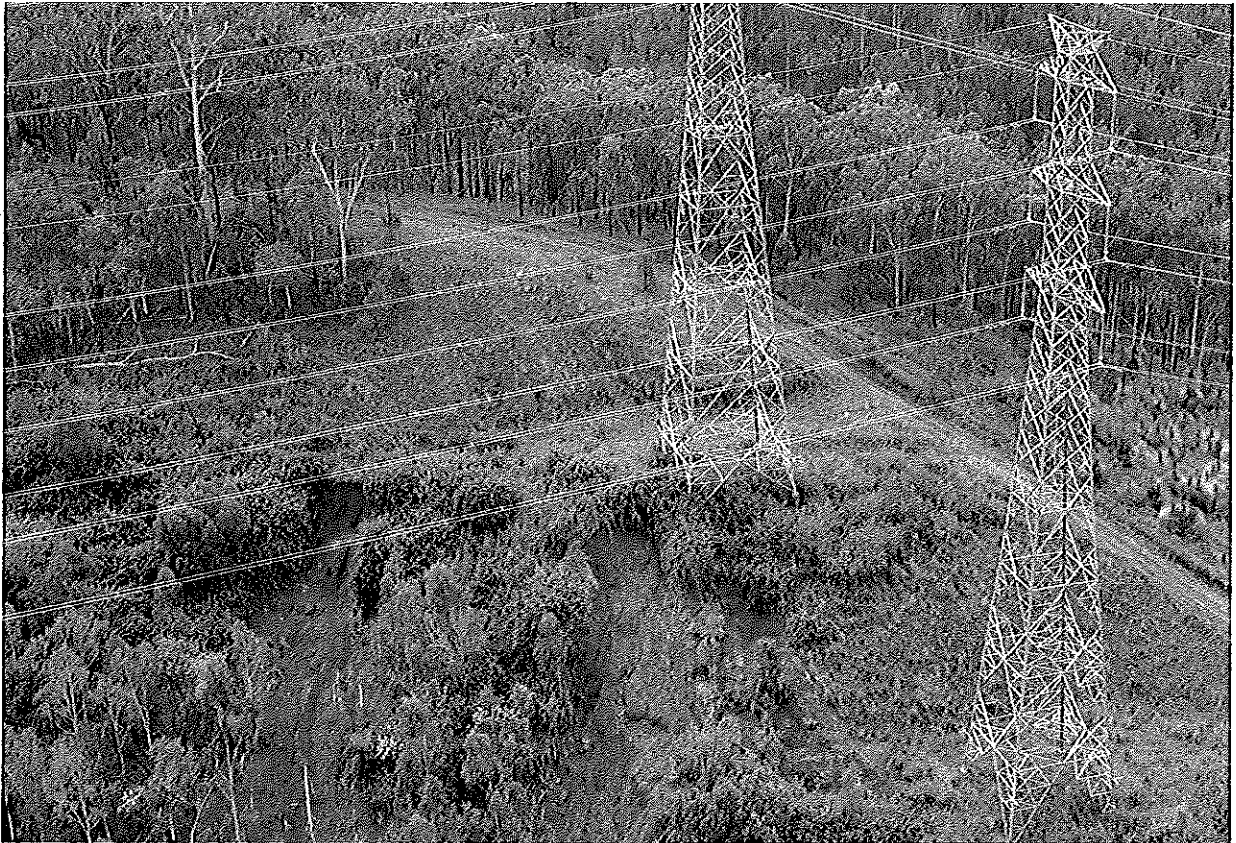
The landslip approached one leg of a steel transmission tower on Feeder 827 (Tarong to Mt England 275kV) (*Figure 3*). The problem was identified on Thursday 13 January by an aerial survey of Powerlink's transmission lines in SEQ.

**Figure 3 - Landslip near tower at Mt England**

Whilst the towers foundations remained secure, being embedded in an underground rock formation, they were further reinforced by installing a series of cable stays which were anchored into rock nearby (*Figure 4*).

This tower will be monitored as part of the ongoing maintenance program for this transmission line and any further remediation work undertaken as required.

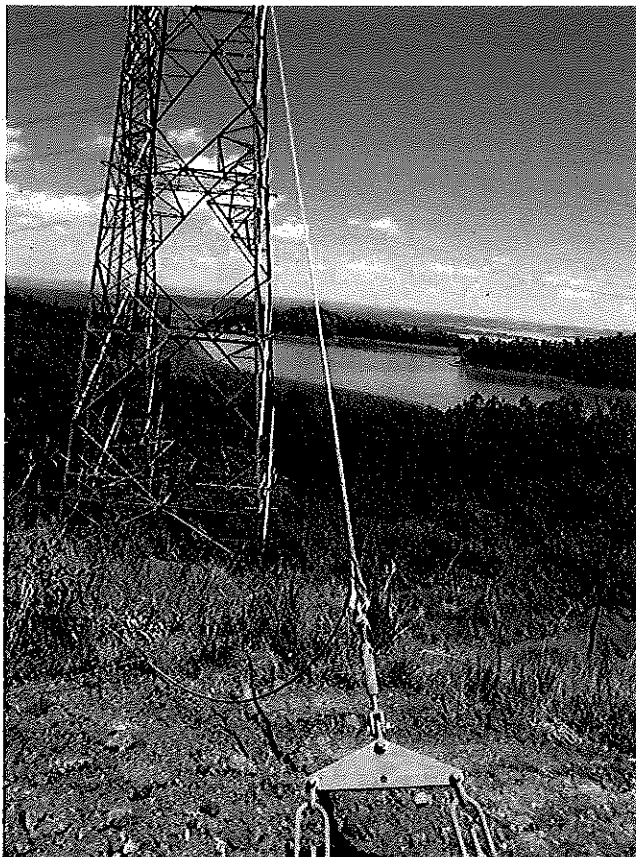
**Figure 4 - Tower secured with cable stays**

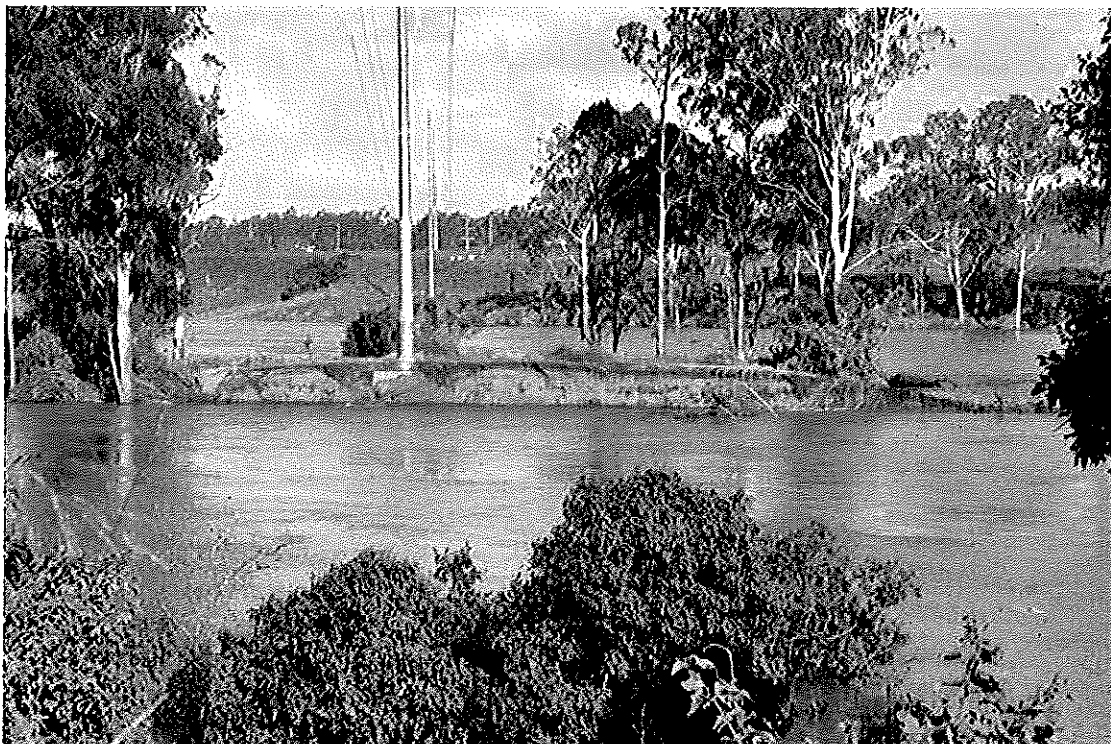
The large volumes of water flowing down the Brisbane River caused major erosion of the riverbank around a steel transmission pole supporting two 275kV circuits : Feeder 809 (South Pine to Rocklea) and Feeder 8818 (Blackwall to Rocklea) (*Figure 5*).

The pole had been installed in a location some 30 metres away from the original riverbank however, the flooded river reached the pole location.

**Figure 5 - Major erosion of the riverbank near Karalee pole**

On Tuesday 11 January, when the flood waters approached the required safety clearance below the lowest conductor, the line was taken out of service. As the electricity demand could be met without this line, the line was left out of service for the remainder of the flood event. The pole was visually monitored, and when the flood waters receded, a survey of the river floor and bank profile was undertaken, as input to an engineering assessment of the stability of the pole.

That assessment determined that the pole was sound, enabling the line to be returned to service (both transmission feeders were energised on Tuesday 18 January, however feeder 809 was not loaded until Friday 28 January due to system conditions, until feeder 832 was in-turn returned to service). As a precautionary measure against potential future erosion of the river bank, large boulders were placed on the river bank adjacent to the base of the pole.

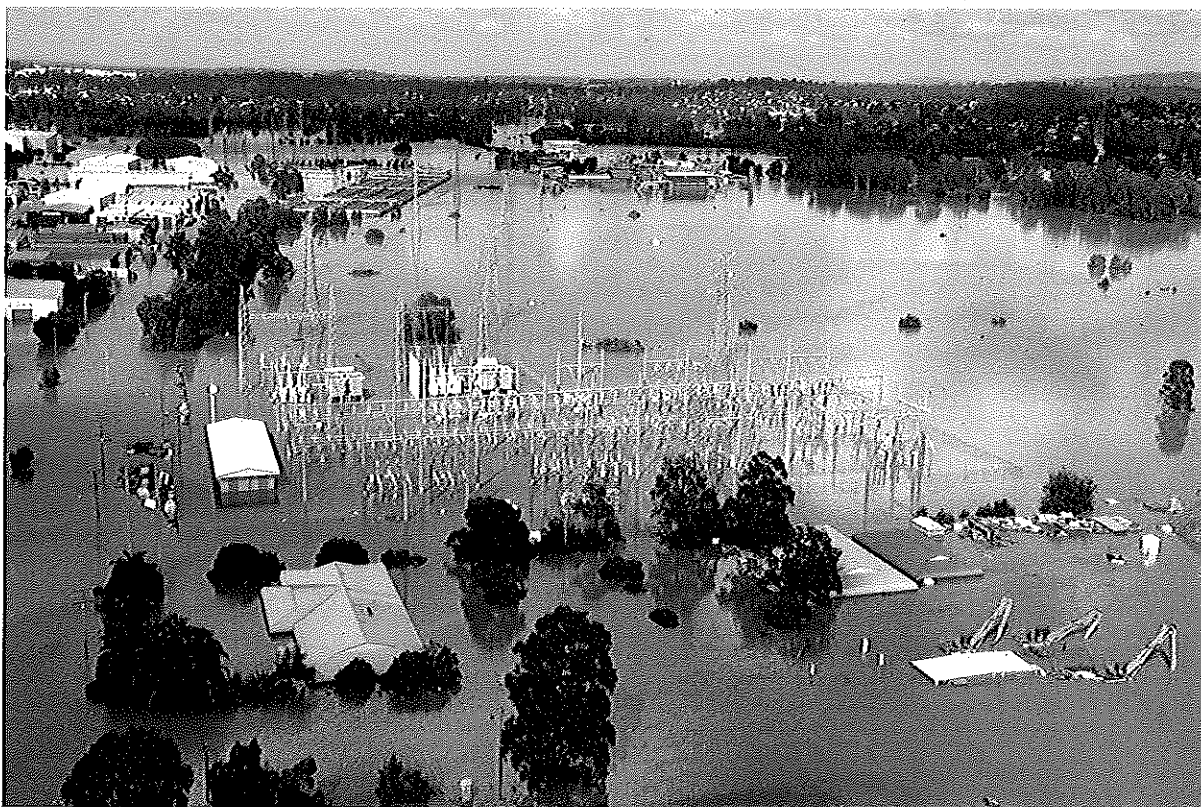
**Figure 6 - Rocklea substation**

Powerlink's Rocklea substation is located in an area which was affected by flooding of the Brisbane River in Rocklea near Oxley Creek. Flood waters inundated the substation yard to a depth of about one metre, which in itself was not a material problem. However, there was some water ingress (about 0.5 m) into the control building which houses the protection and control systems (*Figure 6 & Figure 7*).

On Wednesday 12 January, as the flood waters were rising, and prior to the above-mentioned water ingress, Powerlink implemented contingency plans to protect most of the protection and control equipment and associated systems from flood damage, and to reconfigure the substation such that power would pass directly through Rocklea substation and onto Tennyson substation. Since that work required technicians to be in the substation with flood waters in the yard, the substation had to be de-energised for safety reasons for the duration of the work, with the consequence that there was no power flow to Tennyson substation for about 3 hours. This required a temporary interruption of electricity supply to some ENERGEX customers in the south-west suburbs and West End of initially about 66 MW, reducing to about 38MW after about 90 minutes.

Once the flood waters receded, the substation was inspected, any water-affected components were cleaned and checked, the protection and control equipment and associated systems were reinstalled and checked, and the substation was returned to its original configuration.

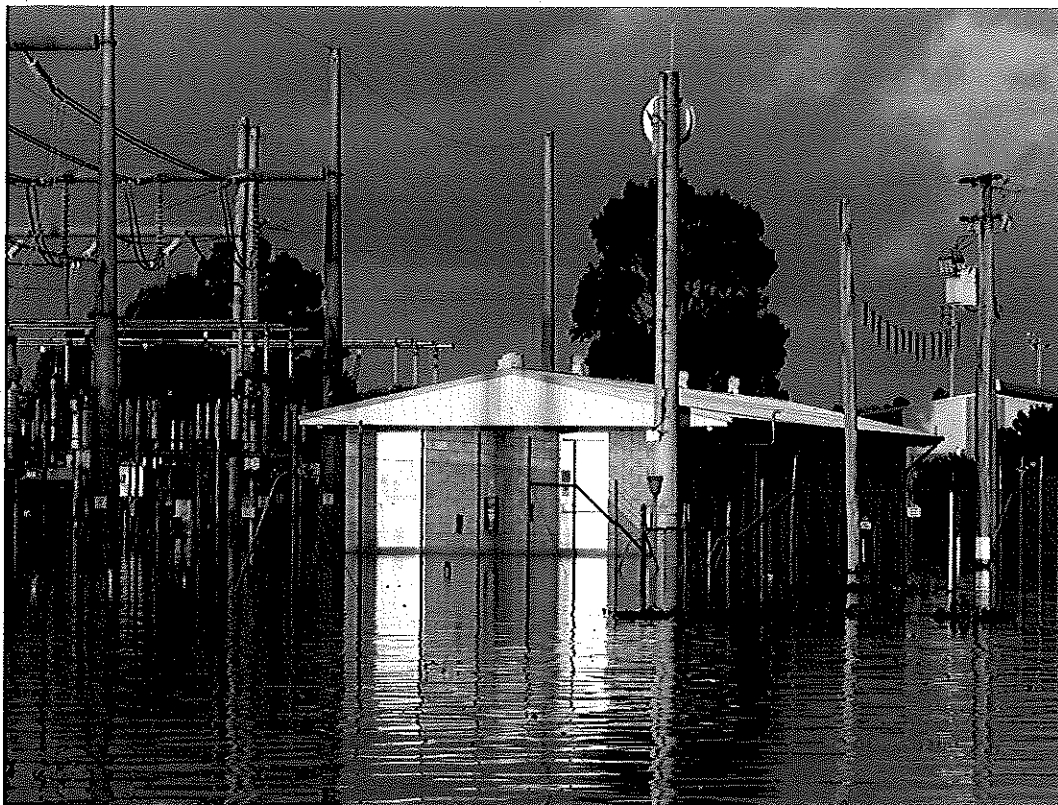
Figure 7 - Rocklea substation inundation

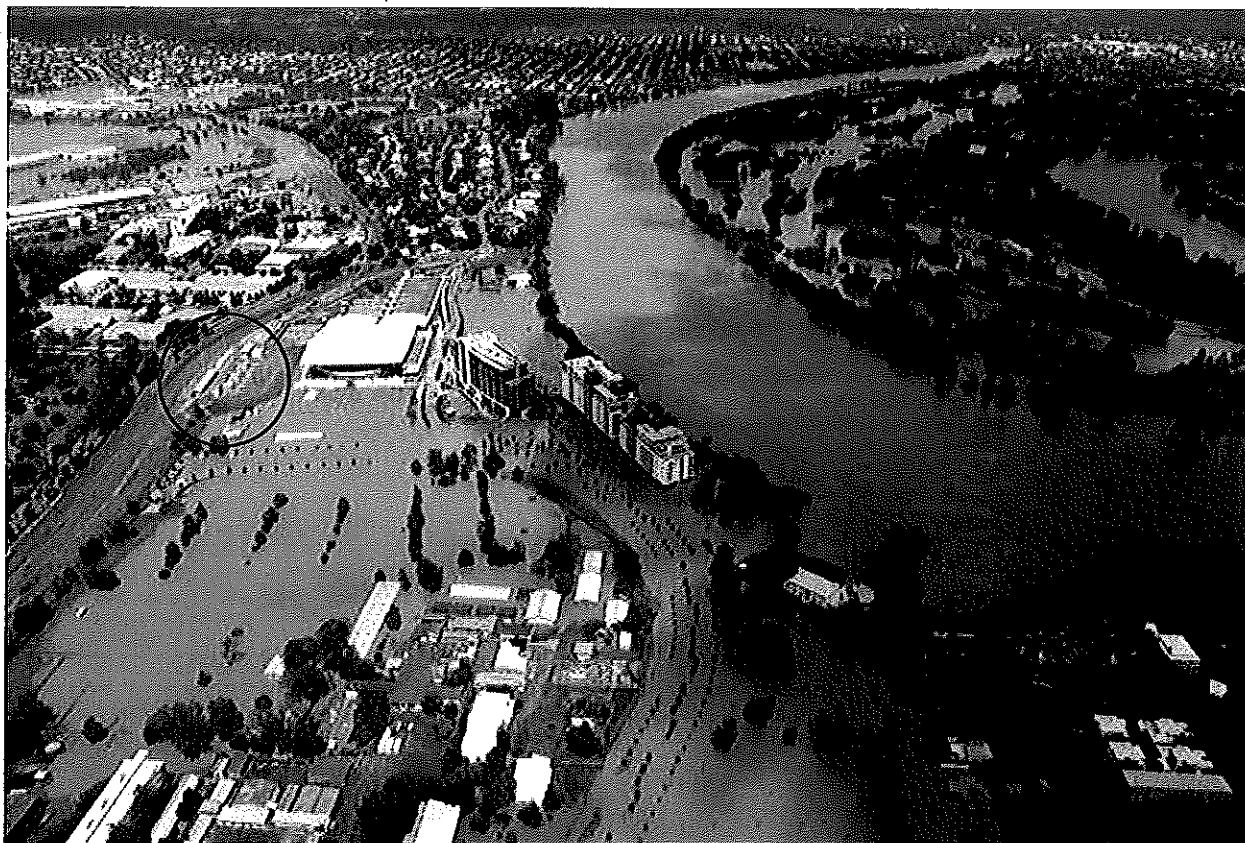
Figure 6 - Tennyson substation

Following the reconfiguration, there was adequate power flow to Tennyson substation to meet the ENERGEX demand. Tennyson substation remained above the flood level (*Figure 8*).
