WIVENHOE DAM

ANNUAL DAM SAFETY INSPECTION 2009

Date of Inspection: 22 October 2009

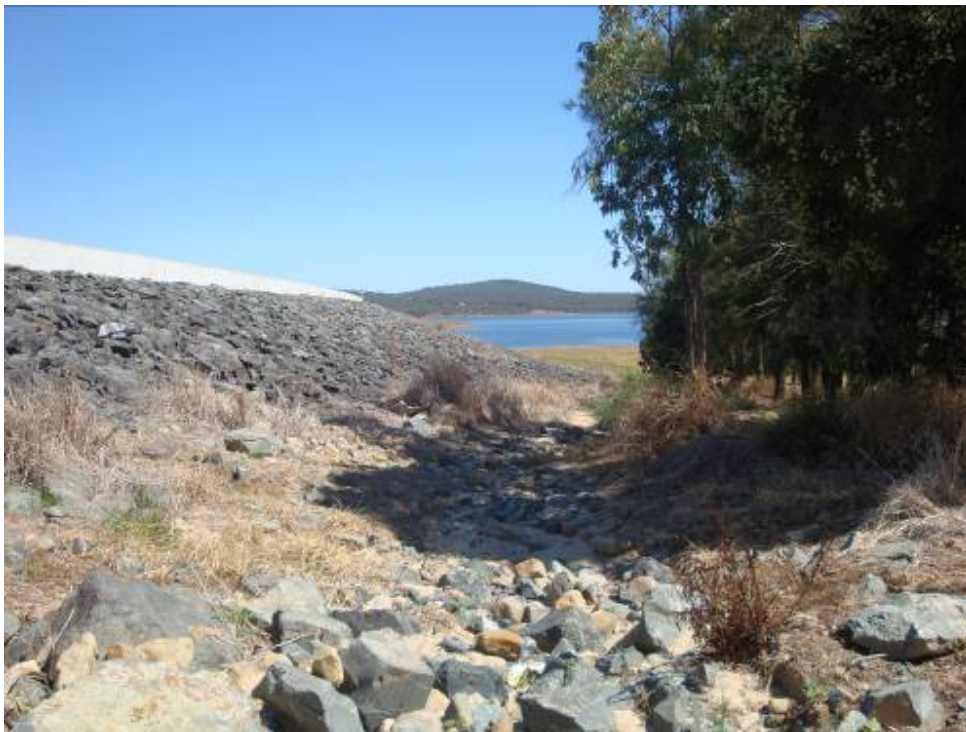
Left Bank Embankment – Trees to be removed

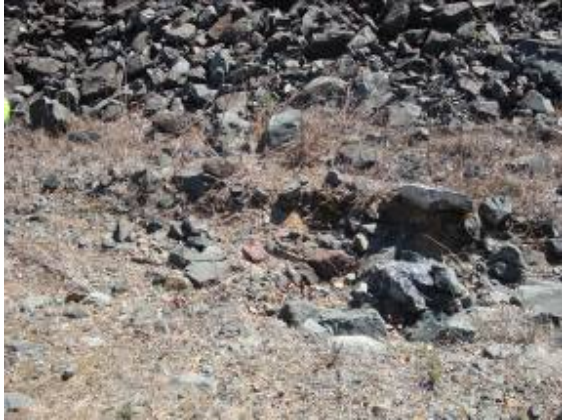
- *Significant erosion repairs have been undertaken along the downstream toe of the embankment. These repairs look to have been quite successful; however some minor areas still require attention.*

Minor erosion areas to be repaired along toe

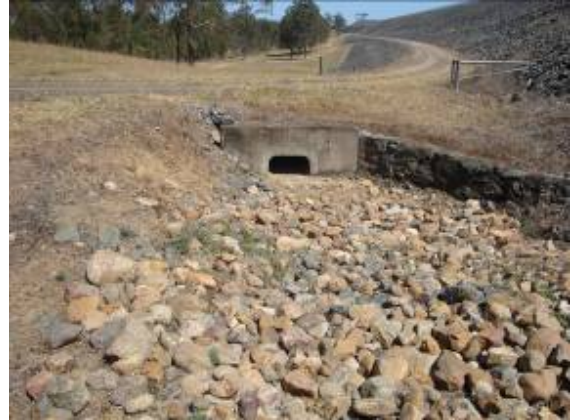
Repaired Area

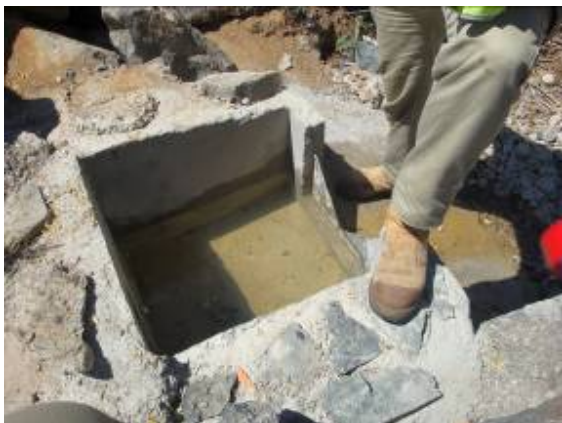
Repaired V Notch Weir

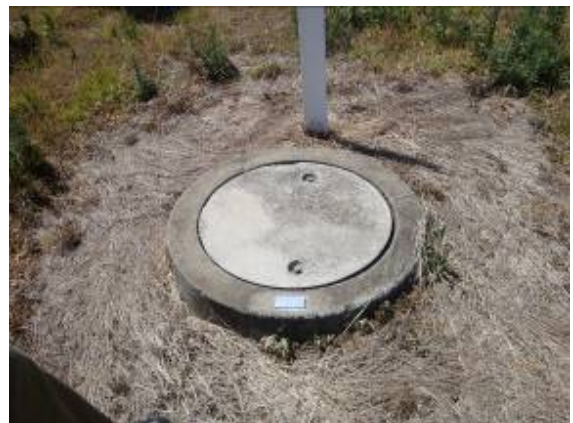
Repaired Pit and new Marker Post

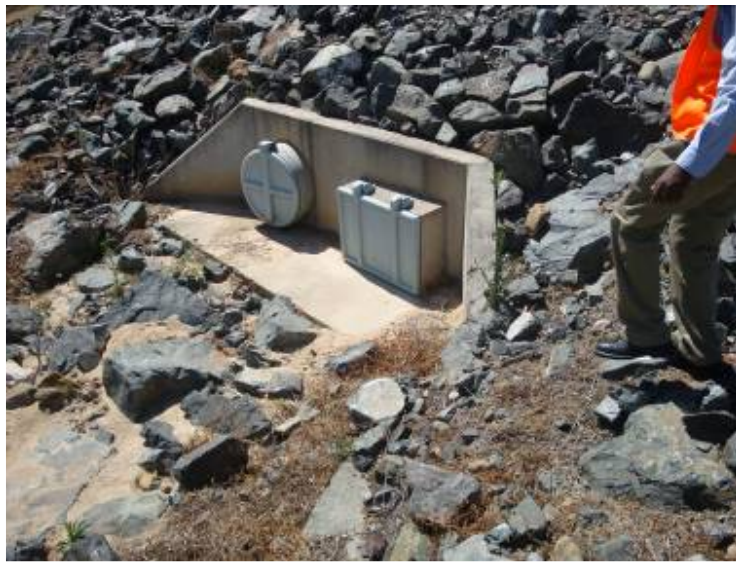
Flap Gates

- *Some minor vegetation is evident on the embankment face and the current weed spraying program should continue.*
- *The flap gate drains near the left bank end of embankment are to be modified to reduce the risk of the flap gates jamming open. The EAP is to include instructions for checking of these gates in major flood events.*
- *All trees within five metres of the toe of the embankment are to be removed.*
- *The hinges on the park flood gate are to be greased and missing bolts reinstated.*

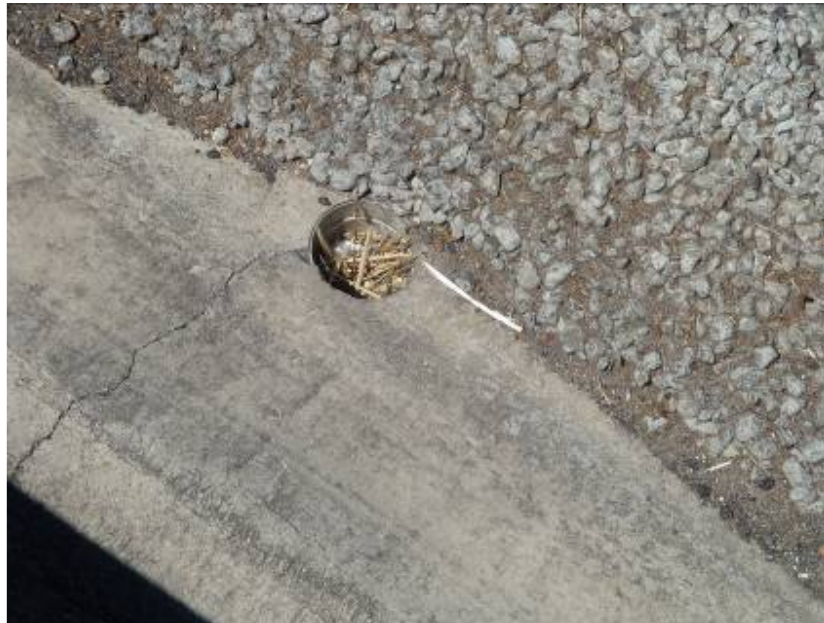
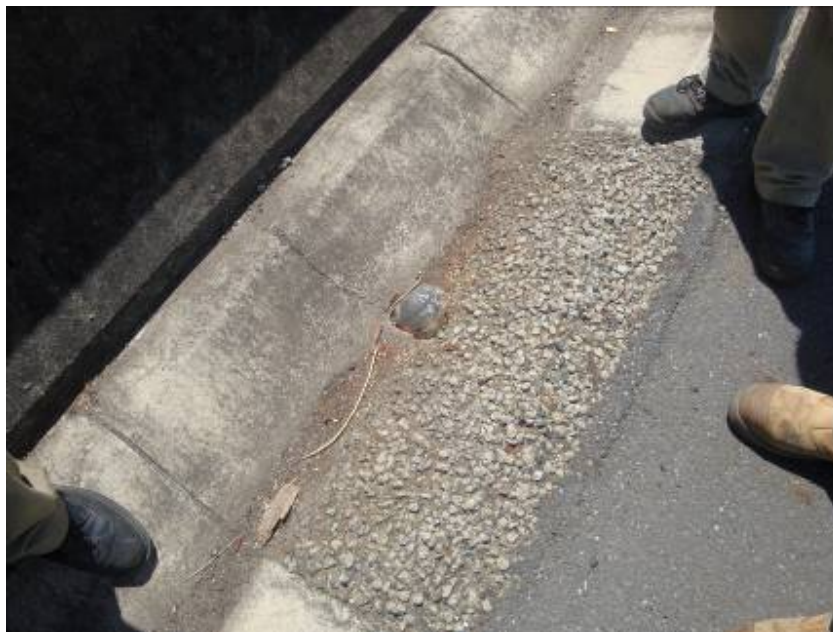
- *The drains under the wave wall are to be modified to prevent blocking and a store of suitable plugs is to be kept at the dam to enable these drains to be closed off in the event of a flood that impacts on the wave wall (in these circumstances the road would be closed due to flooding and would not be used by the public). This issue is outstanding from the 2008 inspection.*

Broken/Blocked Road Drain

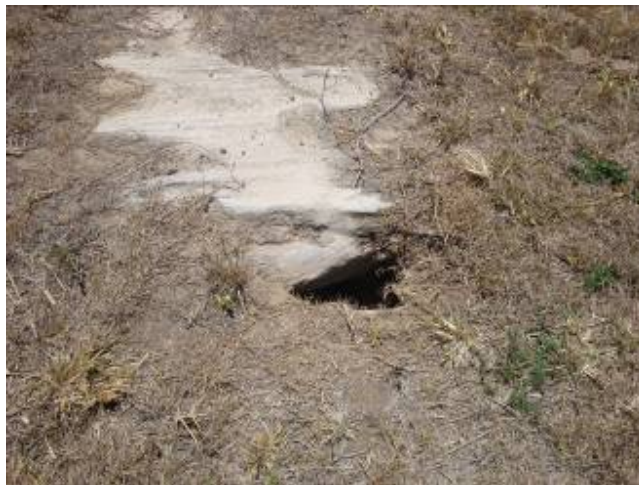
Erosion Hole

- *Some minor vegetation is evident on the embankment face and the current weed spraying program should continue.*
- *All trees within five metres of the toe of the embankment are to be removed.*
- *All termite mounds within five metres are to be sprayed and destroyed.*
- *Vegetation growing in the area of the old river diversion is to be burned off each year just prior to the annual inspection to allow proper inspection of this area.*
- *The erosion hole near the V notch weir is to be filled.*

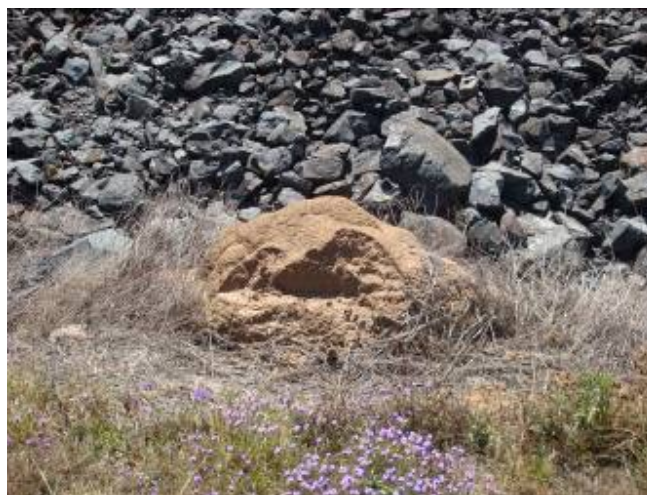
Termite Mound

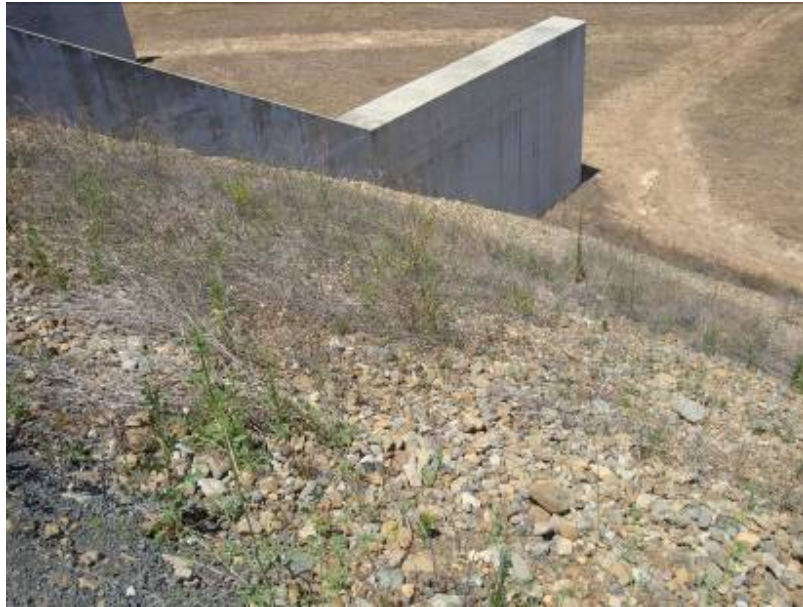
Vegetation to be sprayed

- *Some minor vegetation is evident on the embankment face and the current weed spraying program should continue.*
- *All trees within five metres of the toe of the embankment are to be removed.*
- *All trees within three metres of the spillway retaining walls are to be removed.*

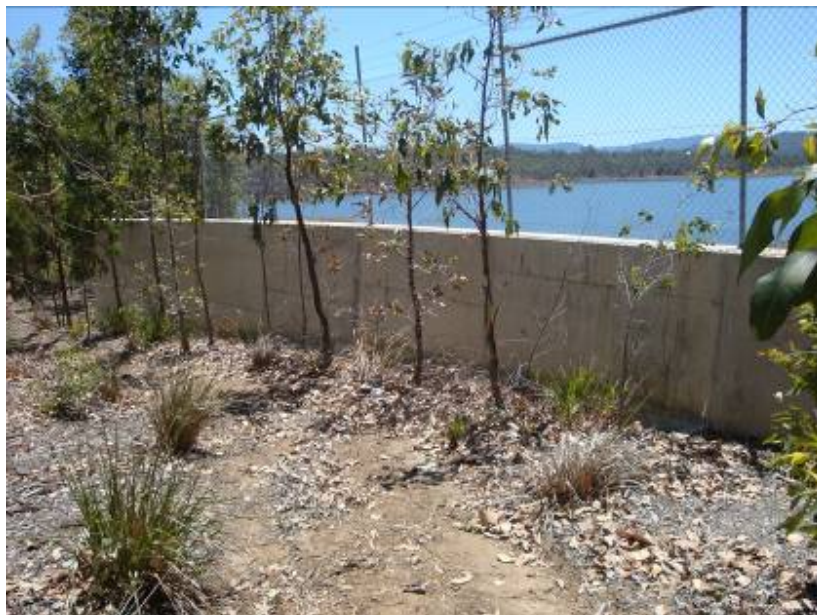
Trees to be removed

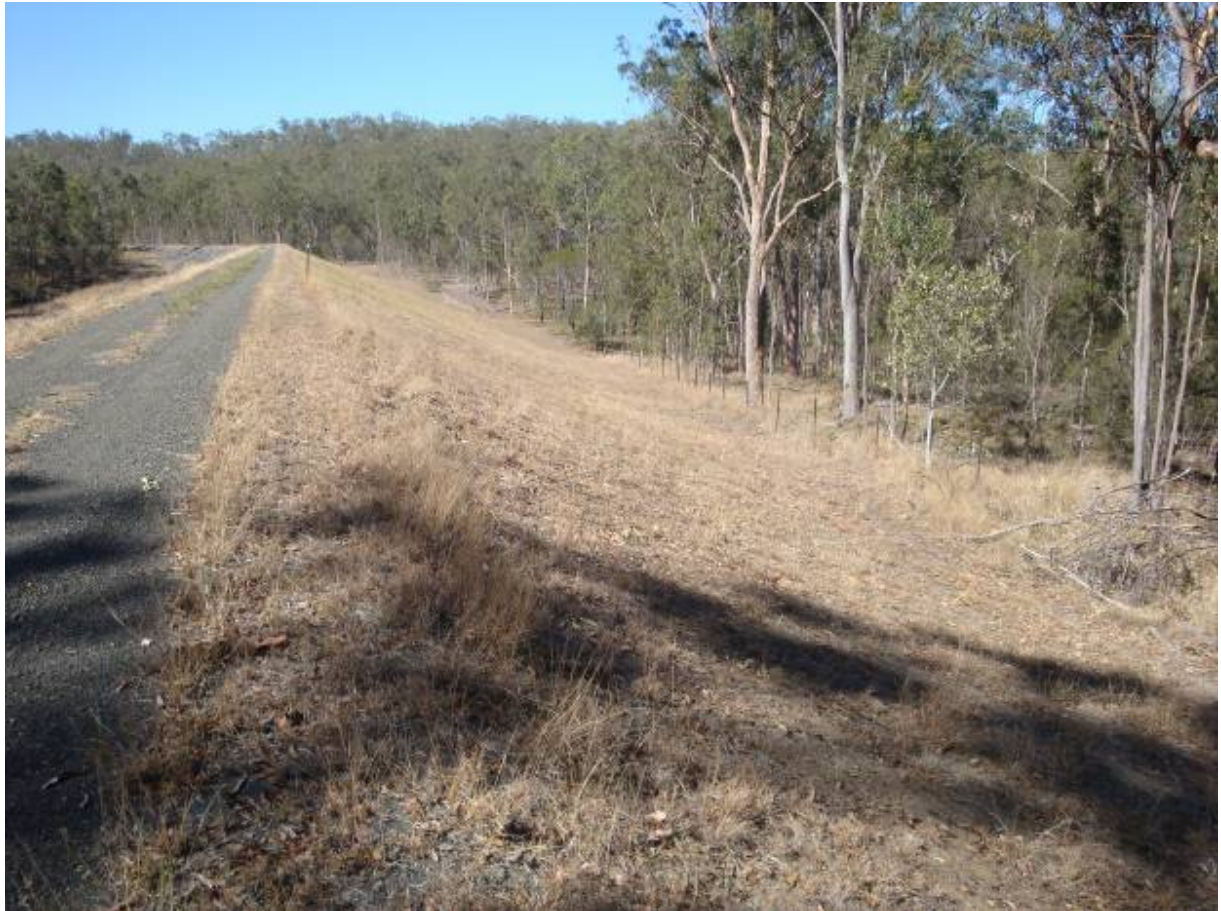
Saddle Dam

- *The condition of the saddle dams is greatly improved from the 2008 Annual Inspection. However, some undesirable vegetation (mainly small tree regrowth) is still evident on the embankments and the current weed spraying and mowing program should continue.*
