WIVENHOE DAM

ANNUAL DAM SAFETY INSPECTION 2008

Date of Inspection: 11 November 2008

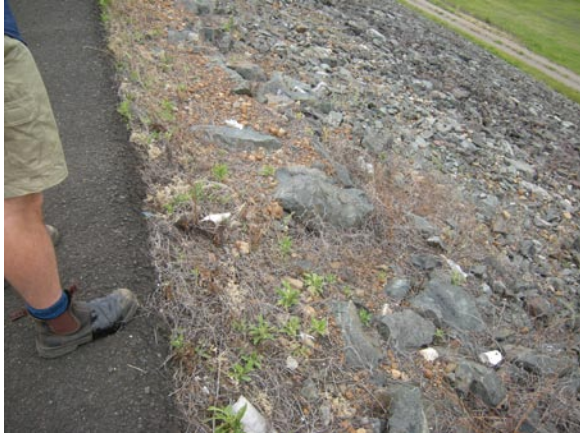
- ***Due to breakdown of rip rap on the downstream side of the embankment, some areas of rip rap are close to requiring replenishment. These areas should be closely monitored for signs of any erosion damage. Presently the areas generally appear sound and stable.***

Areas with poor rip rap cover

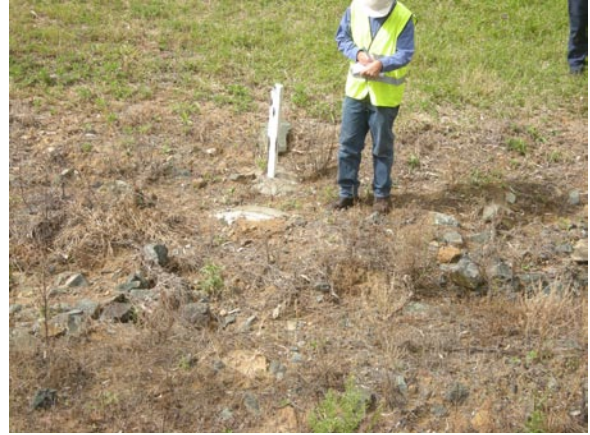
Silted Inspection Pit

- ***There is a series of pipelines that gather runoff from the toe drains for outflow into suitable natural drainage points. Some of the inspection pits on these pipelines have been buried under silt transported by runoff from rainfall events. All inspection pit lids are to be cleared and repaired. The pits are then to be marked and numbered with suitable marker posts. Each pit is to be inspected on a six monthly basis. Written records of these inspections are to be provided to the Principal Engineer Dam Safety.***

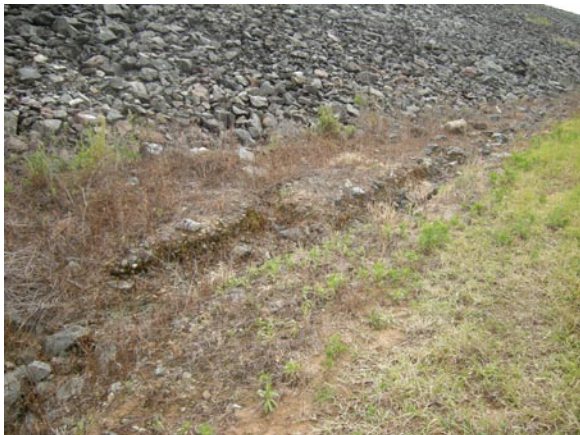
Erosion areas to be repaired along toe

- ***Erosion repairs are required along the downstream toe of the embankment. This erosion has been caused by runoff from rainfall events along the toe drain. The access road adjacent to this toe should also be repaired (regraded) and maintained.***

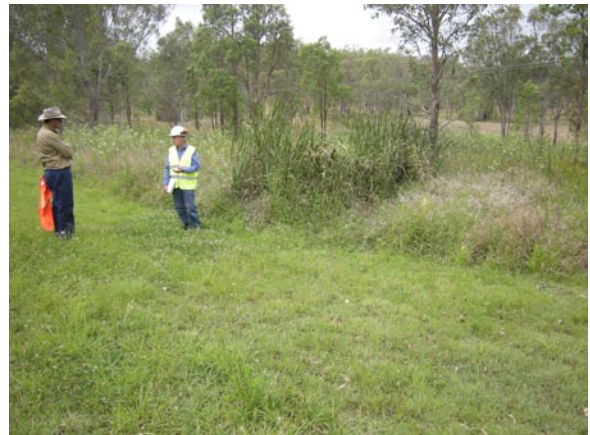
Pipe Outflow to be repaired and maintained

- ***The outfall arrangement from the toe drain collection pipeline is to be repaired and maintained. The pipeline may be broken in this area and this should be investigated (using a pipeline camera if appropriate) and repaired as necessary. Outflow from this pipeline should be recorded at the same frequency as the nearby V-notch weirs (weekly).***

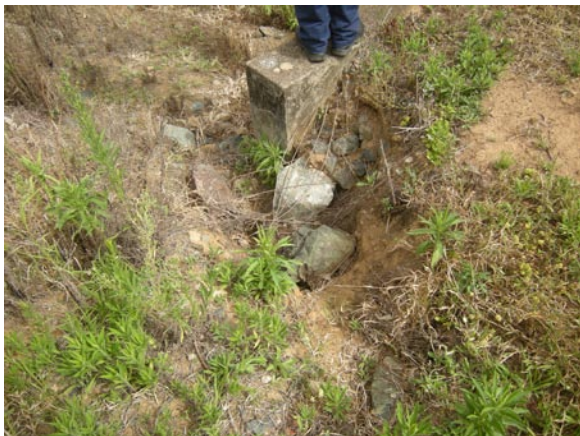
Erosion areas to be repaired along toe

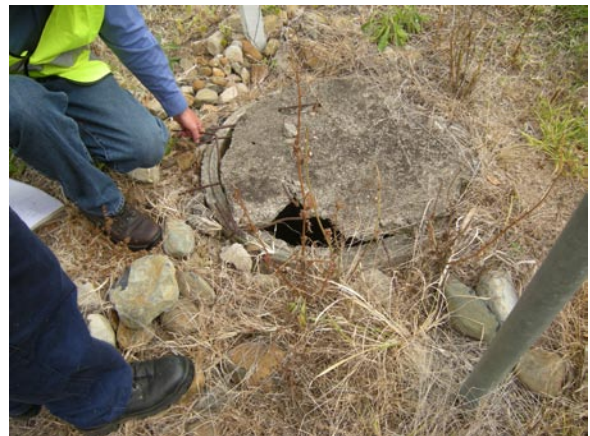
Broken inspection pit cover

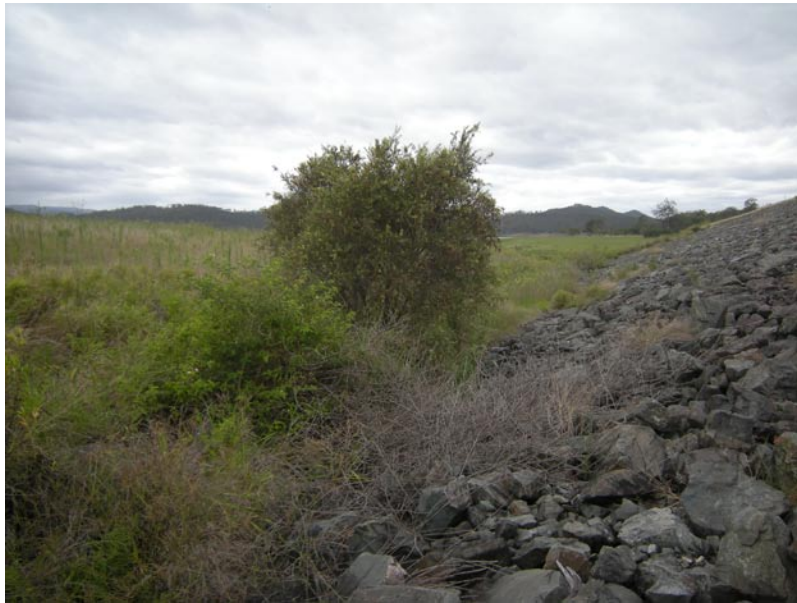
Trees to be removed

- *The vegetation near the spillway that may cause debris problems during flow events is to be removed.*
- *Vegetation growing on the embankment is to be sprayed with a suitable herbicide.*
- *Debris is to be removed from around the flap gate drains near the left bank end of embankment and these gates are to be inspected and cleaned out on a quarterly basis.*
- *All trees within five metres of the toe of the embankment are to be removed.*

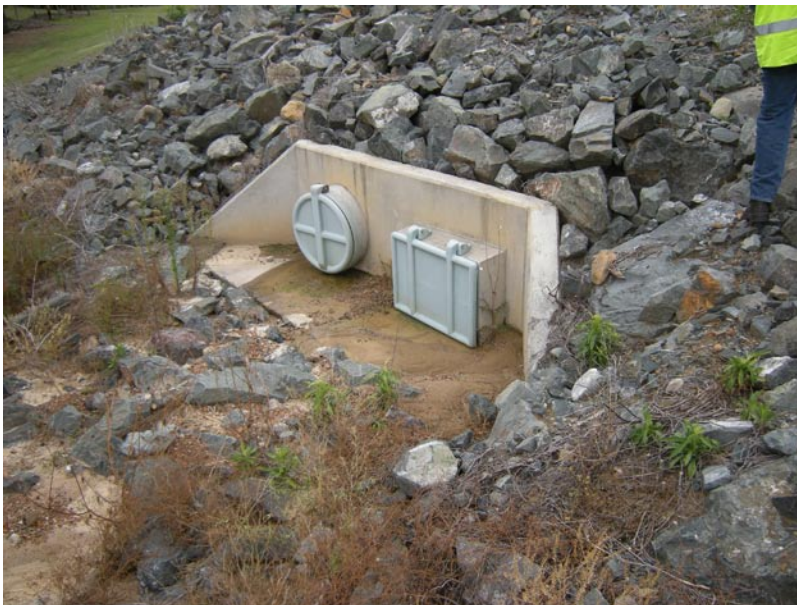
Flap gate drains

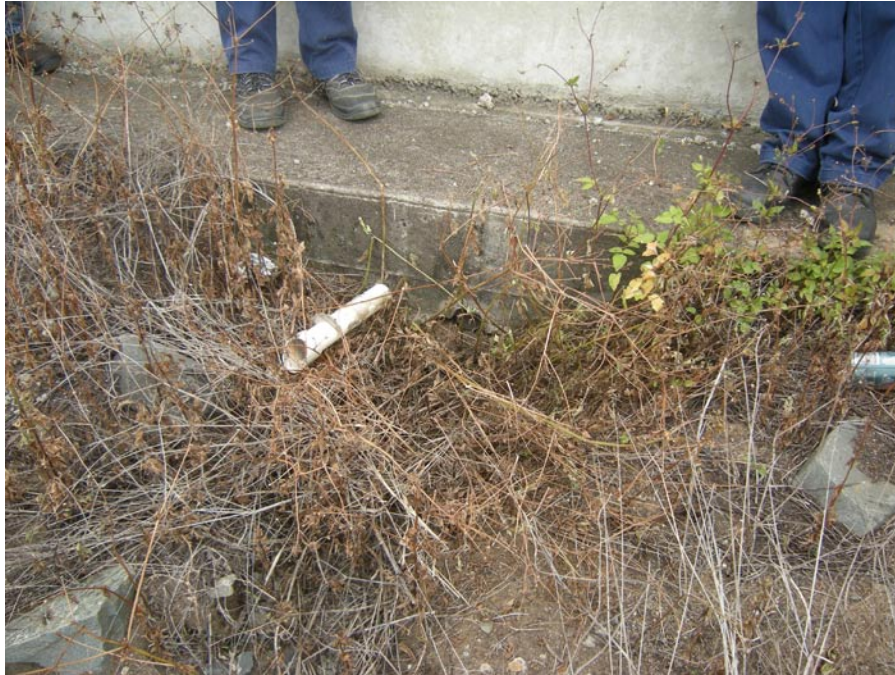
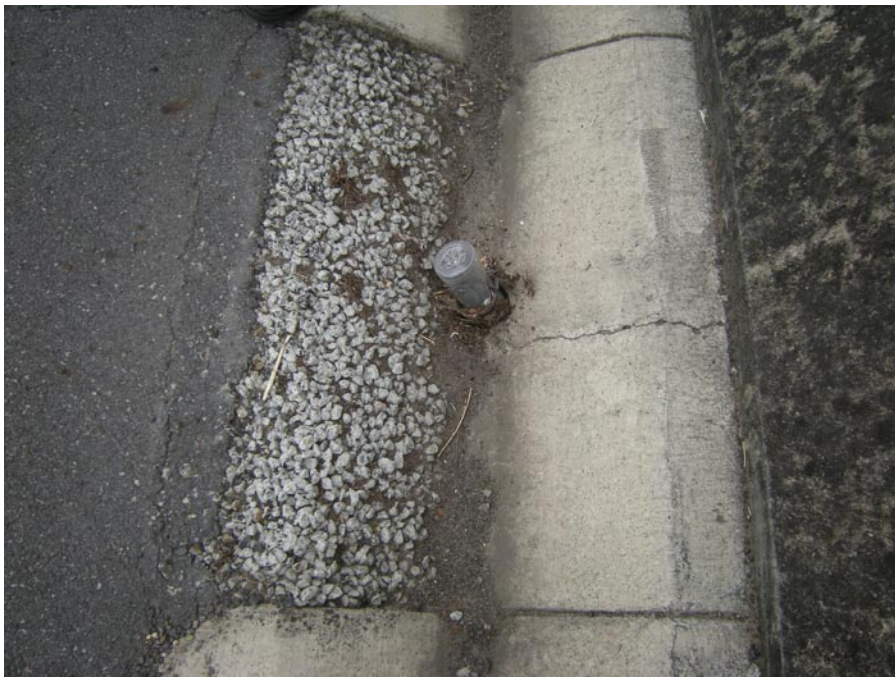
Broken/Blocked Road Drain

- *The broken road drains are to be repaired/modified so that they work in a reliable fashion to drain the road in a way that maintains vehicular safety for the public road users. A facility is to be installed to allow the dam operators to block these drains should the dam level be likely to reach the base of the wave wall (in these circumstances the road would be closed due to flooding and would not be used by the public).*

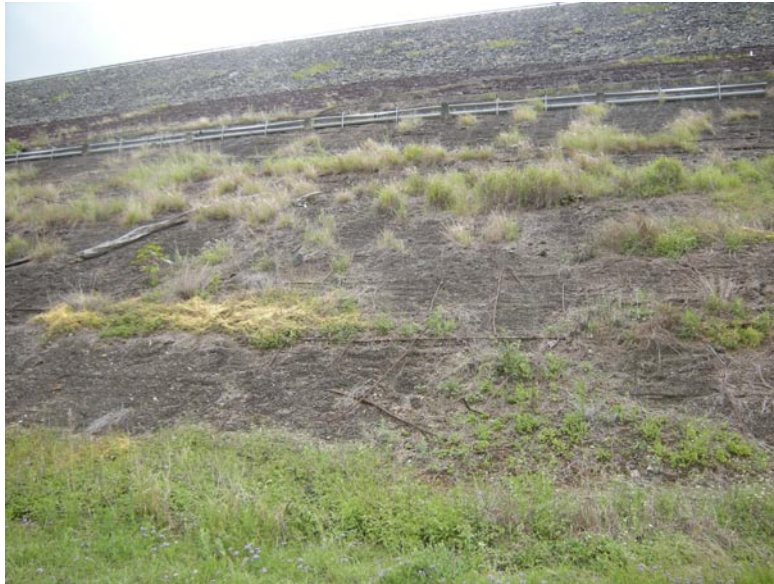
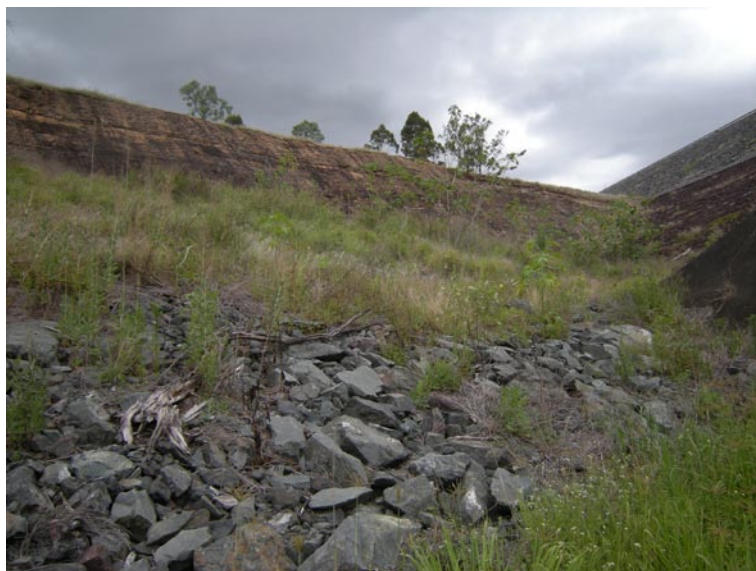
Vegetation to be sprayed

- *Vegetation growing in the rip rap and concrete faced rock is to be sprayed with a suitable herbicide (particularly in the area of the old river diversion).*

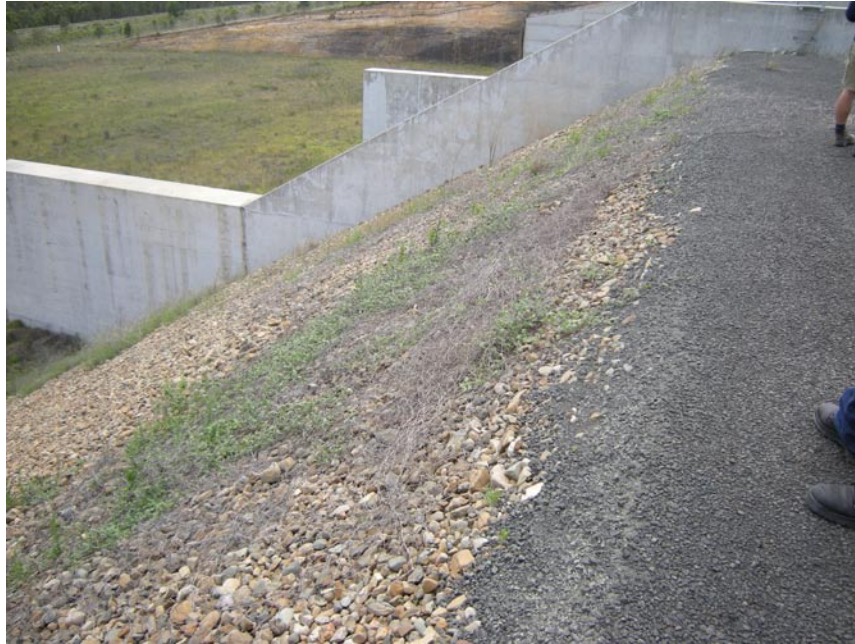
Vegetation to be sprayed

- *Vegetation growing in the embankments is to be sprayed with a suitable herbicide.*
- *The drain above the right bank fuse plug is to be cleaned.*
- *The water ponding along the downstream toe of the fuse plugs is to be permanently drained away and a five metre wide track is to be constructed along the toe for inspection and dam surveillance purposes.*

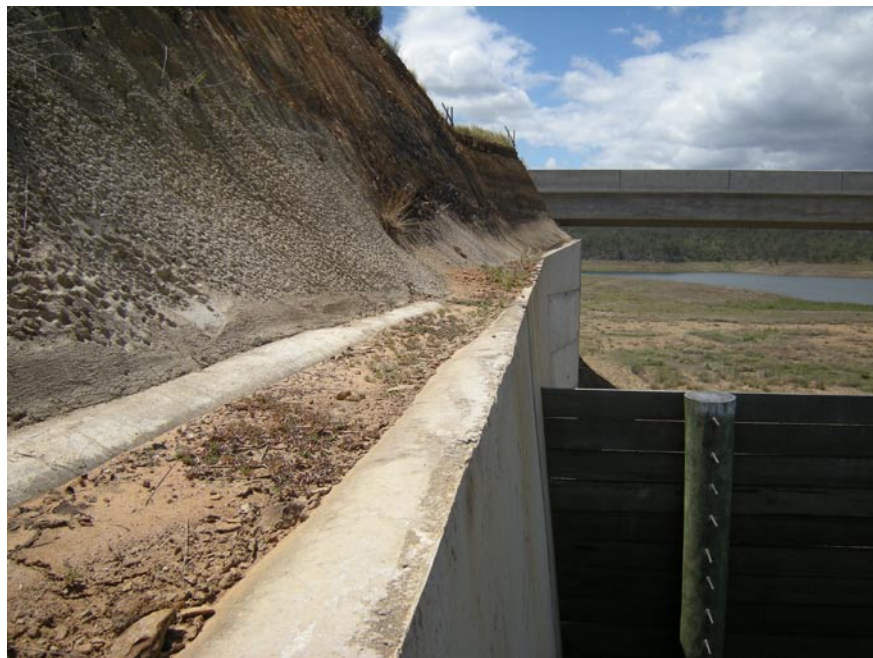
Drain to be cleaned

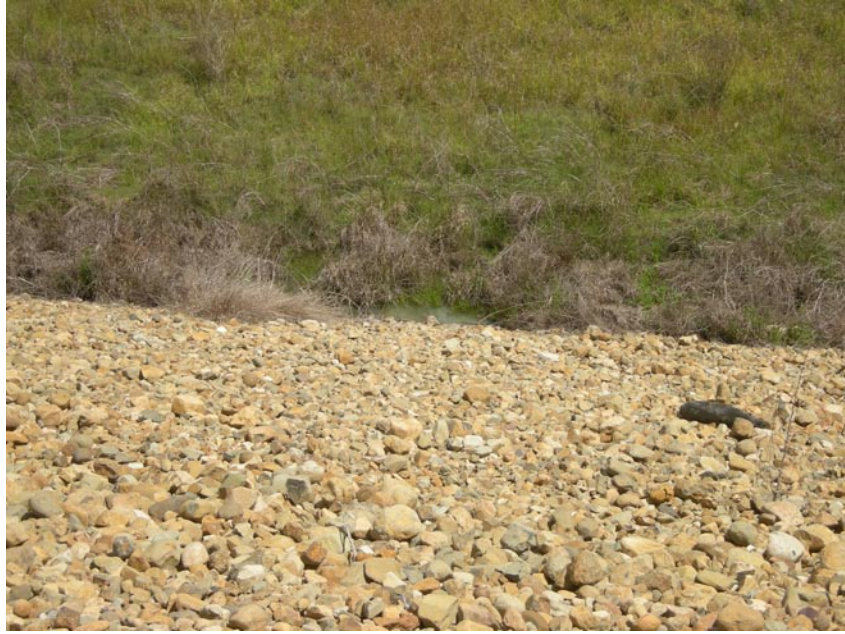
**Water ponding along toe of fuse plug embankments
to be permanently drained**

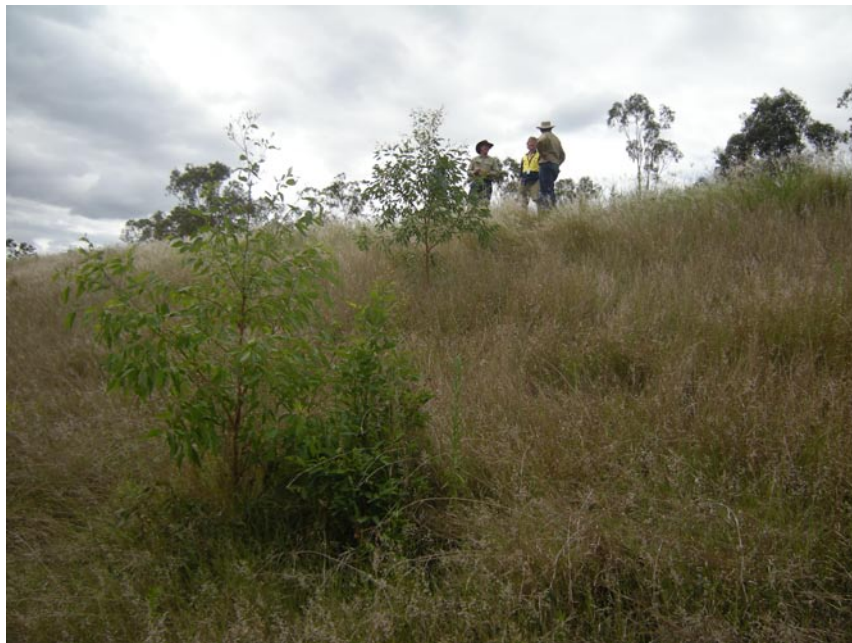
Trees on Saddle Dams to be removed

- *The numerous trees on the saddle dams are to be removed and no trees are to be allowed within five metres of the toe of the saddle dams.*
- *The saddle dams are to be mowed to allow proper inspection and are to be mowed just prior to the next Annual Inspection.*

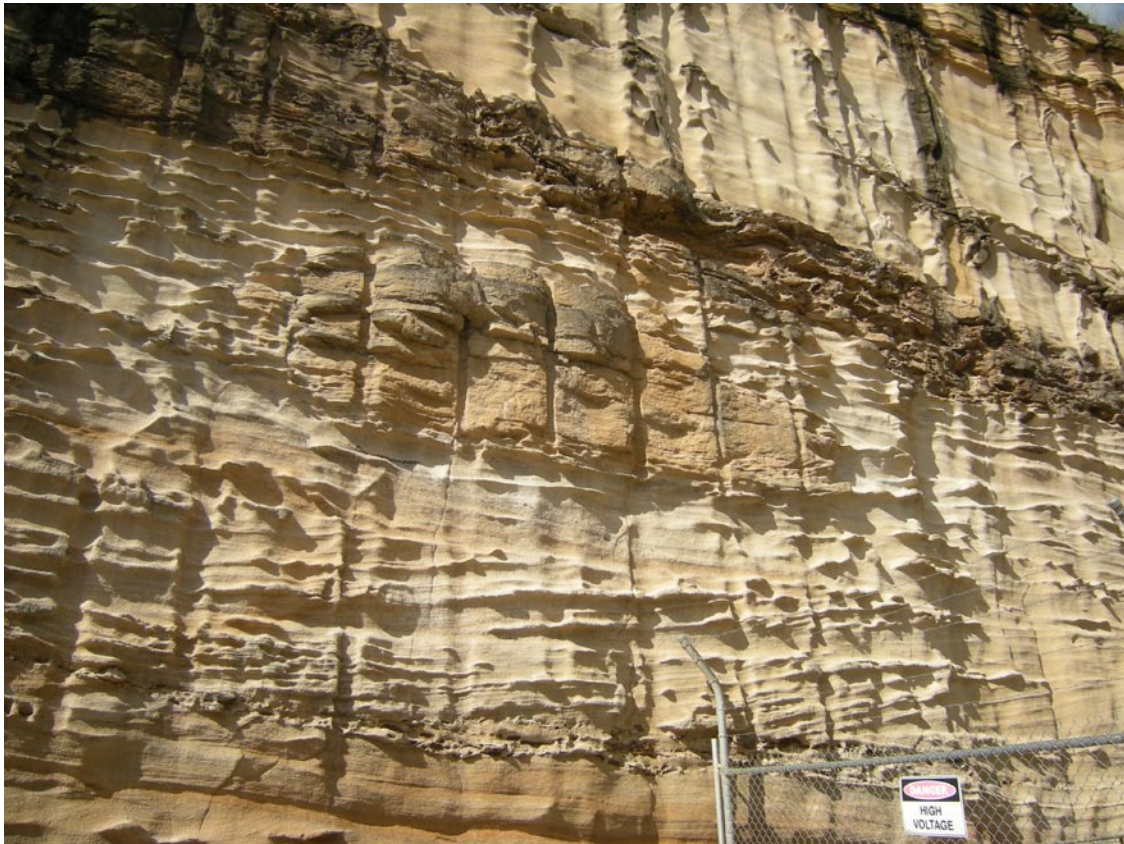
The sandstone cliffs adjacent to the outlet works also continue to erode and the rock debris generated by this erosion is causing a hazard both to personnel and the dam infrastructure (particularly in the electrical switch yard). This hazard should be investigated and eliminated through the construction of.

Eroding sandstone cliffs

- *Suitable engineering works are to be constructed to eliminate the hazard to persons and dam infrastructure caused by the erosion of the sandstone cliffs adjacent to the outlet works.*
