Natural Resources
and Water

SEQWATER WATER SERVICES DAM SAFETY AUDIT

June 2007

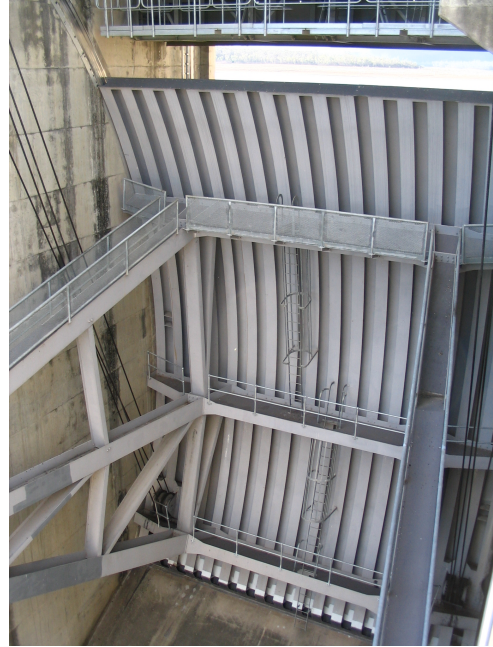
Based on a site visit the standard of maintenance was high. The radial gates at Wivenhoe have recently been recoated and the radial gates as well as bulkheads at the other dams are on a 10 year painting program. In many cases wire ropes for gates and bulkheads have been non-destructively tested to verify their condition and in some cases replaced. Gate seals appeared in good condition, equipment regularly exercised, OH&S upgrades undertaken, etc. SunWater are contracted to operate and maintain the dams and appear to be both well resourced and experienced in dams maintenance.

Downstream side of a
Wivenhoe Dam radial
gate.

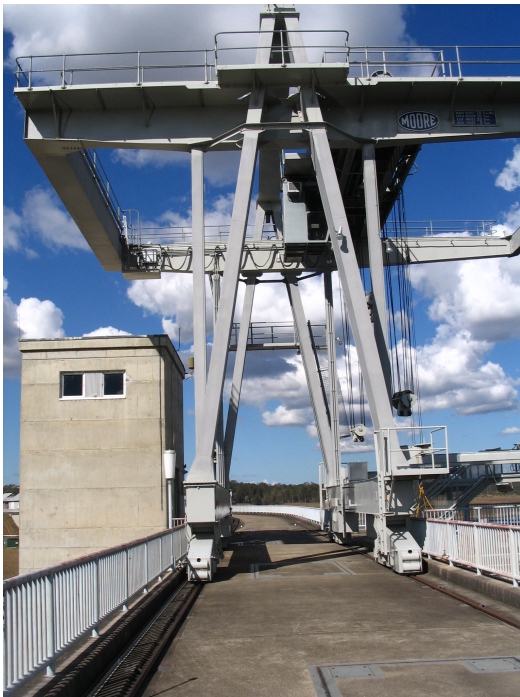
North Pine
Dam gantry
crane.

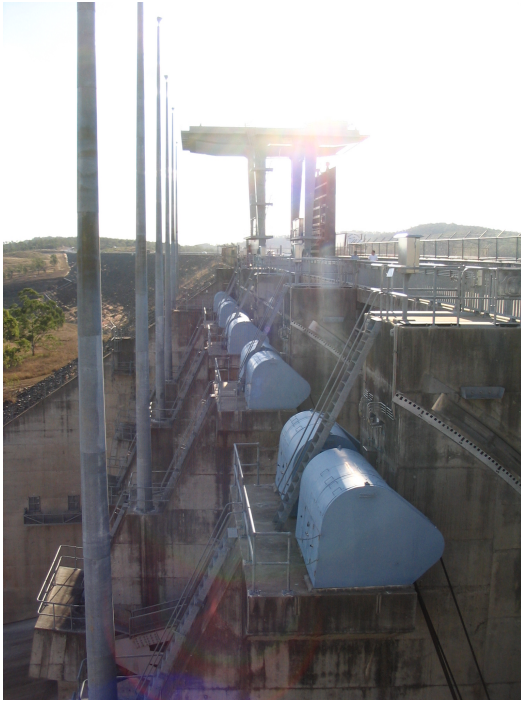
Wivenhoe Dam crest showing winches for raising & lowering radial gates.
