WIVENHOE DAM

RADIAL GATE TRUNNION BEARINGS

PEER REVIEW

MAY 2006

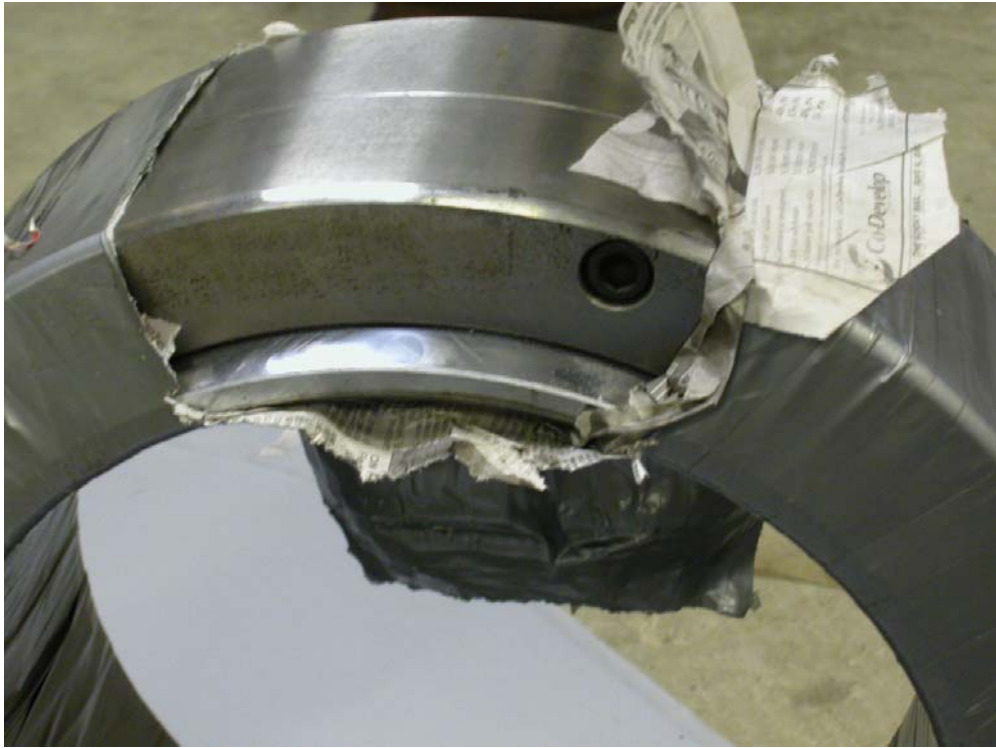
contamination on the surfaces. For example the retaining collar (Item 3 Dwg 560) and 'shaft sleeve' (Retaining Ring Items 4 & 5 Dwg 560) are 316 grade stainless steel which will not corrode, yet from the photographs (Images 1 & 2) they appear to be in a similar condition to the chromed surface of the bearing. Therefore it cannot be definitively stated that bearing surfaces are corroded.

Photo 1
Wivenhoe Dam: Spare Bush, Assembled
Note protruding chromed surface of inner ring

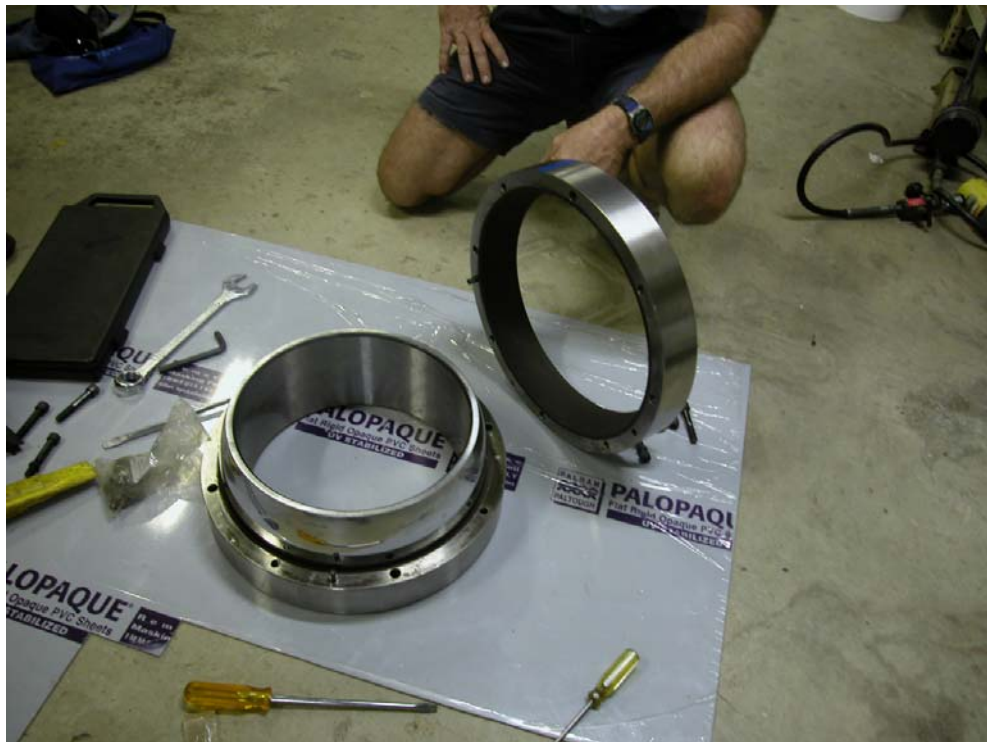
Photo 2
Wivenhoe Dam: Spare Bush, Dismantled
Note Black PTFE coating on outer ring

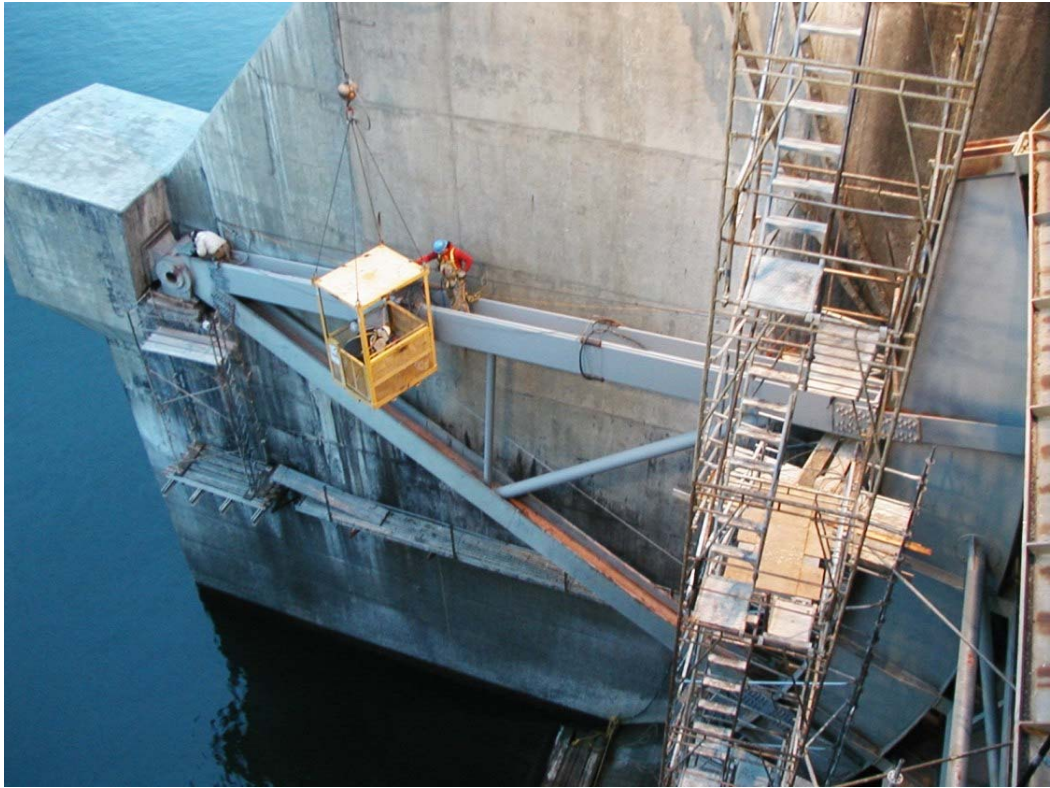
Photo 3
Priest Rapids Dam Washington State USA

Has recently replaced the LUBRITE bushes on its large radial gates with a synthetic bearing material ORKOT (see photos in Appendix B). LUBRITE bushes are bronze journal bushes with hard lubricant slugs. Other contacts report unconfirmed problems with LUBRITE bushes.

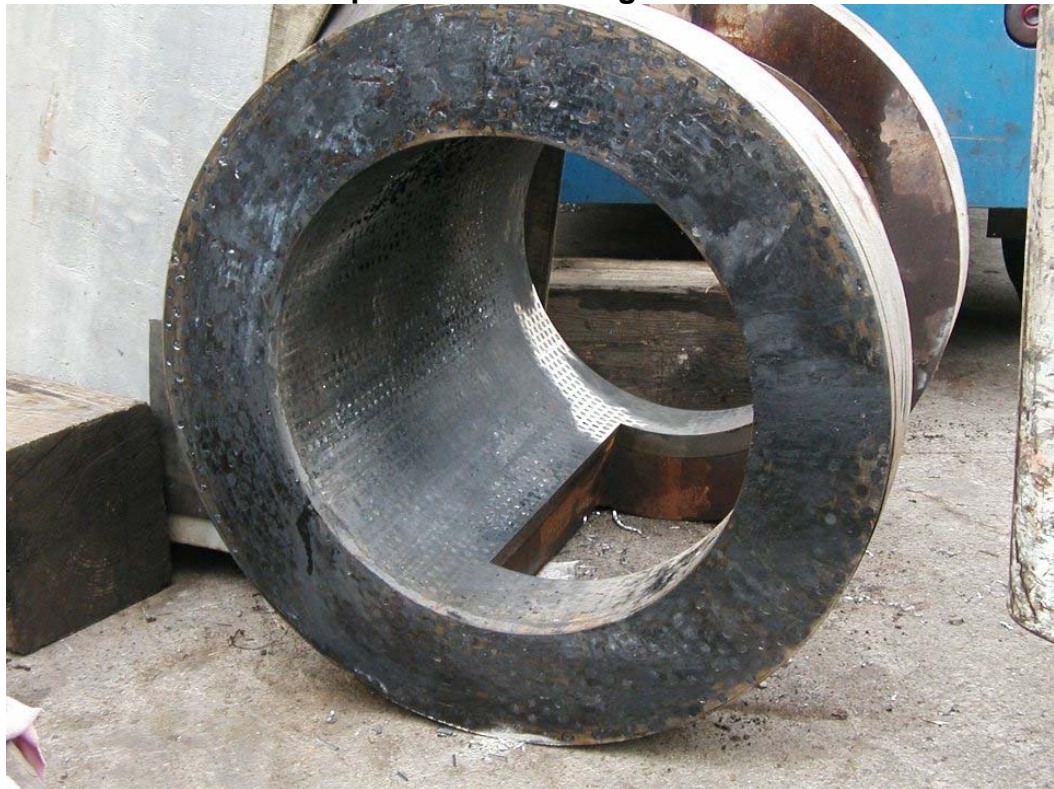
Photo 6
Priest Rapids Dam Washington State USA
Deteriorated Lubrite Bush Replaced by ORKOT

The bearings were replaced with Orkot which is a Teflon (PTFE) composite material. They found it swelled up and required some remedial work after installation.

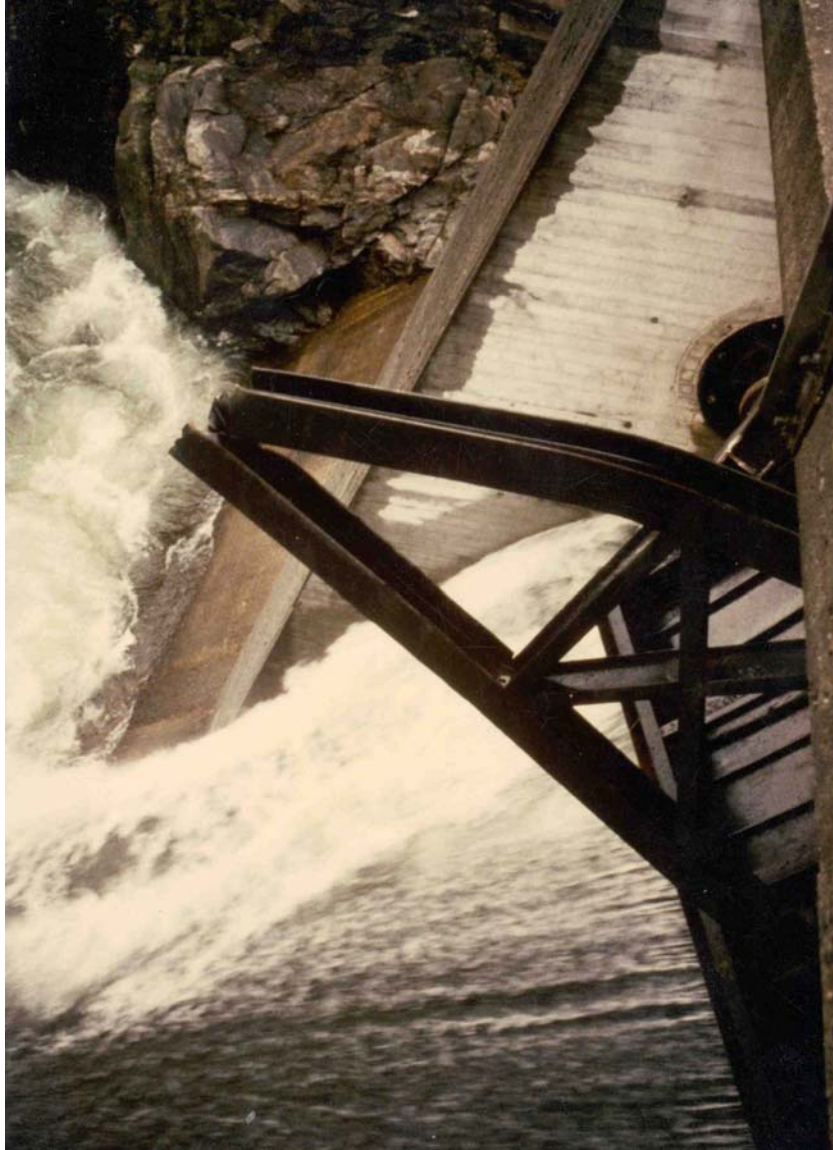
Norconsult are a firm of consultants in Norway. They have strain gauged numerous gates on Norwegian dams and report a number of failures including at least one dam in Norway where the gate arm failed due to excessive friction.

Photo 7
Gate Failure: Ulefoss, Norway
Photo Supplied by H. Fosker of Norconsult, Norway

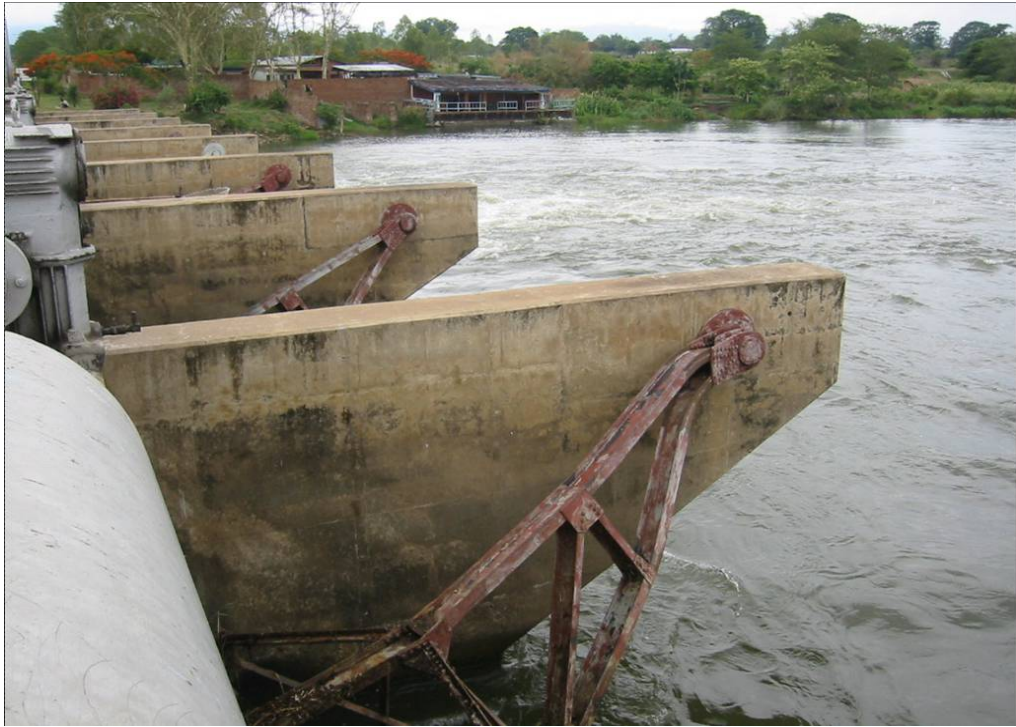
Photo 8

- During initial opening the structure distorts or the trunnion attachment fails. This may be catastrophic (associated with buckling) like Folsom Dam or result in gate damage and possible jamming like the dam in Malawi.
- The hoist fails to generate enough torque to raise the gate, this is highly unlikely. Or the gate fails in a partially closed condition, again highly unlikely, as the torque from the gate weight and moment arm would far exceed the torque from the bearing friction.

**Gate Failure: Liwonde barrage, Malawi, Africa
Photo Supplied by H. Fosker of Norconsult, Norway**
