FLOOD COMMISSION SUBMISSION

A SUITABLE RIVERSIDE PROPERTY DESIGN. (GLENFALLOCH BARRICADE)

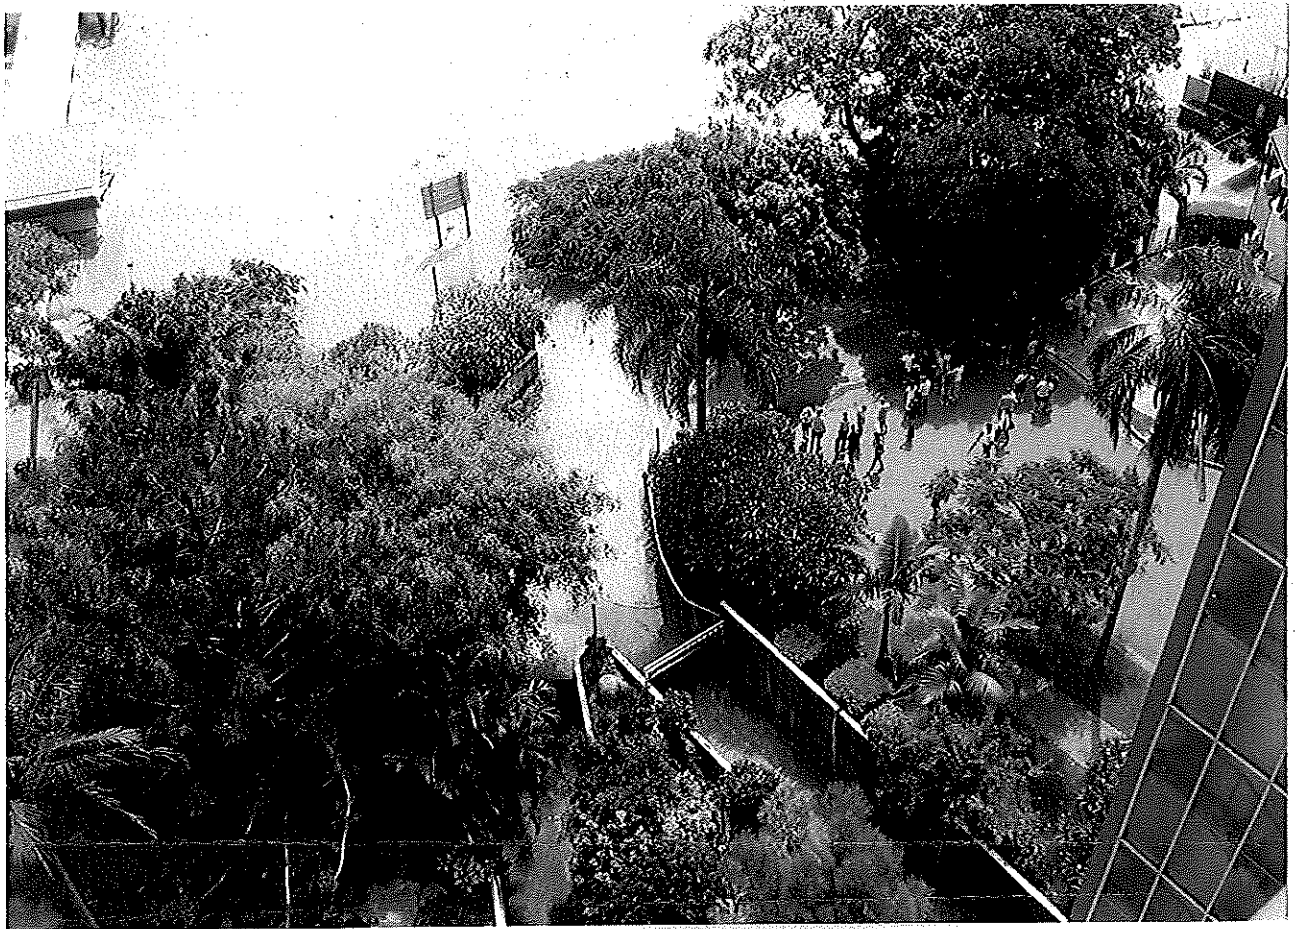
The Glenfalloch building is 51 years old, fourteen stories high and served by two under building garage entrances off a cul de sac at right angles to the river. It is built on the Brisbane River flood plain. Each garage is accessed by a separate driveway, and importantly, each driveway has two meter high side walls.

During the 1974 floods, residents of the time, constructed effective, temporary steel and timber barriers across each garage entrance, the flood vulnerable spots for the property. These barriers were retained and suitably stored for 37 years.

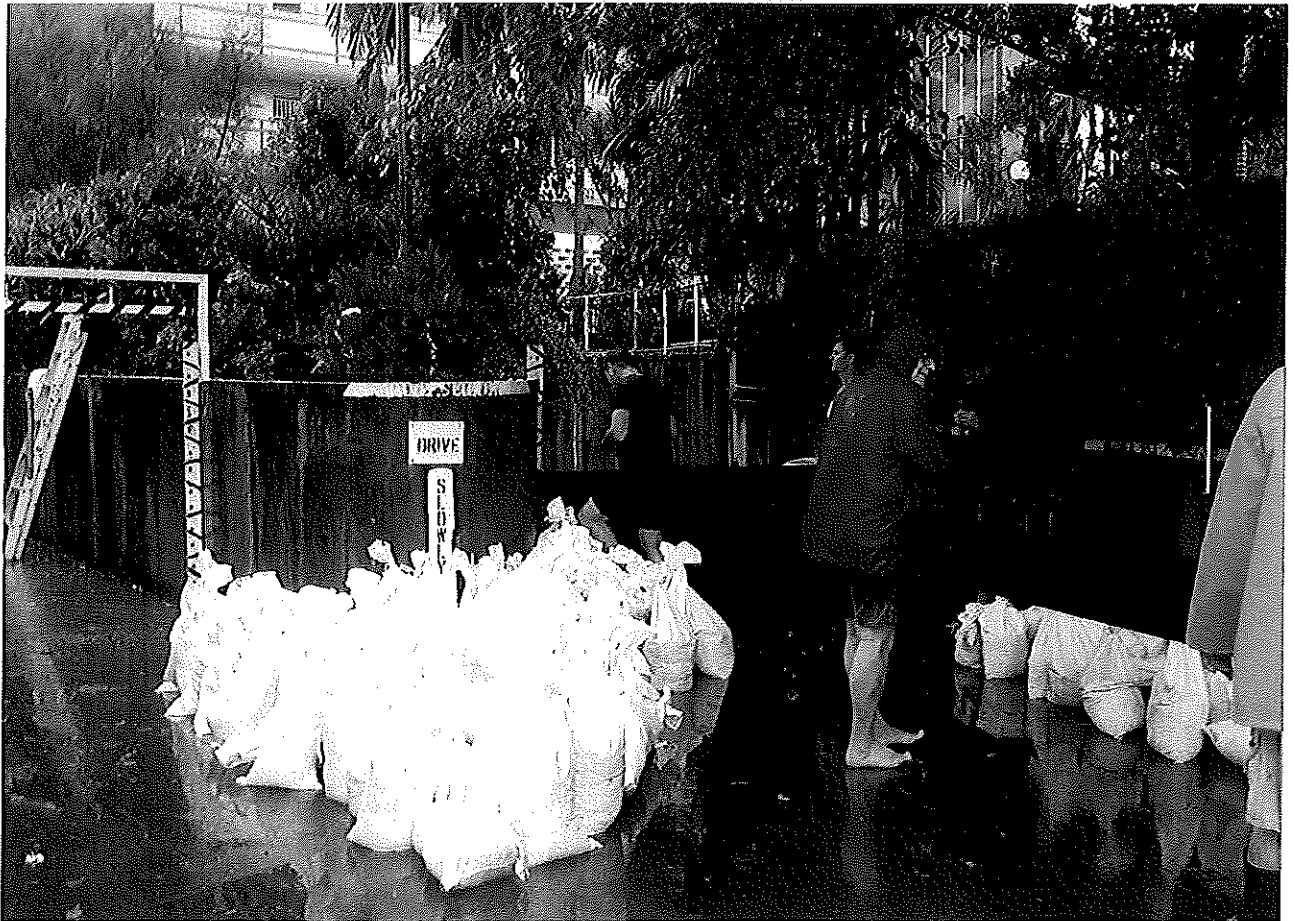
The Glenfalloch building design excludes any vulnerable openings into the garages other than outlet pipes for our two electric garage sump pumps and of course the driveways.

Consequently, providing these openings could be controlled, there could be little or no water inundation unless the river level exceeded the lowest point of the barricades.

The barricades prevented virtually any water entering the garages and were such that a flood height of about another meter could have been defeated.

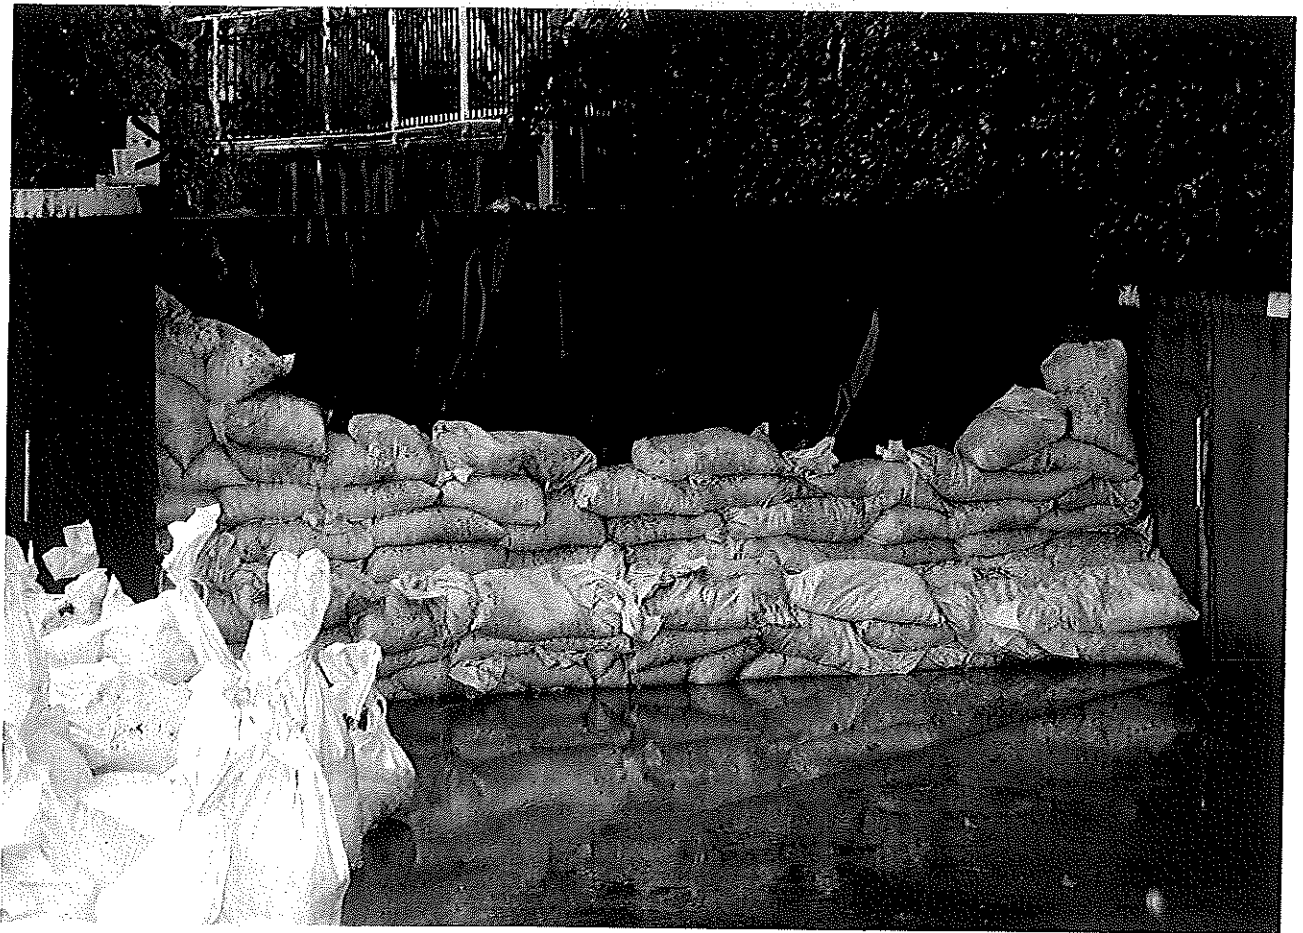
Our two barricades took about 6 hours to complete in the rain, using a dozen willing volunteers. Now we are familiar with our simple barricades we could probably re erect them in about two hours if necessary.

The task involved moving and sorting timber sleepers, securing steel side supports to driveway walls, fitting and bolting swollen wet timbers, obtaining and filling 150 sand bags and the actual construction of the two timber, plastic sheeting and sand bag barriers.

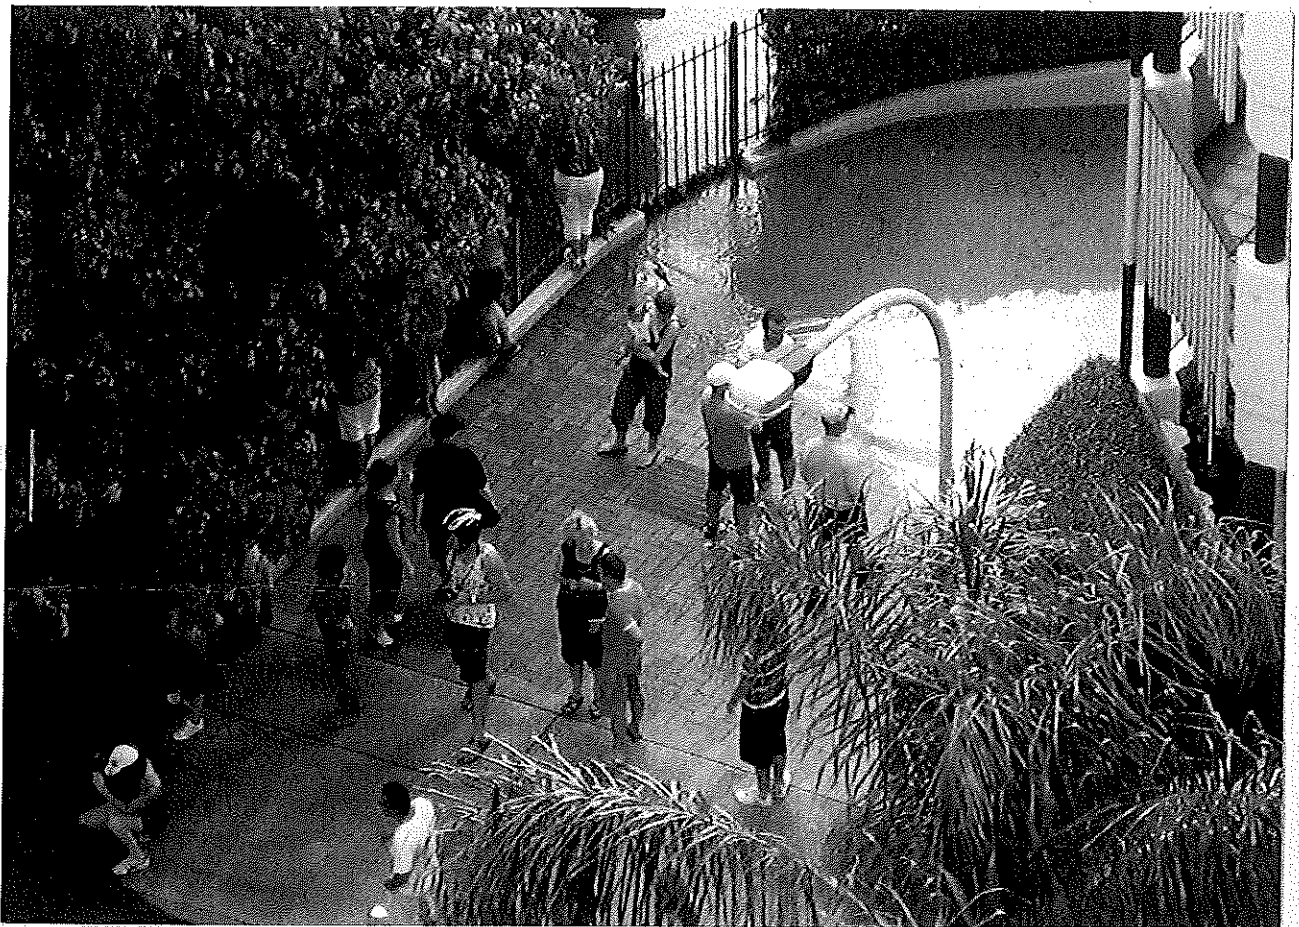
Others used ineffective 'sticky tape' to hold up flimsy plastic sheeting while some built sand bag walls without any essential (water sealing) plastic sheeting.

Indeed one property owner used loose sand only, as presumably sand bags had not been obtained. This of course quickly turned to a different shade of mud in the steady rain.

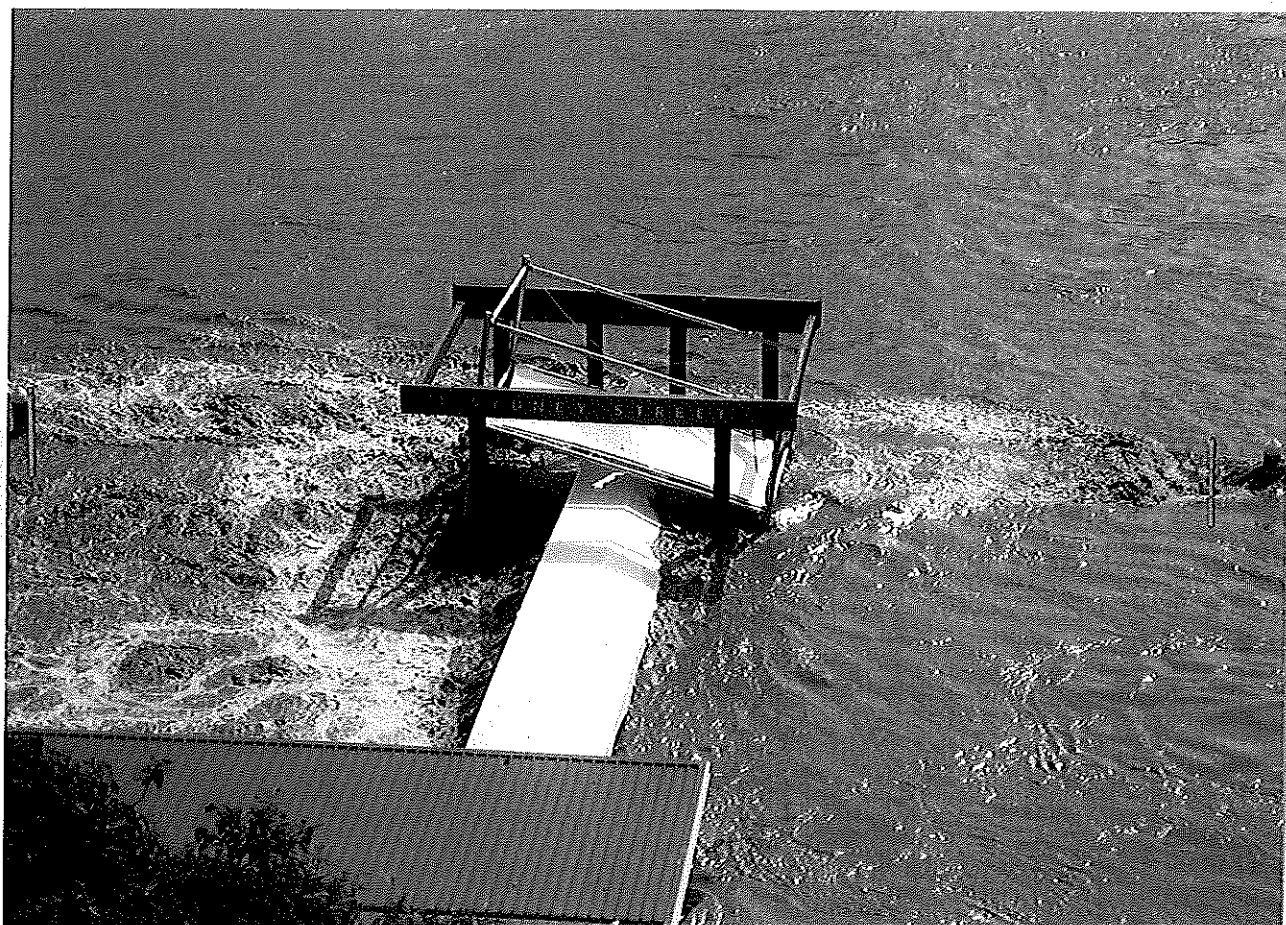
Ferry Terminal Maintenance: The Sydney Street ferry terminal showed signs of strife very early on. One of the two upstream collars, (one of four collars securing the floating stage to embedded pylons), had seized rendering it unable to slide up the pylon as the river level rose.

This was inspected by a uniformed individual early on, however there was no maintenance response. As a consequence the normally floating platform was slowly dragged under rising river water until it eventually sank, dragging with it the connecting walk way. This was well before any significant floating debris struck the now damaged terminal.

This costly damage could have been prevented or limited by prompt maintenance action.

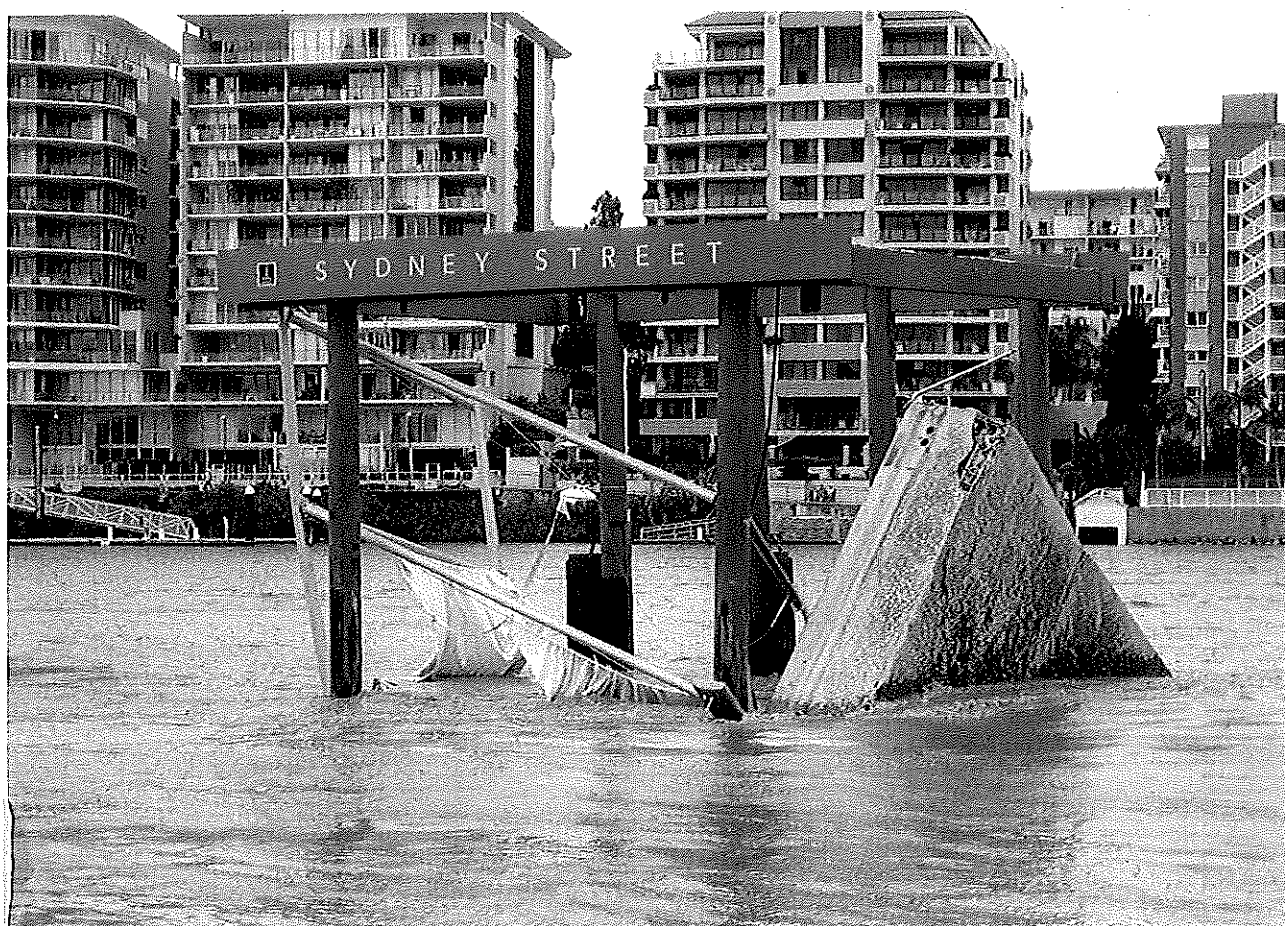
Ferry Terminal Design: The floating sections of City Cat terminal pontoons were constructed with a blunt bow facing up stream. This flat surface ensured debris large and small simply built up against the pontoon increasing down stream pressure.

At Sydney Street, a section of the concrete floating walkway rammed the wreckage of the terminal, well after the pontoon had been dragged under by the jammed collar. Because of the shape of the now submerged pontoon this concrete section was not deflected away into the main stream, damaged the wreckage further then eventually sank in place taking with it, much of what still remained of the damaged terminal.

A conventional bow shaped pontoon could have deflected much of the floating debris, with a more satisfactory outcome.

Ferry Landing Stage Design: That ferry landing stages be redesigned with their upstream bows shaped to deflect floating debris back into the main stream.

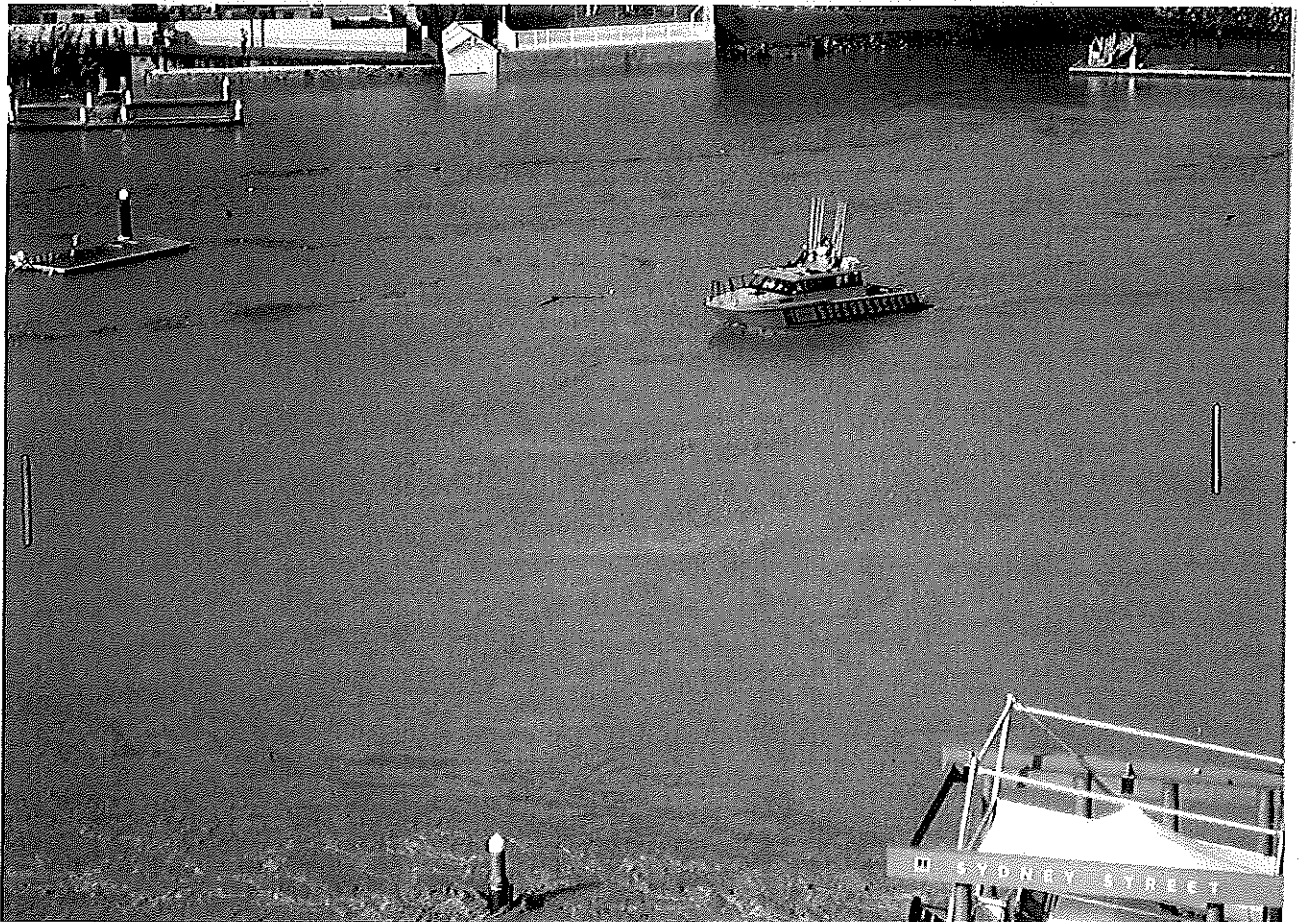
Coast Guard Support: On the Tuesday, two yellow Coast Guard boats loitered mid stream opposite the Ferry Terminal for over half an hour while the crews took photos. During this time five of the lighter and softer non concrete landing stages which floated down the river struck the intact moorings protecting two boats on the south side of the river. One of the Coast Guard boats was a thirty foot or so Shark Cat type catamaran. This tough, stable and powerful boat could have nudged each of the floating pontoons back into mid stream, well before they struck, damaged and became lodged within the

otherwise operational moorings. It was very frustrating for all observers to see such inaction.

Tasking of Volunteer Organisation Equipment / Personnel: That capable volunteer emergency equipment / personnel be better tasks and used.
(e.g. Coast Guard boats could defend undamaged moorings from floating debris within their capability, when not tasked elsewhere)
