Queensland Bulk Water Supply Authority SEQWater

WIVENHOE DAM COMPREHENSIVE INSPECTION JULY 2006

SURVEILLANCE REPORT **FINAL REPORT**

Report No: DC07063

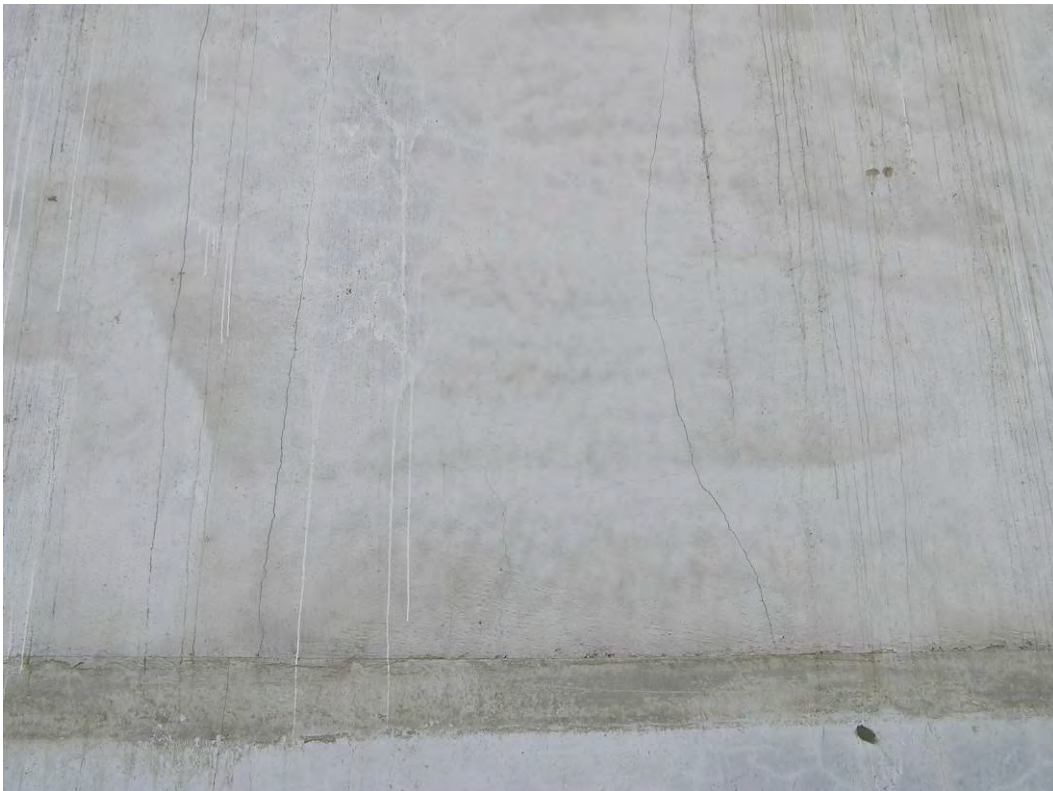
Photograph No. 3: New Auxilliary Fuse Plug Spillway & Highway Bridge

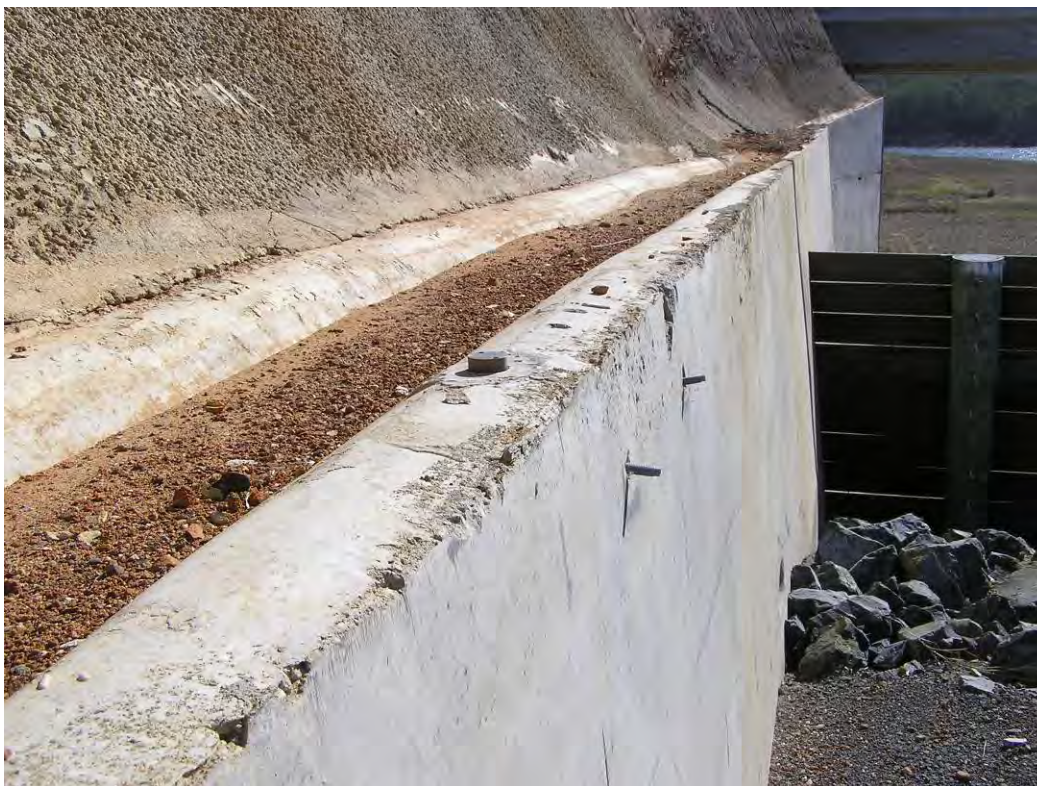
Photograph No. 4: Auxilliary Spillway Left Hand Inlet Training Wall Showing Cracking
