7 January 2008

SEQ Water  
Information Centre Brisbane Valley Highway  
PO Box 367  
FERNVALE QLD 4306

**RE: Site Inspection Report and Proposal for Further Work  
Outlet Works Cutting Stability, Lake Wivenhoe**

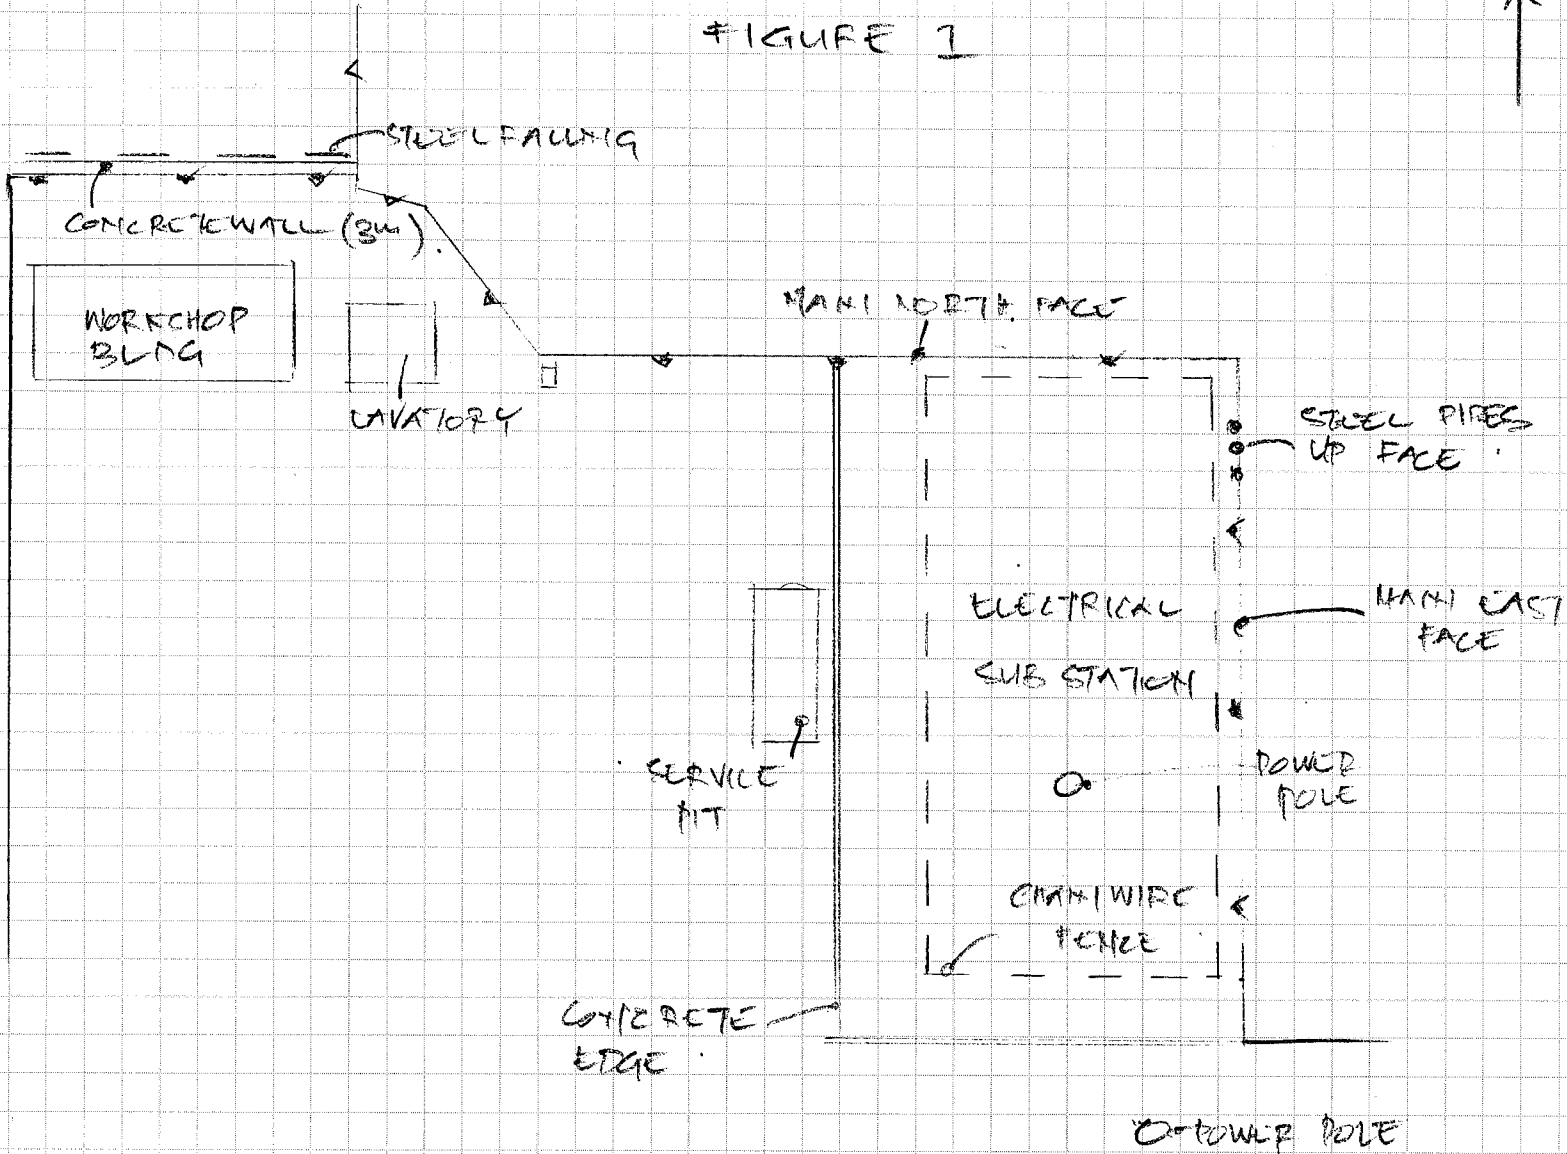
SITE SKETCH (NOT TO SCALE)  
FIGURE 1

Work shop buildings are located at the western end of the cutting and an electrical substation is located at the eastern end of the cutting. The substation is surrounded by chain wire mesh fencing. A steel service pipe runs along the main northern face about 1 m off the ground and 3 steel service pipes run up the main eastern face. A sketch of the general layout is shown on Figure 1.

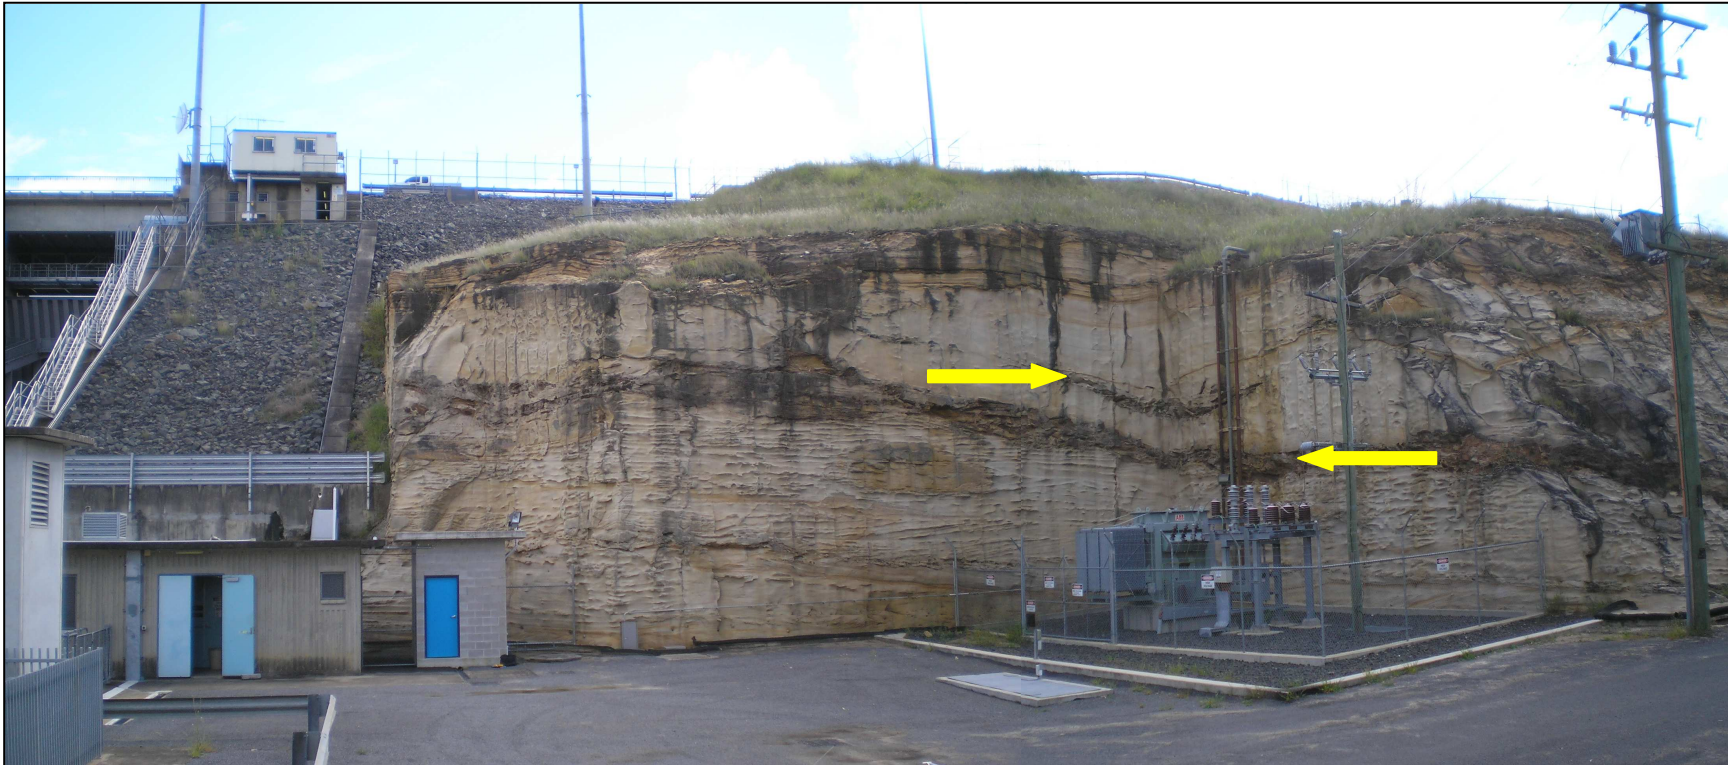
Two bands of highly weathered to extremely siltstone present in the northern and eastern faces lie concordant with the sandstone beds varying between about 0.3 m and 0.8 m thick. The weathered siltstone bands have eroded more rapidly than the sandstone and have begun to undercut the overlying face by typically 0.2 m to 0.3 m but on the main eastern face the undercutting extends up to about 0.5 m deep.

**Photo 1: View of cutting looking towards north. Electrical substation located to right and workshop buildings located to left. Highly weathered siltstone beds arrowed.**

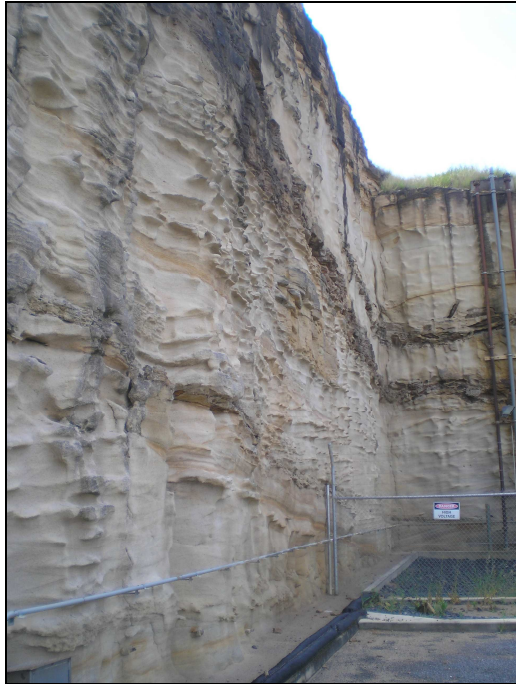
No.	Identified Stability Issues	Preliminary Remediation Options
1	Ravelling of the sandstone face resulting in large cobble and small boulder size fragments being released from the wall. (General across all faces)	<ul style="list-style-type: none"> <li>Establishment of fence barrier at toe of cutting at say 1.5 m to 2 m from face,</li> <li>Scaling / smoothing of the cutting face with an excavator to remove ravelling potential. Access around substation difficult and would probably require it to be isolated.</li> <li>Installation of chain wire mesh draped over and anchored into face,</li> <li>Shotcreting of surface,</li> <li>Or combination of above.</li> </ul>

**Photo 2: View of main north face towards east. Uneven surface relief visible; surface ravelling occurring.**

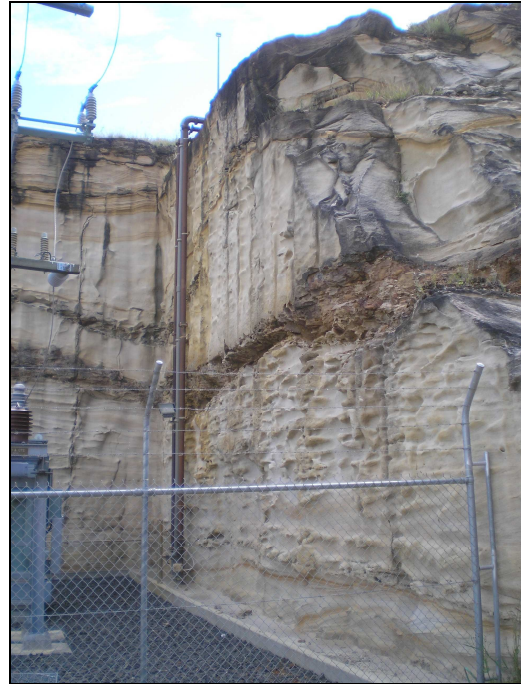
2	Erosion of the siltstone beds causing undercutting and instability of overlying sandstone beds. (Main northern and eastern faces)	<ul style="list-style-type: none"> <li>• Shotcreting with reinforcement dowel bars or mesh. Drainage requirements such as weep holes or strip drains to be considered to control hydrostatic pressures behind the shotcrete.</li> </ul>
3	Minor blocks / slabs of sandstone 0.5 m to 1.5 m height. (Western end / main north face)	<ul style="list-style-type: none"> <li>• Removal of blocks with an excavator.</li> <li>• Retention with chain wire mesh draped over and anchored into face, however may not provide enough restraint for larger blocks.</li> </ul>
4	Major blocks / slabs / wedges of sandstone 2 m to 2.5 m height extending some distance into face. (Western end of cutting)	<ul style="list-style-type: none"> <li>• Removal with an excavator. Need to consider affect on stability of surrounding rock mass and effect on nearby infrastructure.</li> <li>• Stabilise with rock bolts however need to consider potential for dislodgement during installation.</li> </ul>

**Photo 3: View of main east face towards north. Undercutting of siltstone beds evident.**

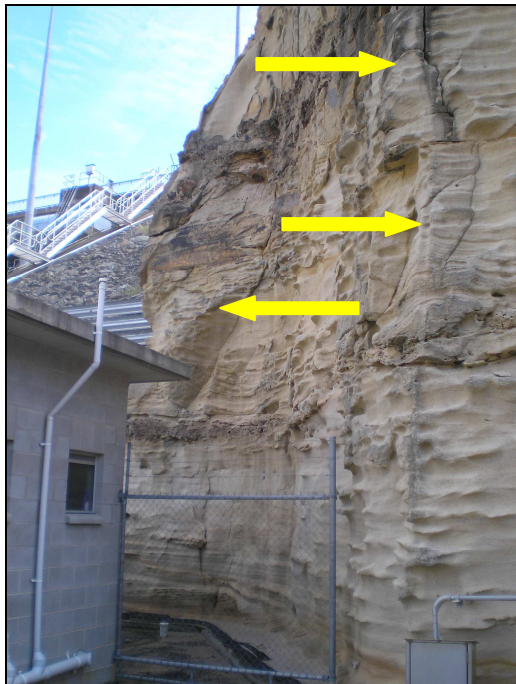
A number of irregular shaped sandstone blocks and/or slabs about 0.5 to 1.5 m in height were identified at the western end of the main north face. Larger blocks up to about 2.5 m in height were identified at the western end of the cutting. It is unclear at this stage if the blocks have been formed by systematic joint sets or random fractures within the rock mass. The blocks could possibly be released with further erosion and water ingress along the face.

**Photo 4: View of small faces towards western end of cutting. Irregular, potentially unstable blocks / slabs arrowed.**

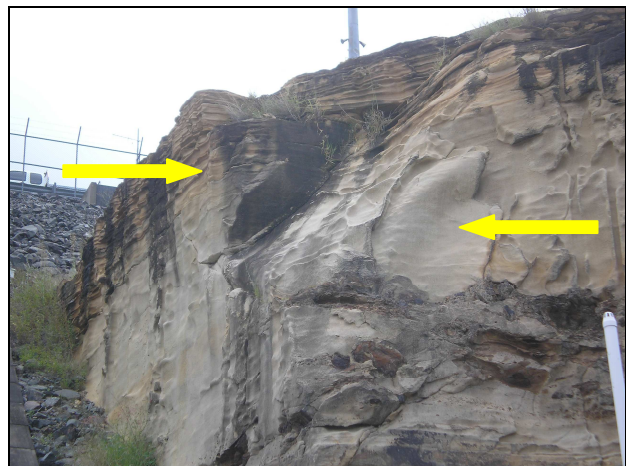
**Photo 5: View of top of western end of cutting. Potentially unstable block arrowed.**
