**IN THE MATTER OF  
THE QUEENSLAND FLOODS COMMISSION OF INQUIRY**

**THIRD STATEMENT OF TERRENCE ALWYN MALONE**

2. This statement addresses only the matters raised by Mark Babister in paragraphs 46-48 of his report "*Brisbane River 2011 Flood Event – Flood Frequency Analysis*" dated 18 September 2011. In summary, Mr Babister has suggested that there may have been mechanical failure with Seqwater's City gauge during the January 2011 Flood Event.
3. I do not make any comment on the remainder of Mr Babister's report.

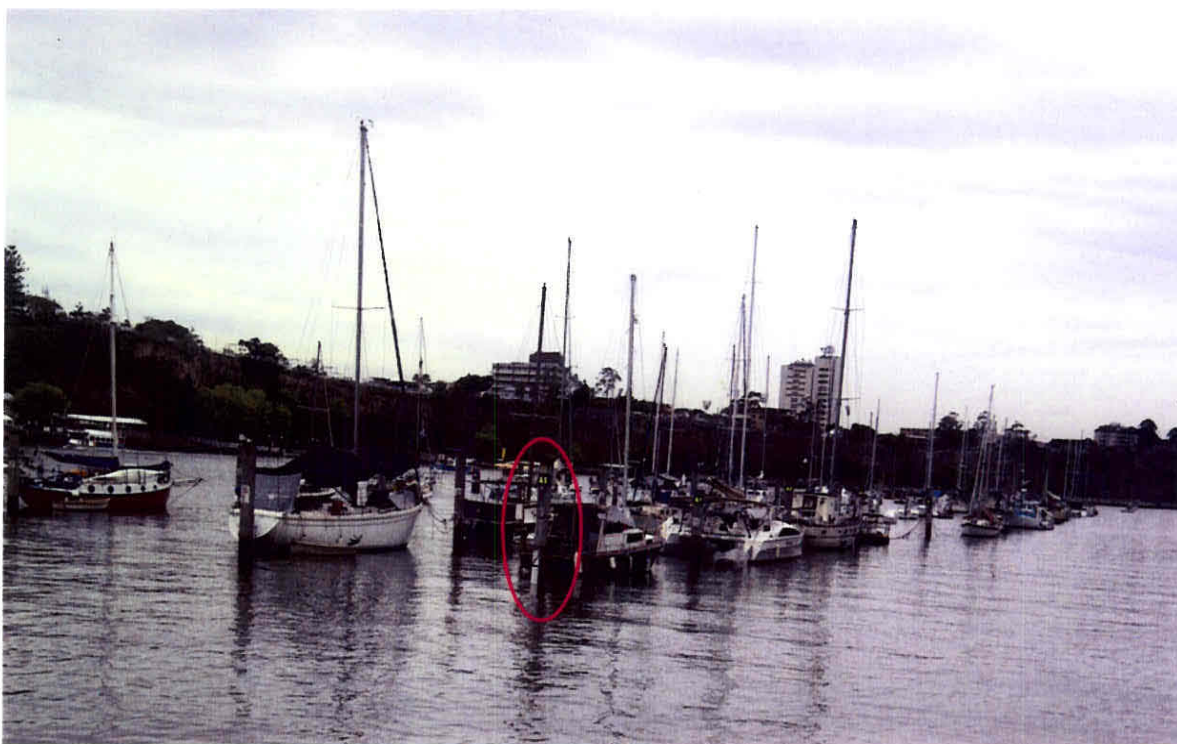
Figure 1 Brisbane Port Office Staff Gauge

11. There is another datum reference which is relevant. It is Lowest Astronomical Tide (*LAT*). LAT is 1.24m below AHD and about 0.09m below LWD.
12. The staff gauge only extends up to 3.8m LWD. This means that for river heights above 3.8m LWD the staff gauge cannot be physically inspected so as to check the readings derived from the instrumentation.

13. Figure 1 below shows the Brisbane Port Office gauge, the upper 1.8m of which was washed away during the January 2011 Flood Event.

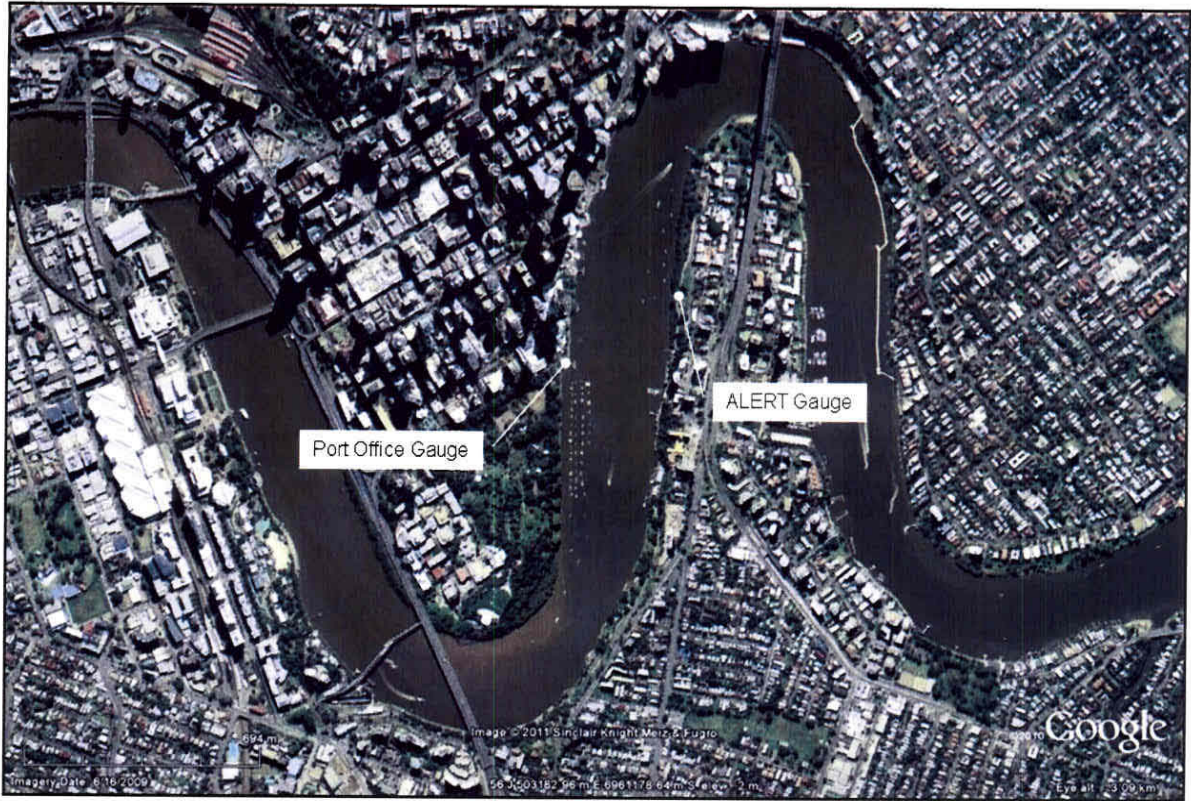
*Figure 2 Brisbane Water Level Gauges*

23. The relative location of the water level gauges in the Town Reach is shown in Figure 2 below.

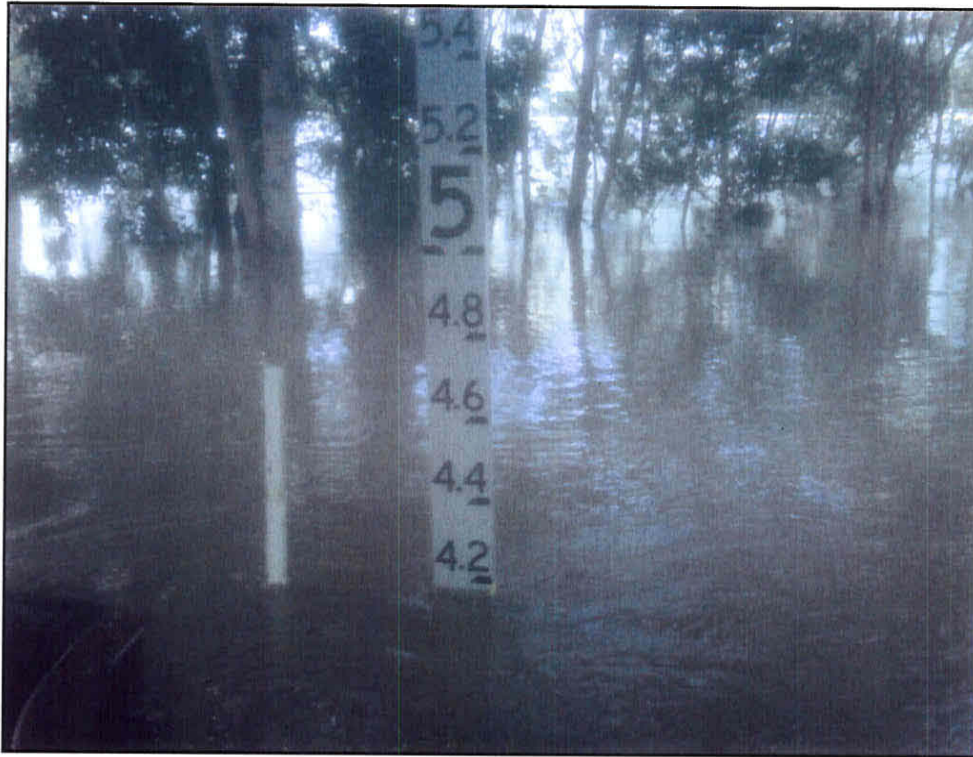
*Figure 3 Brisbane ALERT gauge 07:50 13th January 2011*

29. These observations provided a check on the reading obtained via the ALERT system in the Flood Operations Centre. If necessary, the Brisbane ALERT gauge was re-calibrated to match the observed water level (as observed water levels are preferred to the instrumentation readings).
30. Further, the Senior Flood Operations Engineers (Rob Ayre and John Ruffini) took photos of the surveyed staff gauge at the Brisbane ALERT gauge site at 07:50 on 13<sup>th</sup> January 2011, several hours after the peak. The photograph is shown in Figure 3 below.
31. Records previously provided to the Commission show the Brisbane ALERT gauge had fallen from a peak of 4.46m at 03:39 to 4.20m at the time of the photo (07:50).

32. The staff gauge for Seqwater's Brisbane ALERT gauge is in an area of relatively slack water.
33. The photo in Figure 3 does not show any wave set up or turbulence which might account for artificially elevated water levels.

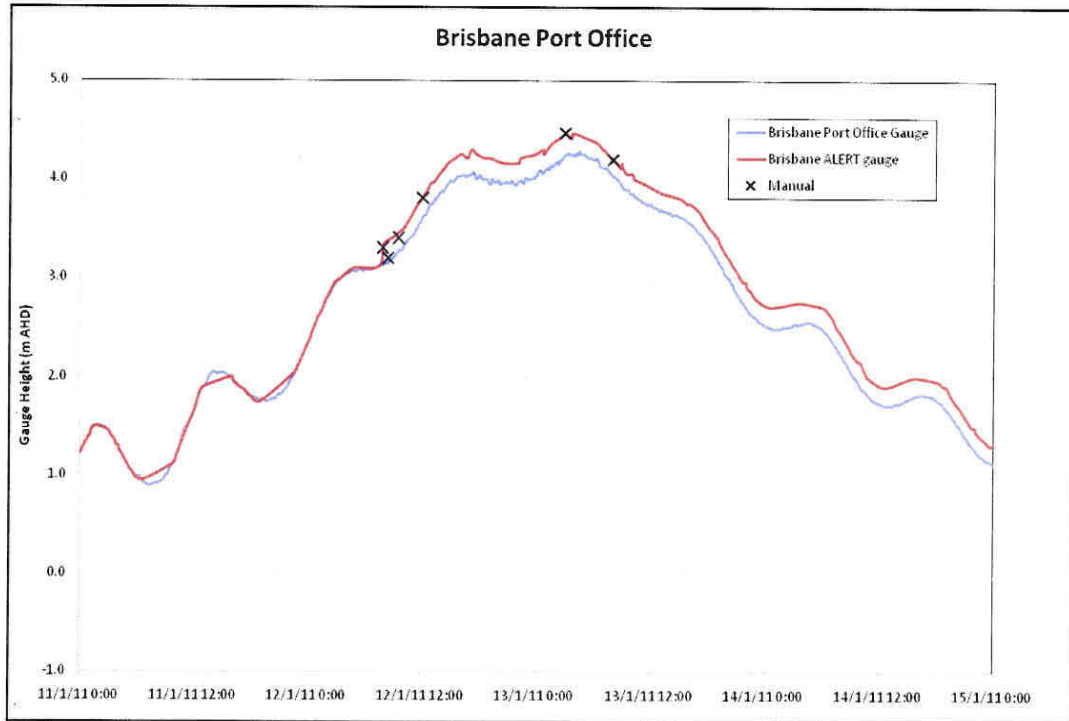
Figure 4 Comparison of Brisbane Gauge Readings

34. A comparison of the readings taken at the MSQ Port Office gauge, the Seqwater ALERT gauge and manual readings from the Seqwater staff gauge adjacent to the Seqwater ALERT gauge is shown on Figure 4 below. Up until the early hours of 12<sup>th</sup> January, the difference between the two gauges was less than 50mm. However at that point, the gauges started to deviate but the Brisbane ALERT gauge readings were confirmed by manual readings from the staff gauge. A difference of about 200mm was then maintained for the remainder of the event.

35. I do not know if MSQ took any manual staff gauge readings at the Port Office gauge to confirm that the instrument was reading correctly during the January 2011 Flood Event. In any case, as I explain above, the flood peak was above the maximum height of the gauge board on the pylon so it would not have been possible to perform check readings once the river height exceeded 3.80m (LWD). During the January 2011 Flood Event, the Brisbane River exceeded this height at the Port Office at least 24 hours before the peak of the event.

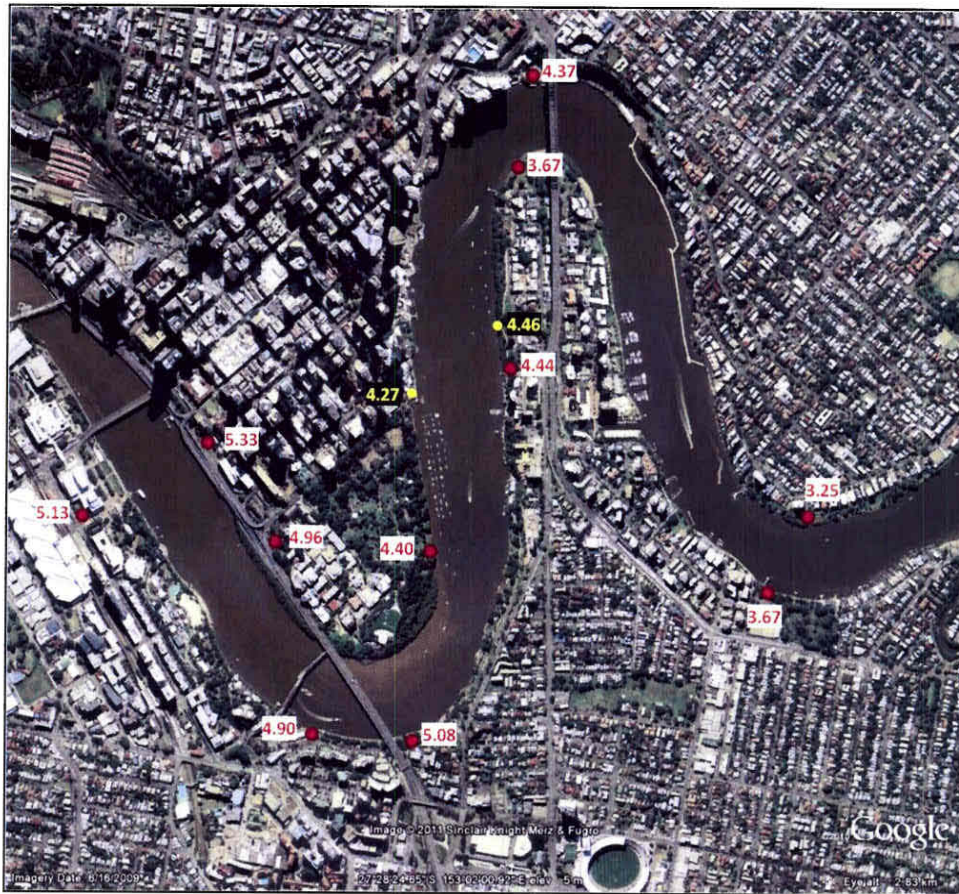
Figure 5 Peak Water Levels in Town Reach Jan 2011

36. My understanding is that BCC surveyed peak water levels in the vicinity of the Town Reach as indicated on Figure 5. The red spots indicated surveyed peak water levels and the yellow spots peak water levels at the gauges.
37. In the Town Reach, the surveyed water levels on the left bank upstream and downstream of the Port Office gauge are both higher than the 4.19m/4.27m recorded by the MSQ Port Office gauge and provided to BoM. This suggests that the peak water level recorded at the MSQ Port Office gauge is too low.

38. The surveyed levels shown in Figure 5 clearly show the impact of superelevation with peak water levels on the outside of the river bends being higher than those on the inside.
39. However, the MSQ Port Office gauge and the Seqwater Brisbane ALERT are located in a relatively straight section in the Town Reach of the Brisbane River.
40. Survey records from 1974 confirm that there is not a large difference in peak water levels between the left and right banks in the vicinity of the Port Office gauge with the difference less than 30mm in January 1974 as shown in Figure 6 below.
41. As a result, my opinion is that superelevation can be discounted as a possible cause of the difference in peak water levels.
