## **WIVENHOE DAM**

### **FIVE YEAR COMPREHENSIVE DAM SAFETY INSPECTION REPORT**

September 2010

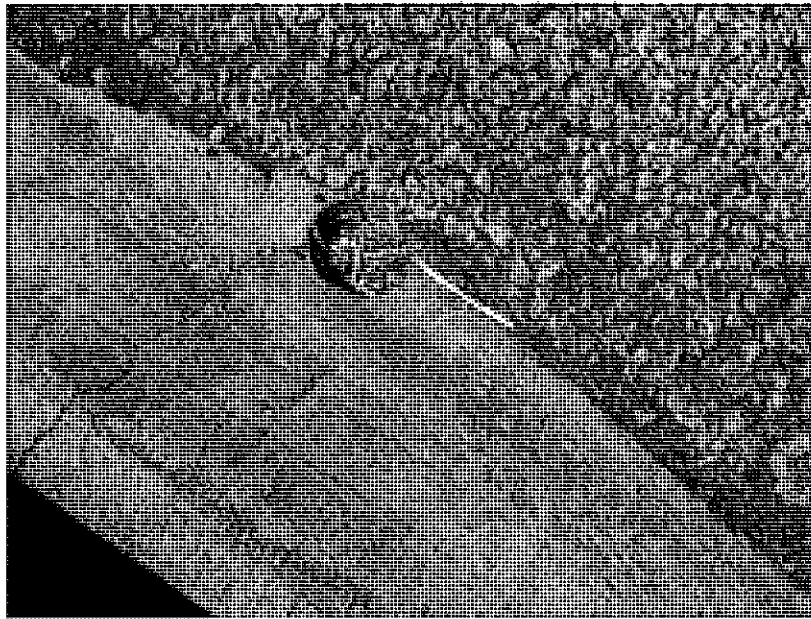
- ***The drains under the wave wall are to be modified to prevent blocking and a store of suitable plugs is to be kept at the dam to enable these drains to be closed off in the event of a flood that impacts on the wave wall (In these circumstances the road would be closed due to flooding and would not be used by the public). This issue is outstanding from the 2008 inspection.***

**Broken/Blocked Road Drain**

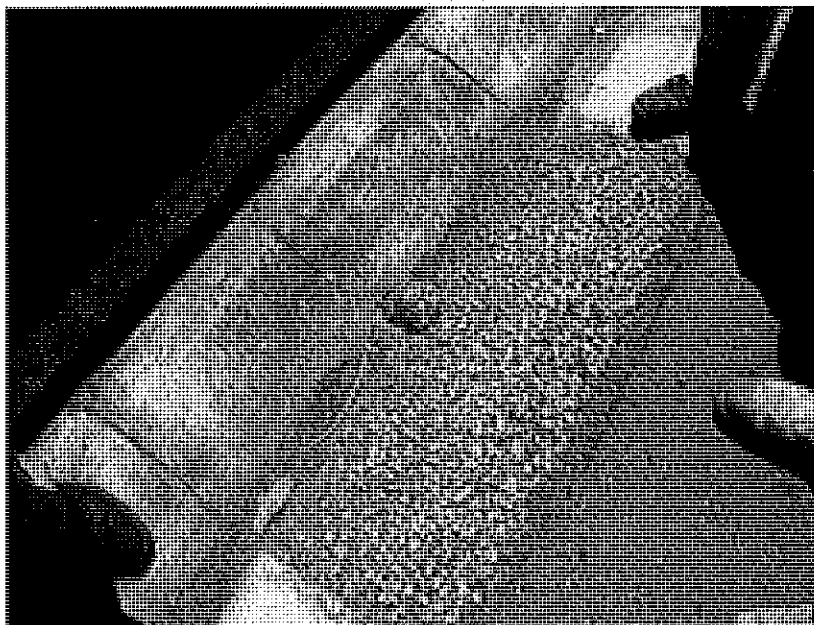
**Broken/Blocked Road Drain**

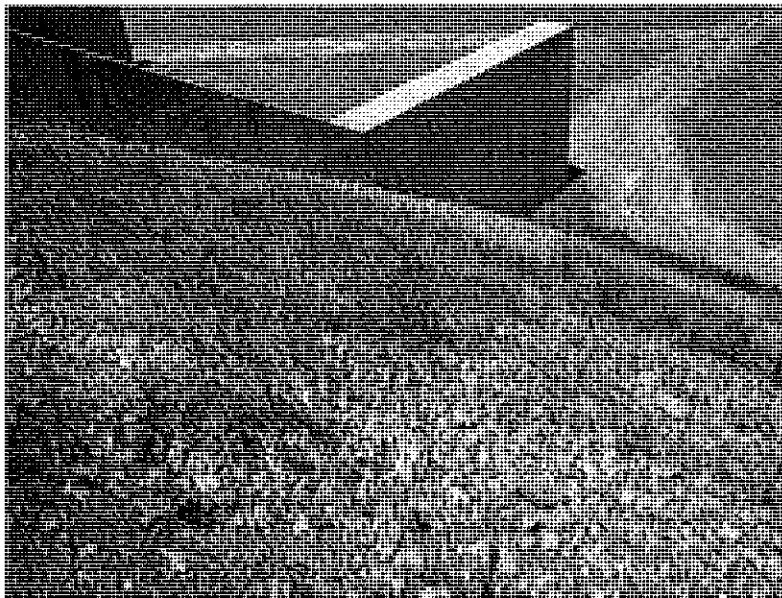
- ***Some minor vegetation is evident on the embankment face and the current weed spraying program should continue.***
- ***Some seepage is evident through the fuse plug embankments and a suitable V-notch weir is to be constructed to allow monitoring of this seepage.***

**Vegetation to be sprayed**

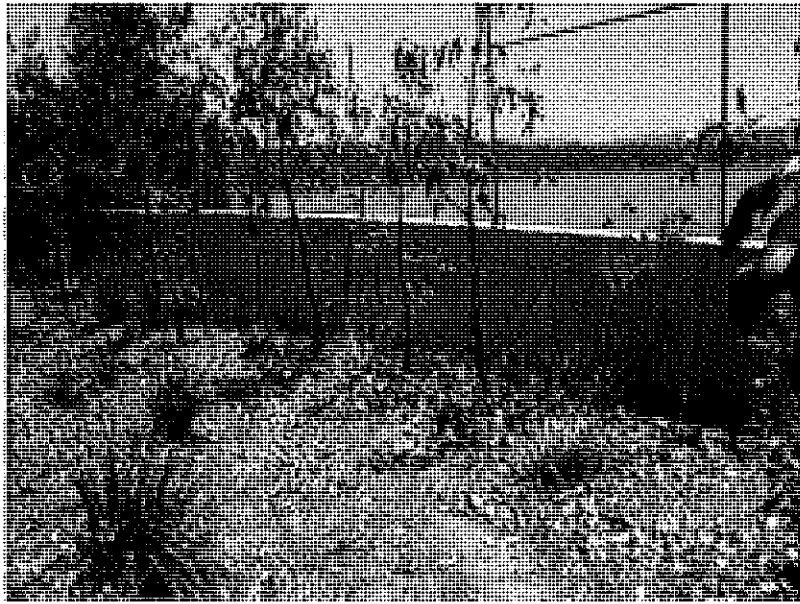
**Trees to be removed**

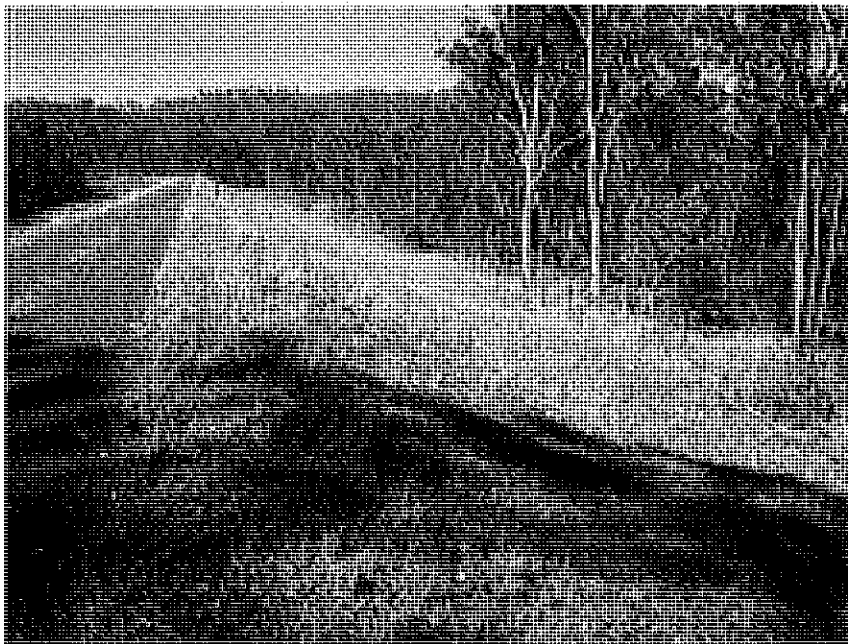
**Saddle Dam**

- *Any undesirable vegetation is to be removed from the embankments and the current weed spraying and mowing program is to continue.*
- *All cattle must be excluded from the embankments and the damage caused by the cattle must be repaired.*

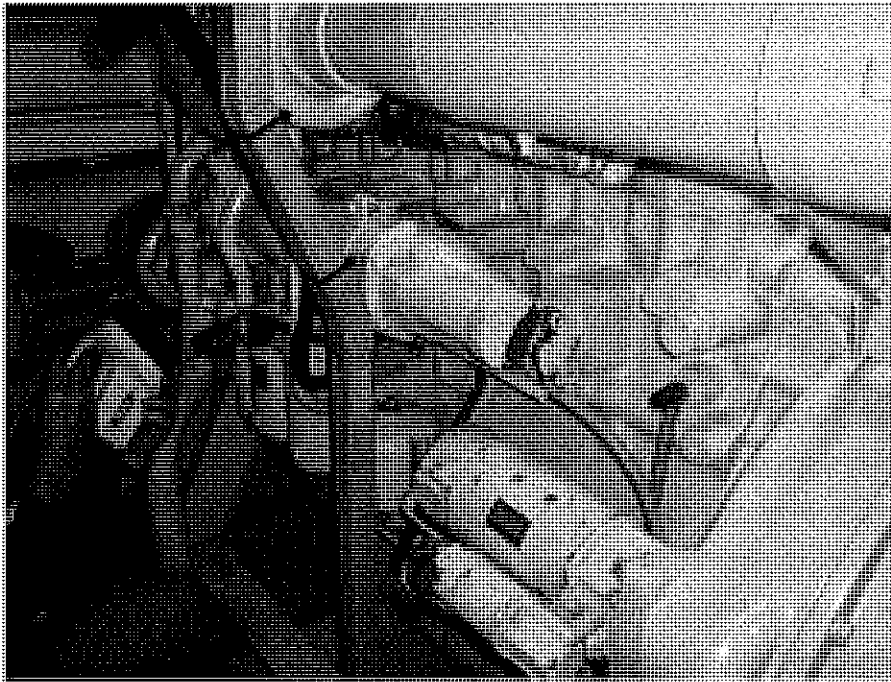
The physical infrastructure at the dam is generally maintained in good condition; however the Standby Diesel Generator is nearing the end of its useful life and should be replaced within the next 12 months. All other major dam components are performing satisfactorily.

**Standby Diesel Generator**

- **Replace the Standby Diesel generator as it is no longer reliable.**
- **Repair the concrete damage to the spillway floor and replace the missing flap gate on one of the spillway underdrain outlets.**
- **Initiate a painting program for the downstream sides of the radial gates. It may be sensible to paint one gate per year over the next five years.**

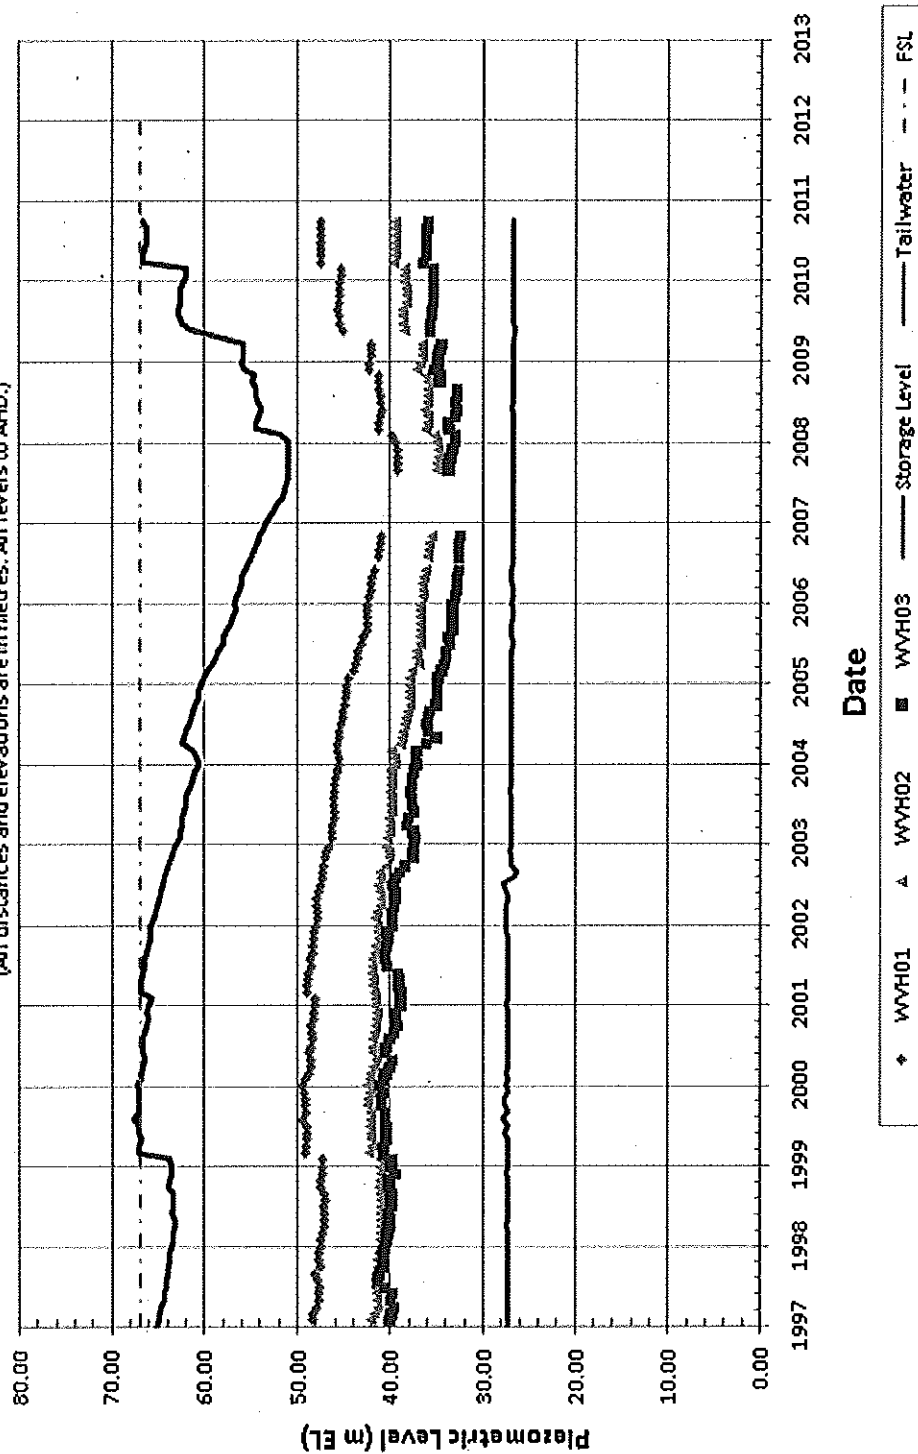
PIEZOMETERS	DESCRIPTION	COMMENTS	CURRENT TRIGGER
WVH01 WVH02 WVH03	These three piezometers are located within the sandstone foundation at EL 15 metres under the embankment core at Ch 1600. WVH01 is 11 metres upstream of the embankment centreline, WVH02 is on the embankment centreline and WVH03 is 11 metres downstream of the embankment centreline. The grout curtain is located midway between WVH01 and WVH02.	<p>The pressure readings from these piezometers are consistent with historical performance dating back to the first filling of the dam in 1988 and historical peak readings have not been exceeded over the last five years.</p> <p>The pressure drop across the grout curtain remains in the order of five metres, indicating some leakage across the curtain. This is in line with historical performance.</p> <p>Some seepage is evident below the embankment in this location which supports the readings indicating some seepage across the grout curtain.</p>	<p>Any reduction in the pressure differential between WVH01 and WVH02 to a value equal to or below 4.5 metres should trigger additional monitoring and investigation.</p> <p>Any increase in the pressure reading for WVH02 in excess of EL 42 metres should trigger additional monitoring and investigation.</p>

Wivenhoe Dam Piezo Levels @ CH1600 & EL ~15  
 (WVH01 @ 11.0 U/S; WVH02 @ 0.0; WVH03 @ 11.0 D/S)  
 (All distances and elevations are in metres, All levels to AHD.)

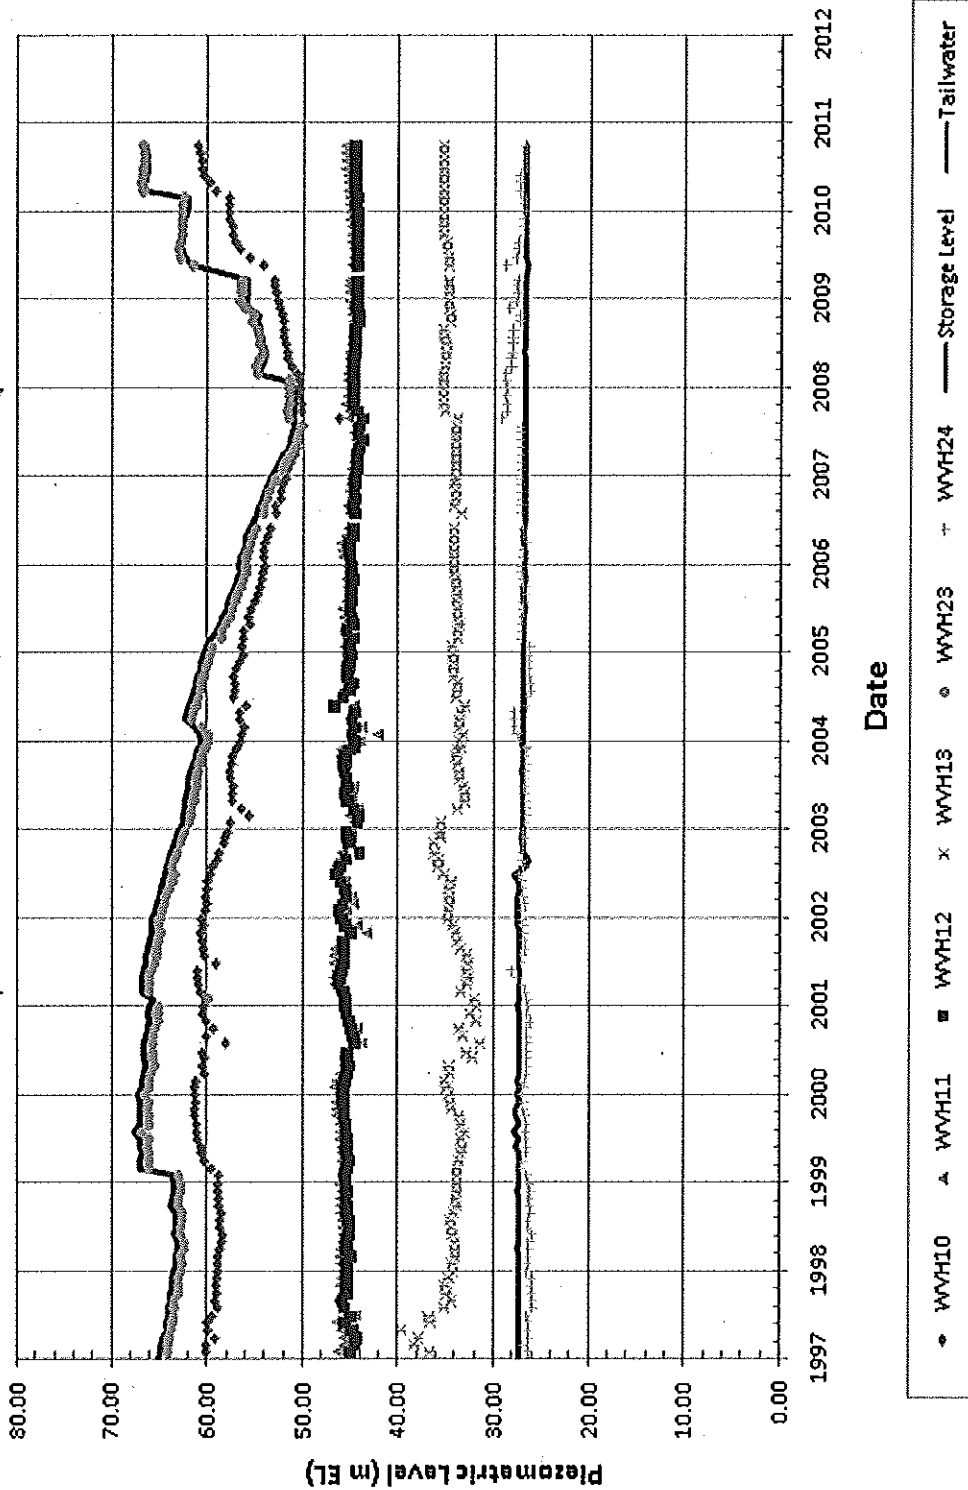
WVH23 WVH24	These two piezometers are located at EL 32 metres within the alluvium at Ch 1600. WVH23 is 42 metres upstream of the embankment centreline and WVH24 is 42 metres downstream of the embankment centreline.	As expected, WVH23 is connected directly to the storage and WVH24 is free draining with no apparent connection to the storage.	Any increase in the pressure reading for WVH24 in excess of EL 64.5 metres should trigger additional monitoring and investigation.
WVH25 WVH26 WVH27	These three piezometers are located within the sandstone foundation at EL 15 metres under the embankment core at Ch 1800. WVH25 is 11 metres upstream of the embankment centreline, WVH26 is on the embankment centreline and WVH27 is 11 metres downstream of the embankment centreline. The grout curtain is located midway between WVH25 and WVH26.	<p>The pressure readings from these piezometers are consistent with historical performance dating back to the first filling of the dam in 1988 and historical peak readings have not been exceeded over the last five years.</p> <p>The pressure drop across the grout curtain remains in the relatively high, indicating that seepage across the curtain is unlikely. This is in line with historical performance.</p>	Any increase in the pressure reading for WVH26 in excess of EL 35 metres should trigger additional monitoring and investigation.

**Wivenhoe Dam Piezo Levels@ CH1600 & EL ~35**  
 (WVH10 @ 8.0 U/S; WVH11 @ 3 U/S; WVH12 @ 3 D/S; WVH13 @ 8.0 D/S; WVH23 @ 42 U/S; WVH24 @ 42 D/S)  
 (All distances and elevations are in metres. All levels to AHD.)

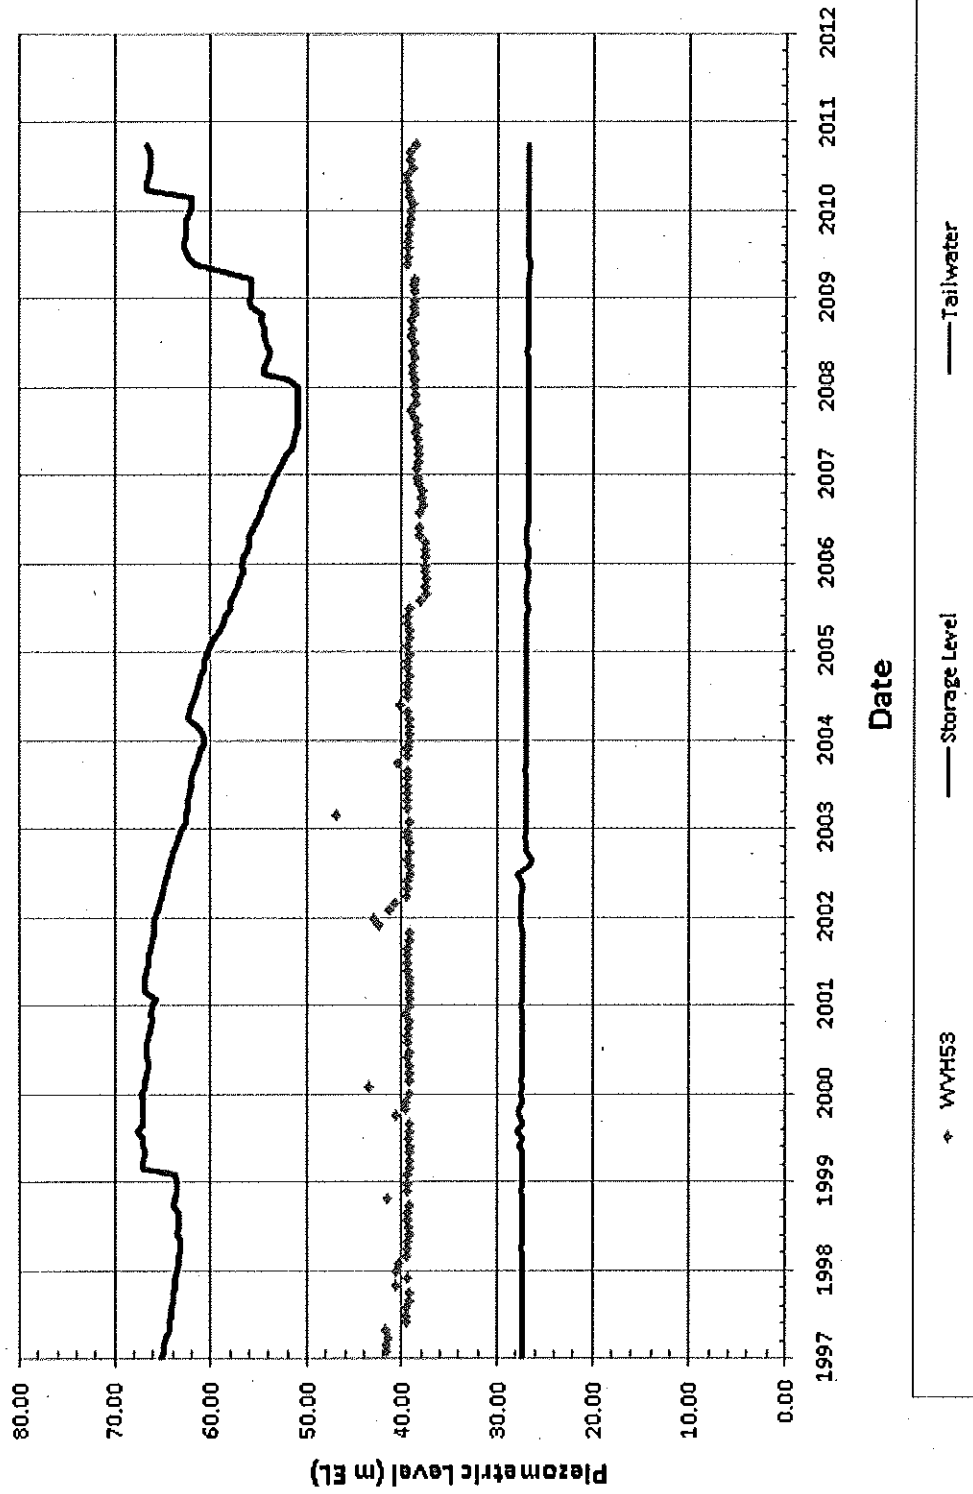
WVH64 being the most upstream piezometer moving sequentially downstream to WVH59, the most downstream piezometer.	over the last five years.	
WVH65	This piezometer is located at EL 39 at the interface of spillway monolith 55 and the spillway foundations, at Ch 1215. The piezometer is located directly under the lower gallery.	The pressure readings from this piezometer are consistent with historical performance dating back to the first filling of the dam in 1988 and historical peak readings have not been exceeded over the last five years.	Any trend showing an increase in the pressure reading for the piezometer.

**Wivenhoe Dam Piezo Levels at Mono S5 - WWH65 @ EL ~39**  
 (All distances and elevations are in metres. All levels to AHD.)

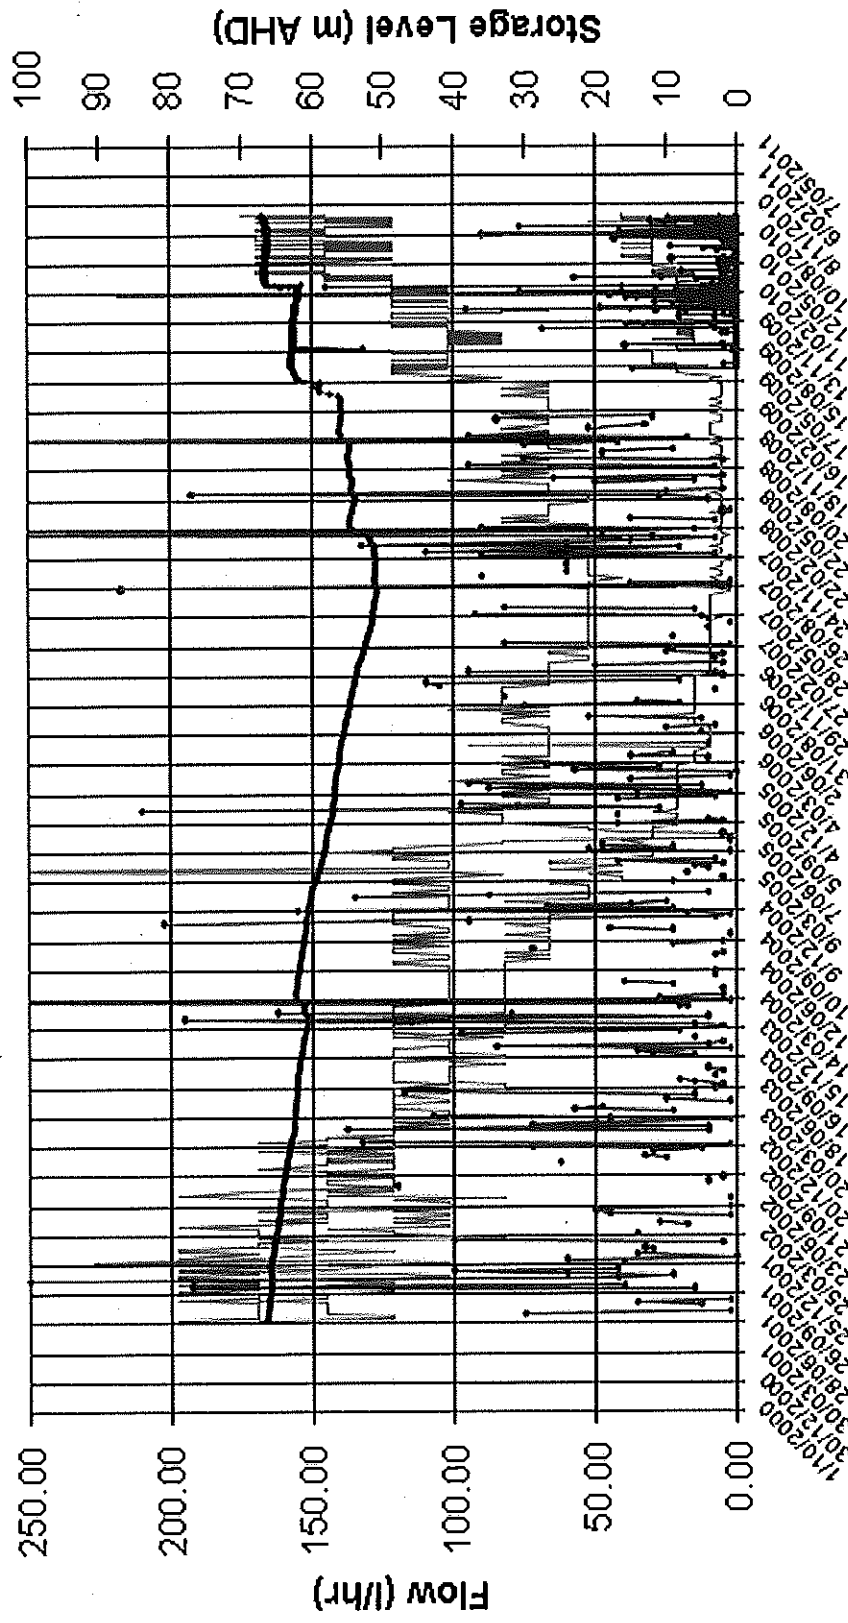
# Wivenhoe Leakage - Gallery Weirs

V- NOTCH WEIR	DESCRIPTION	COMMENTS
Gallery East Gallery West	These two V-notch weirs monitor seepage through the spillway section of the dam and are located in the lower gallery.	A review of the results over the last ten years shows no trends for increased seepage. Recent increases associated with increased storage level are consistent with historical trends. Current steady state seepage levels in the order of 150 litres per hour are not cause for concern.
V-Notch East	This V-notch weir monitors seepage through the left bank embankment. A series of gravel finger drains collect water seeping through the core and foundations as shown on Plans A1-45403 and A2-79207. This water is directed to the V-notch via a series of pipelines.	A review of the results over the last ten years shows no trends for increased seepage. Recent increases associated with increased storage level are consistent with historical trends. Current steady state seepage levels in the order of 150 litres per hour are not cause for concern.

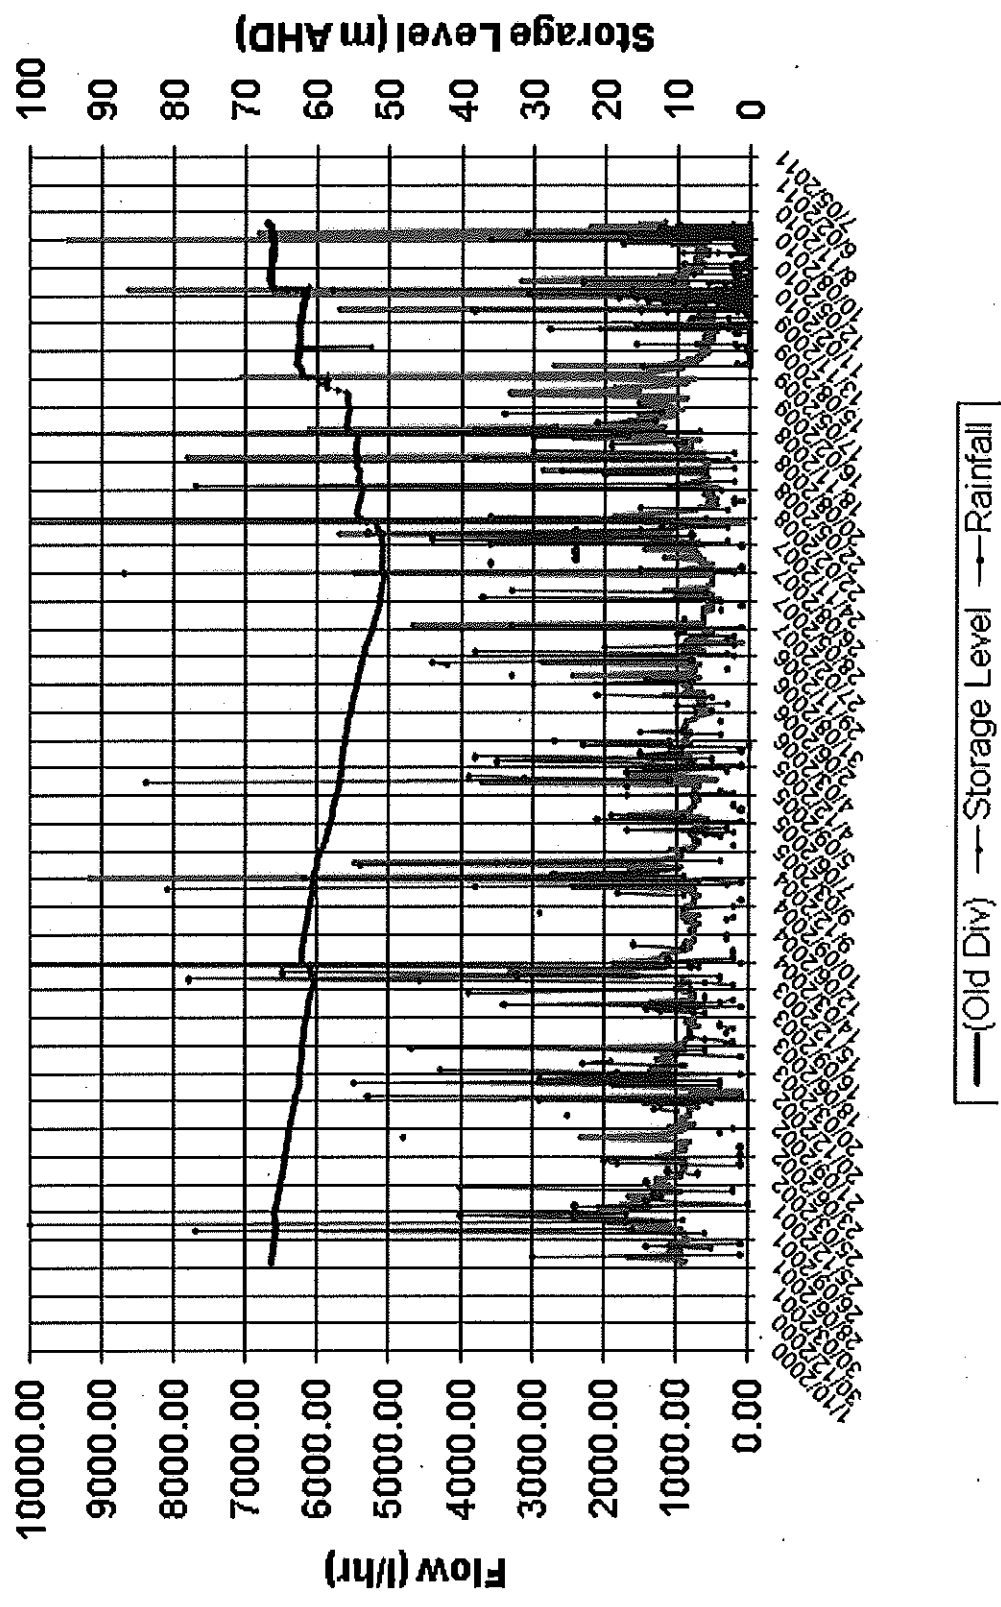
# Wivenhoe Leakage - RHS Embankment Old Diversion Channel

V-Notch West	This V-notch weir monitors seepage through the right bank embankment. A blanket drain collects water seeping through the core and foundations as shown on Plans A1-50789 and A2-79257. This water is directed to the V-notch via a series of pipelines.	A review of the results over the last ten years shows no trends for increased seepage. Recent increases associated with increased storage level are consistent with historical trends. Current steady state seepage levels in the order of 600 litres per hour are not cause for concern.
--------------	---	---
