Statement of Witness

Queensland Floods Commission of Inquiry

FIRST REPORT – FLOOD DAMAGE CLAIM

3 SITE INSPECTION

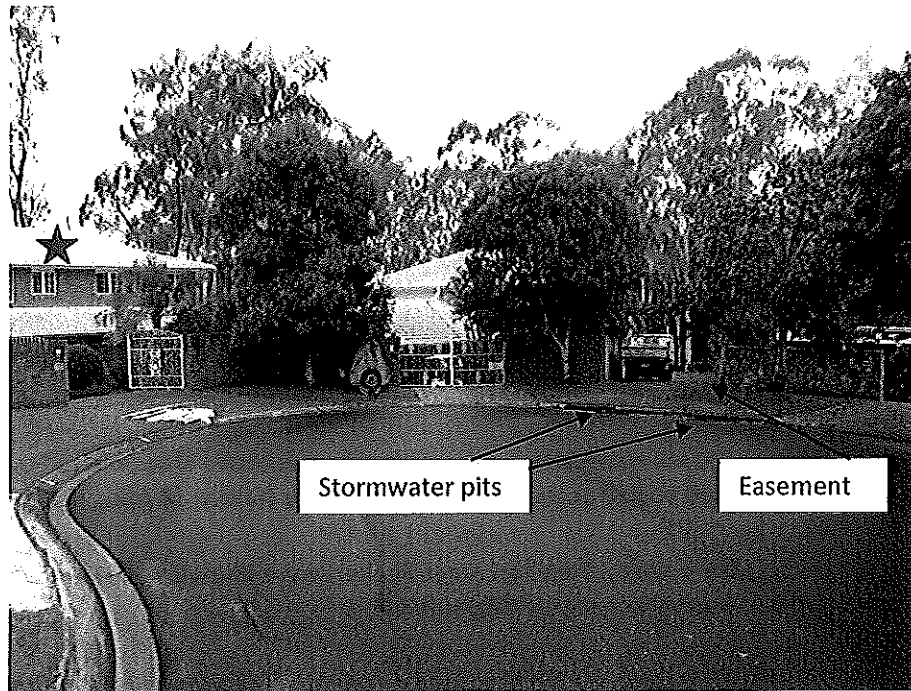
Figure 3-1 [REDACTED] (taken: 18 April 2011)

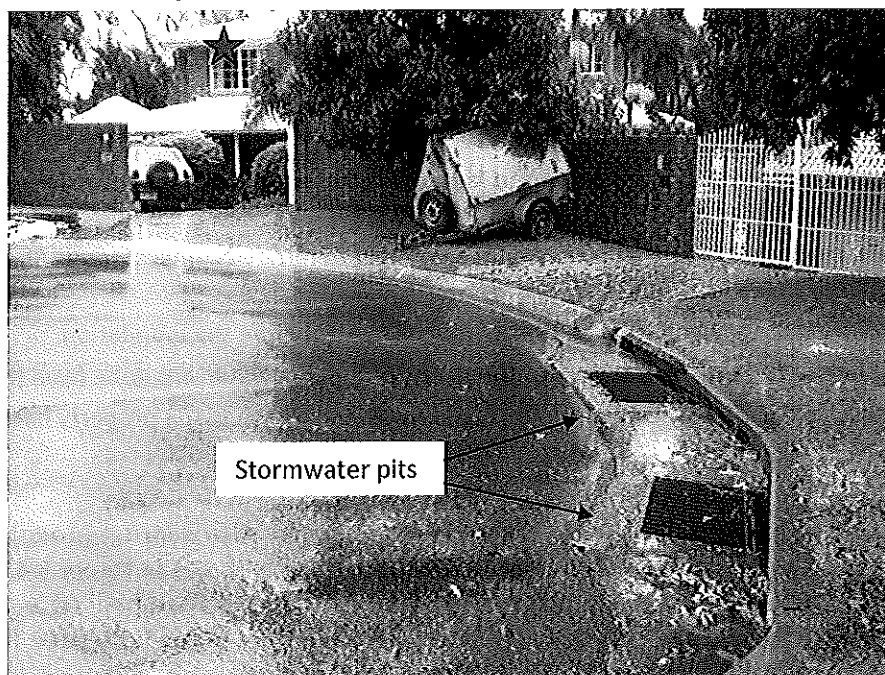
Figure 3-2 [REDACTED] stormwater pits (taken: 18 April 2011)

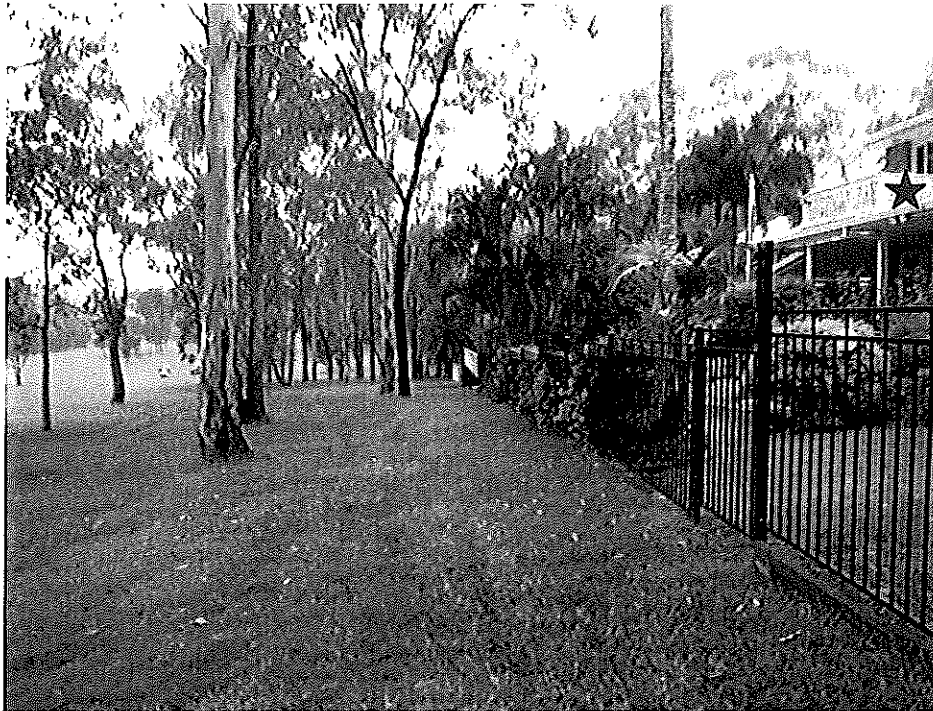
Figure 3-3 Golf course at the back of the property (taken: 18 April 2011)

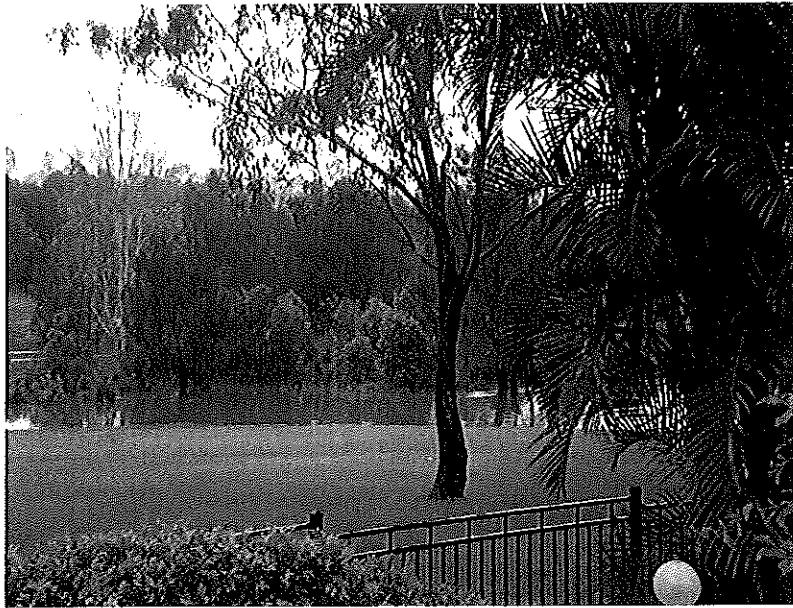
Figure 3-4 Inundation on Golf course at the rear of the property (taken by owner: 4:47pm on Tuesday 11 January 2011)

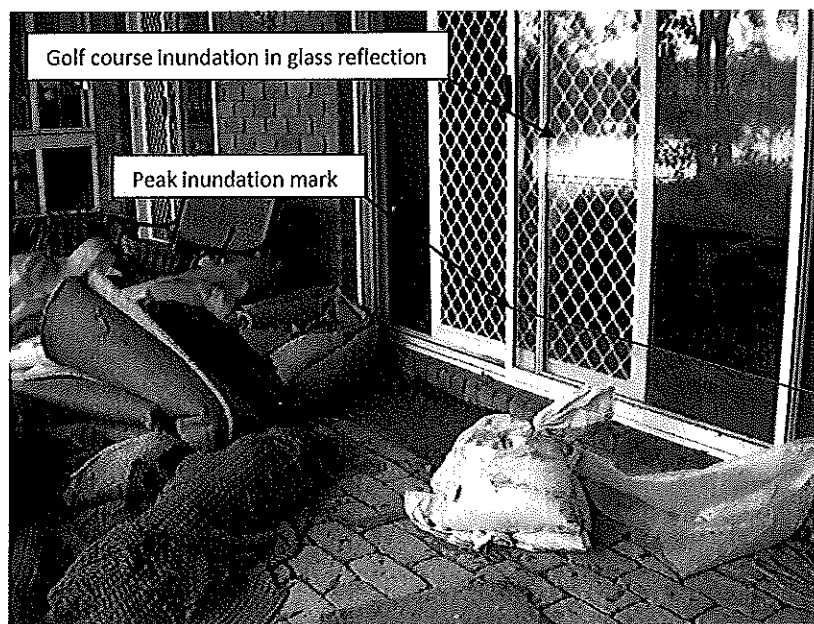
Figure 3-5 Rear of house (taken by owner: 1:55pm on Thursday 13 January 2011)

During the site inspection Mr Fischer pointed to a spot where he believed the peak water level was. This was measured to be approximately 300mm above the slab floor level and matches well with Figure 3-5 provided by Mr Fischer. It was noted that the highest point on the property is at the south-western corner near the driveway. The driveway was estimated to be 100mm lower than this

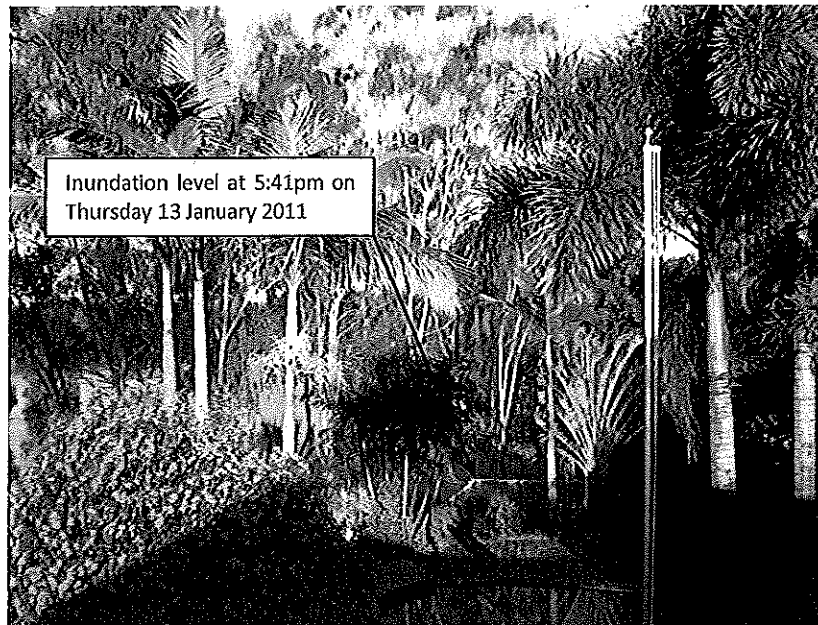
Figure 3-6 Inundation on Golf course at the rear of the property (taken by owner: 5:41pm on Thursday 13 January 2011)

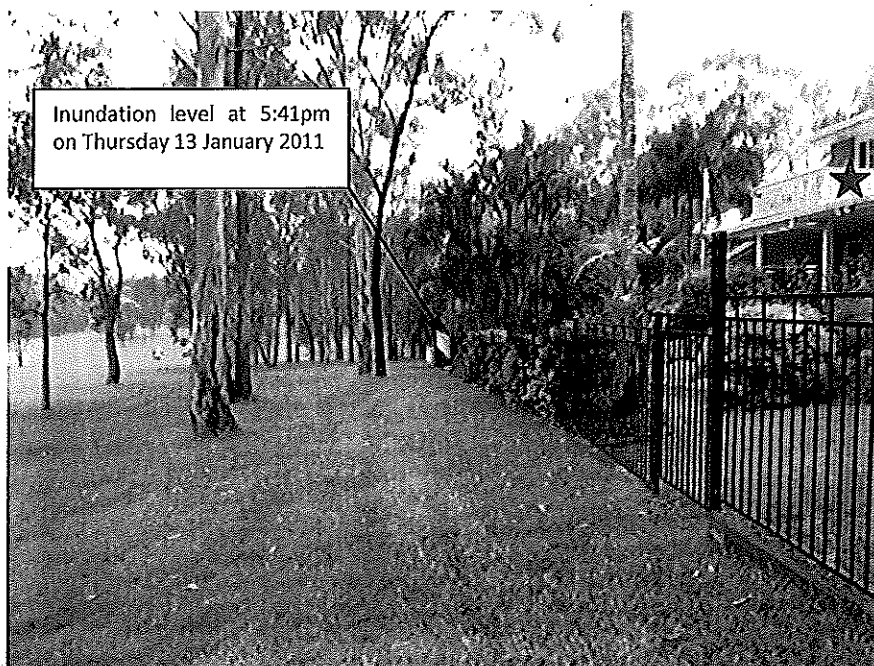
Figure 3-7 Indicative inundation level at the rear of the property (taken 18 April 2011)

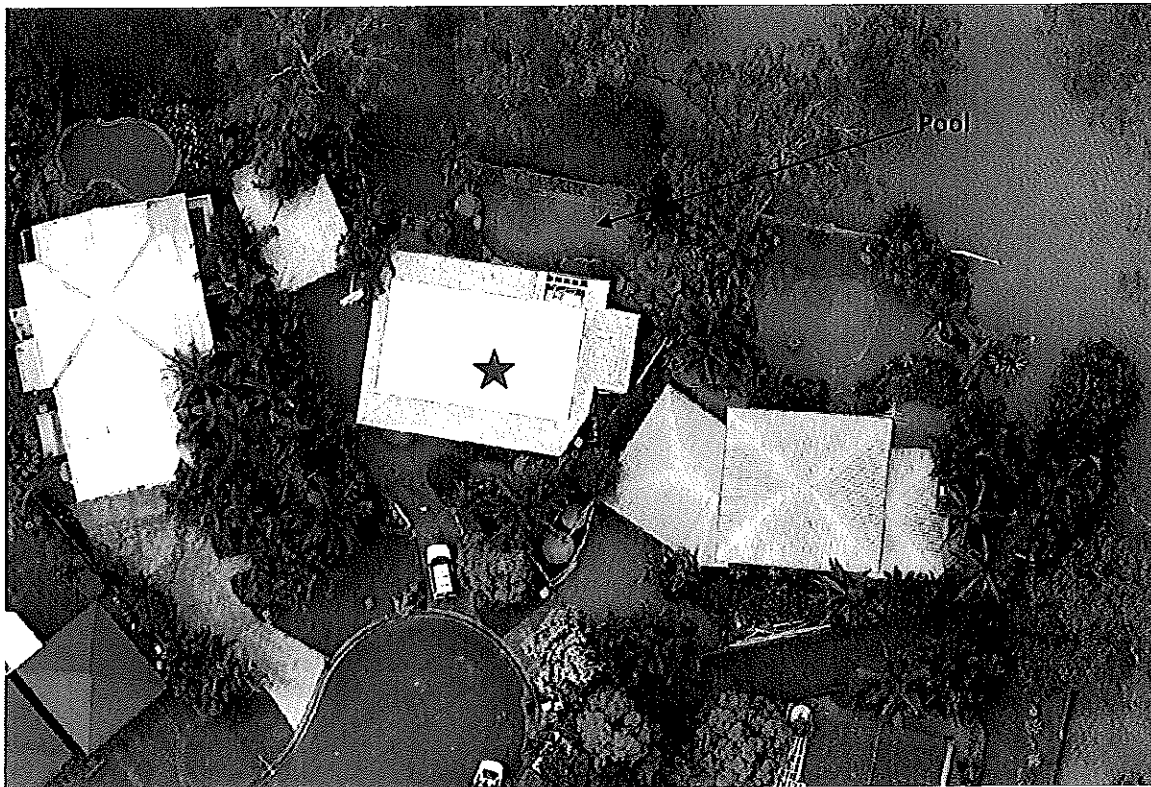
Figure 6-7 is an aerial photo from the Nearmap website taken on Thursday 13 January 2011 after the peak inundation level had occurred. The remains of dirty water are seen in the pool. The cul-de-sac, grassed footpath beside the property driveway and the area immediately next to the stormwater pits do not show signs of inundation. Figure 6-8 is the Nearmap image with Insurance Council of Australia (ICA) supplied inundation extent overlayed. This shows the property was within the inundation extent provided by the ICA.

Figure 6-7 Aerial Image of Inundation showing Site on 13/1/2011 (Nearmap 2011)

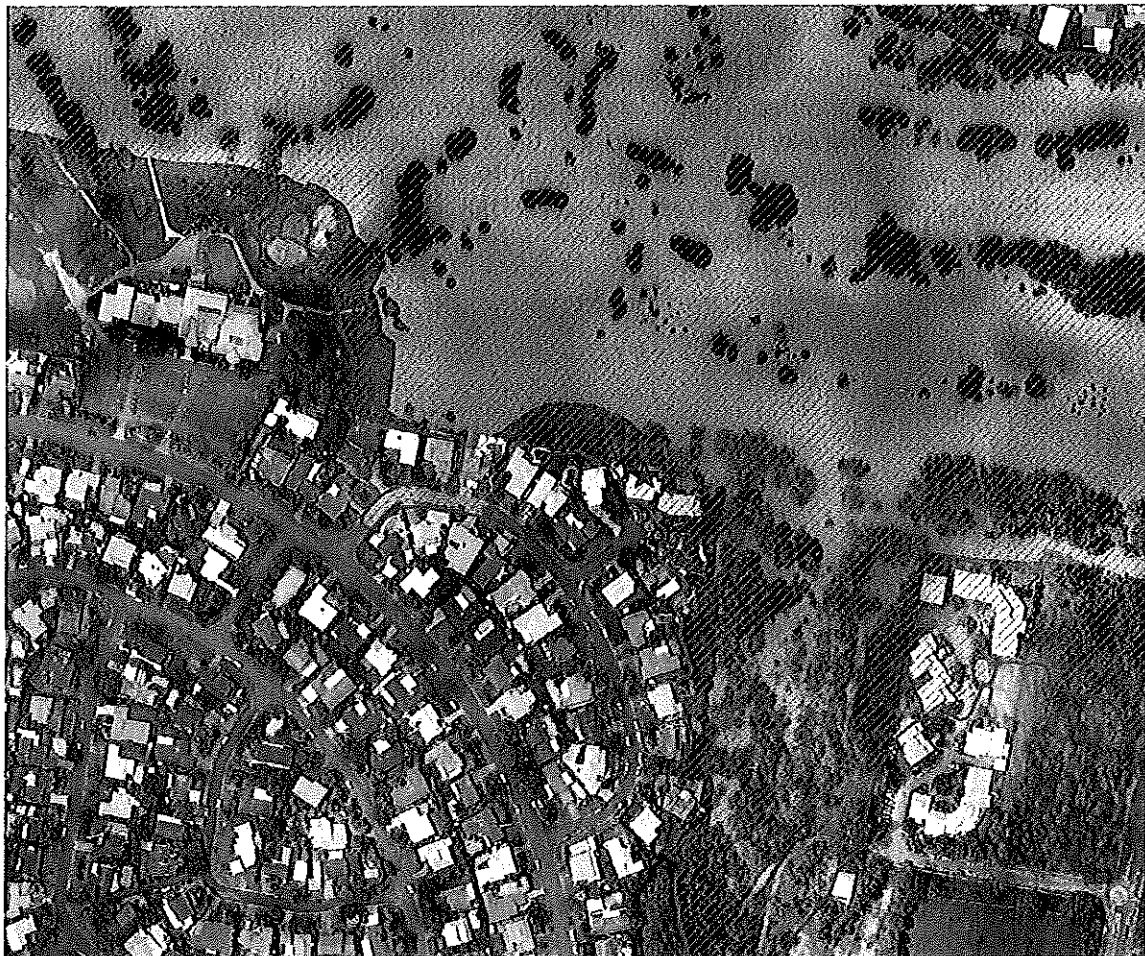
Figure 6-8 Nearmap image of site (13/1/2011) with ICA inundation extent overlay

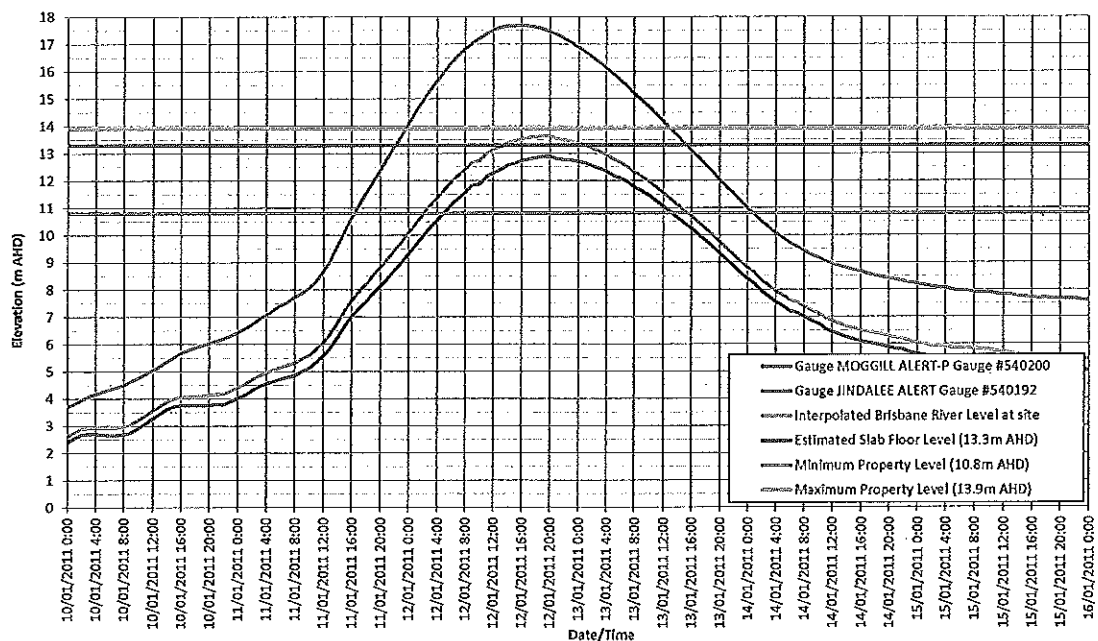
Figure 7-1 Interpolated Brisbane River levels and timing for 6 Eriboll Close, Middle Park

- Figure 7-1 shows the inundation at the property would have commenced at approximately 2:00am on Wednesday 12 January and inundated the slab floor level at approximately 1:00pm on Wednesday 12 January before peaking at a maximum level of approximately 13.6m AHD at around 7pm on Wednesday 12 January and receded below the slab floor level at approximately 2:00am on Thursday 13 January 2011. This agrees well with observed peak inundation depths in the house and correlates well with the owner's recollection of water starting to inundate the bathroom and laundry at lunchtime/afternoon on Wednesday, and no inundation in the house at 6:00am Thursday 13 January.

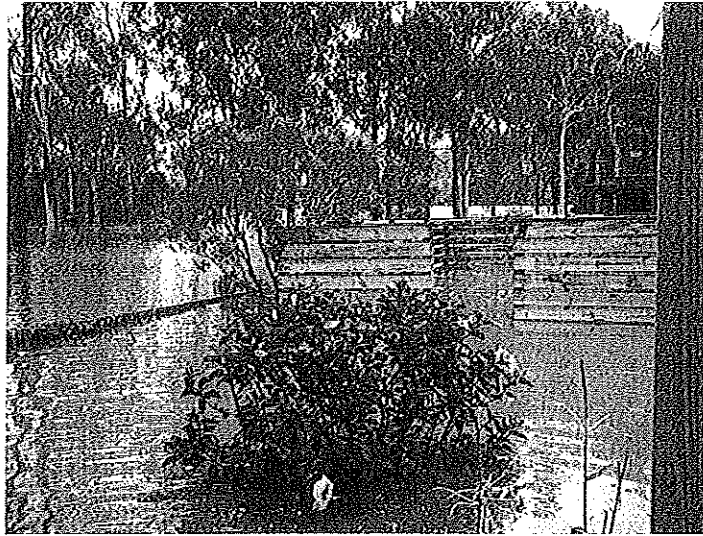
- Unit 13 had approximately 330mm of water through the ground floor at the highest point at approximately 10pm January 12th. This would place the water level at approximately 13.1m AHD in this area at that time.
- Unit 5 had approximately 700mm of water through the ground floor, at the highest point at approximately 10pm January 12th. Confirming water level at 13.1m AHD. Water started entering units 1 to 5 around 6am January 12th, 2011.
- Photographs taken at the site on January 13th suggest the water levels receding from a January 12th peak, though BOM advised that the Brisbane River was yet to peak. This peak information was confirmed in the image published by the Courier Mail (13th January 2011) shown below.

FIGURE 4. UNIT 13, 12.43PM, JANUARY 12, 2011

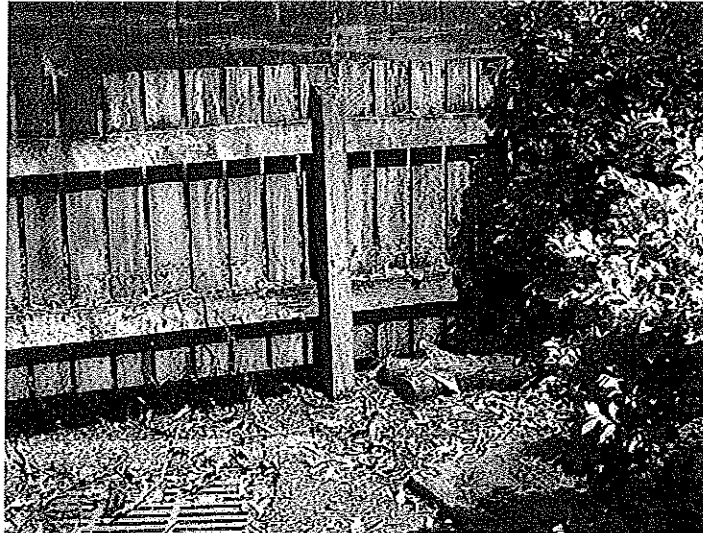
FIGURE 5. UNIT 13, 7:48AM, JANUARY 13, 2011

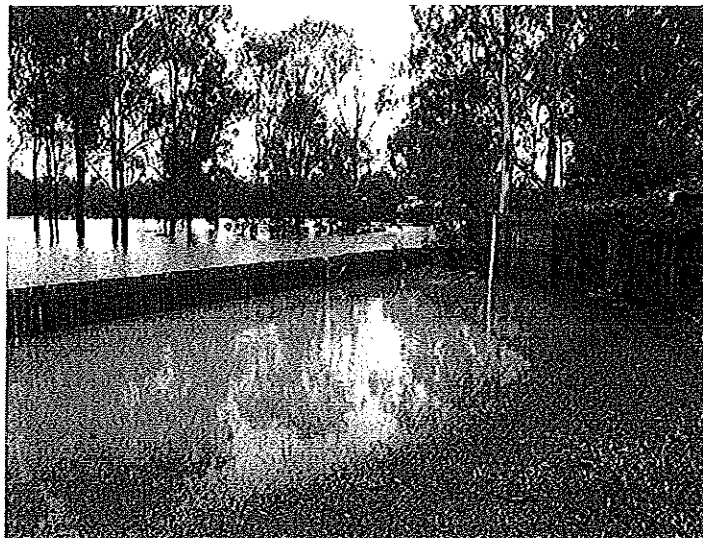
FIGURE 6. UNIT 5, 10:56AM, JANUARY 13, 2011

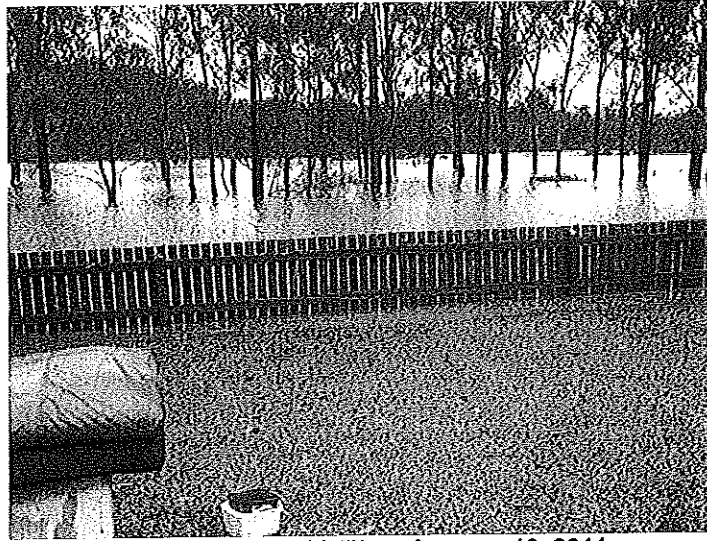
FIGURE 7. UNIT 5, 11:57AM, JANUARY 13, 2011

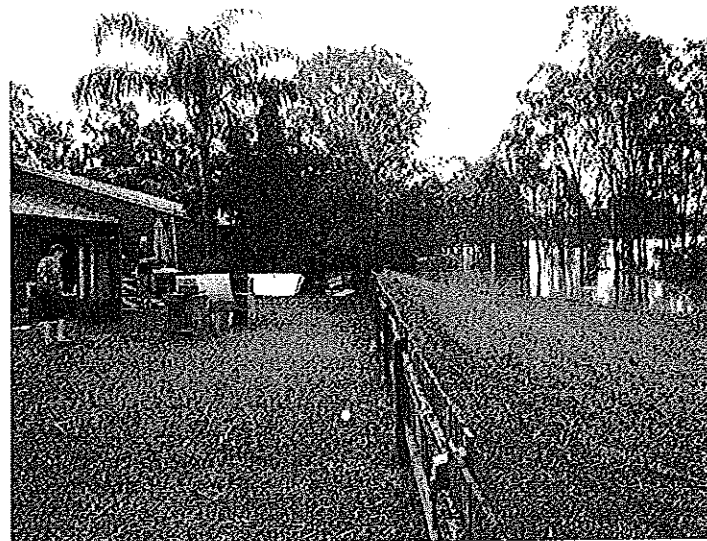
FIGURE 8. UNIT 5, 4:10PM, JANUARY 13, 2011

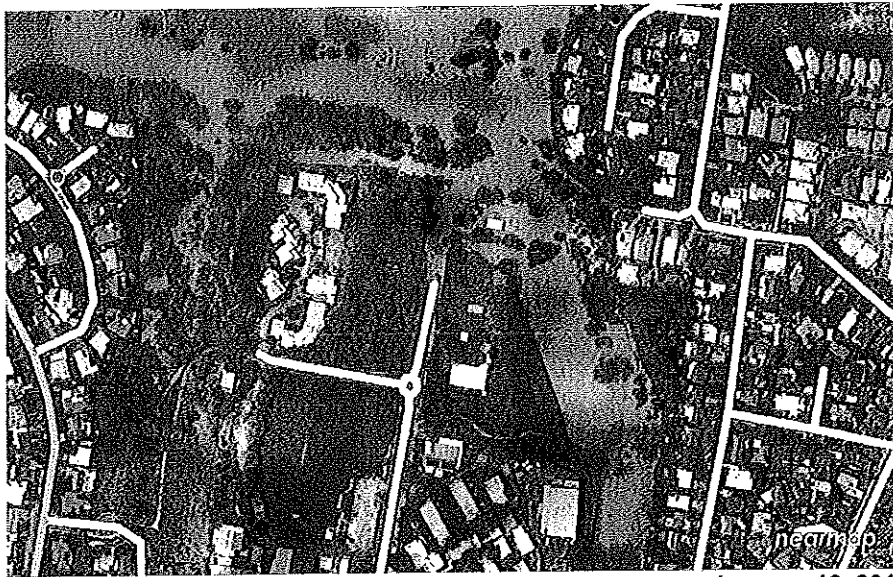
FIGURE 8. RECEDING WATERS, MIDDLE PARK AERIAL PHOTOGRAPH, JANUARY 13, 2011
(SOURCE: NEARMAP)
