Name of Witness	Lynn De Lange
Date of Birth	[REDACTED]
Address and contact details	[REDACTED] Albert Street, Brisbane (Ph: [REDACTED])
Occupation	Retired
Officer taking statement	Detective Sergeant Stephen Platz
Date taken	13/09/2011

**Exhibit; Engineers report on basement inundation at Festival
Towers apartments by Sheehy & Partners Pty Ltd**

Festival Towers Apartments – Basement Water Inundation

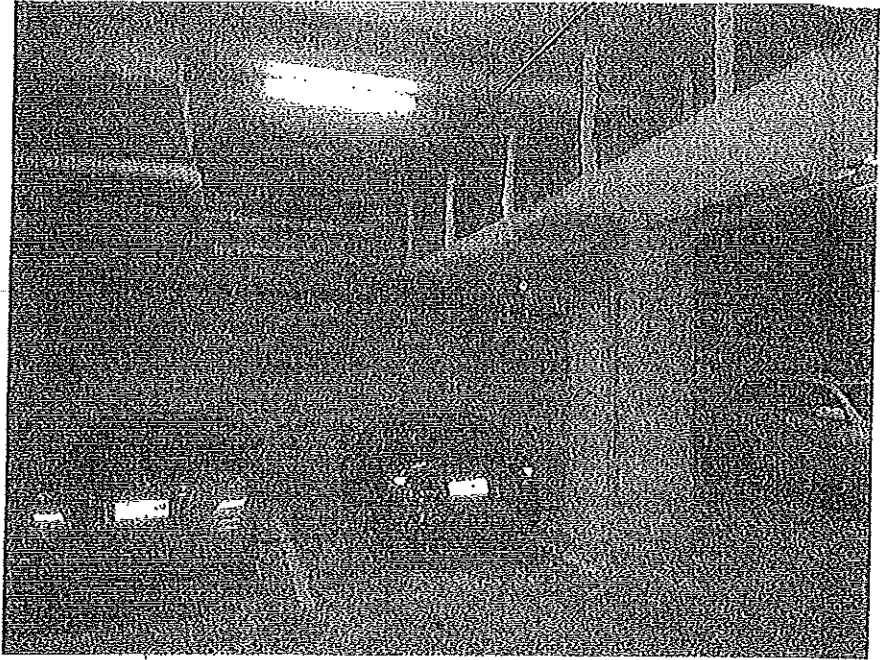
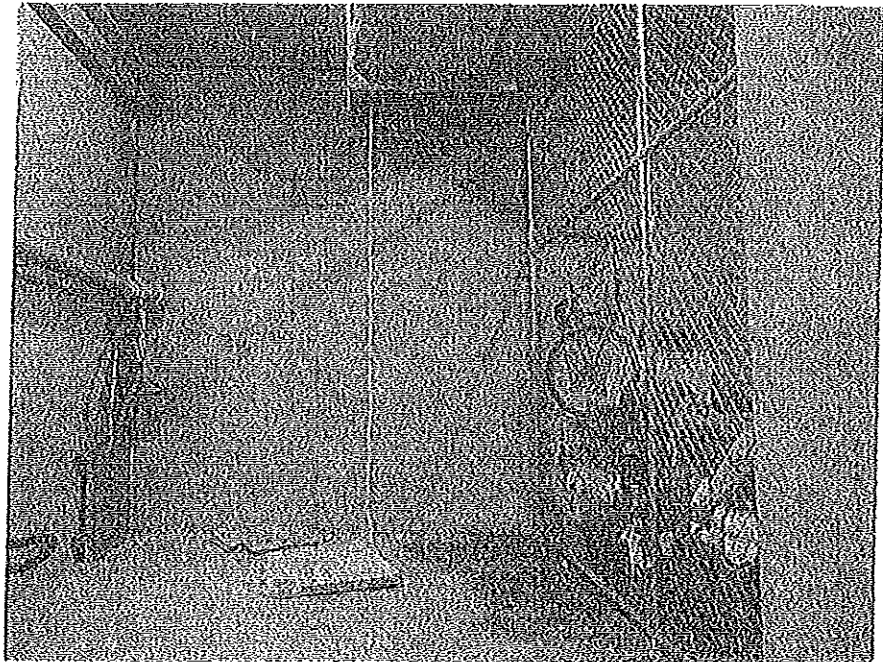
The source of the water inundation is believed to be at the incoming electricity mains to the building on the Charlotte Street Frontage. Marked up drawings are attached and photographs follow for identification of this primary water inundation source. A "waterfall" from this location was observed by staff on site during the event. The water staining on the vermiculite encasing of the incoming conduits and failed fire proofing of the entry location boxing soffit also confirm the likelihood of this location being the main source of water entry into the basement.

Other services entries to the basement show signs of seepage but as noted above are not considered to have contributed to the water inundation of the basement. All seepage sources are long term sources and are catered for by the buildings drainage and sump pumping system. The sump pumps are expected to have operated to minimise the effects of the high water inflow volume from the energex cable entry until such time as the power was cut off to the building or the water level reached the pump controllers causing a failure of the pumps. In any case the rate of pump outflow would not have been able to cope with the rate of water inflow from the energex cable entry source.

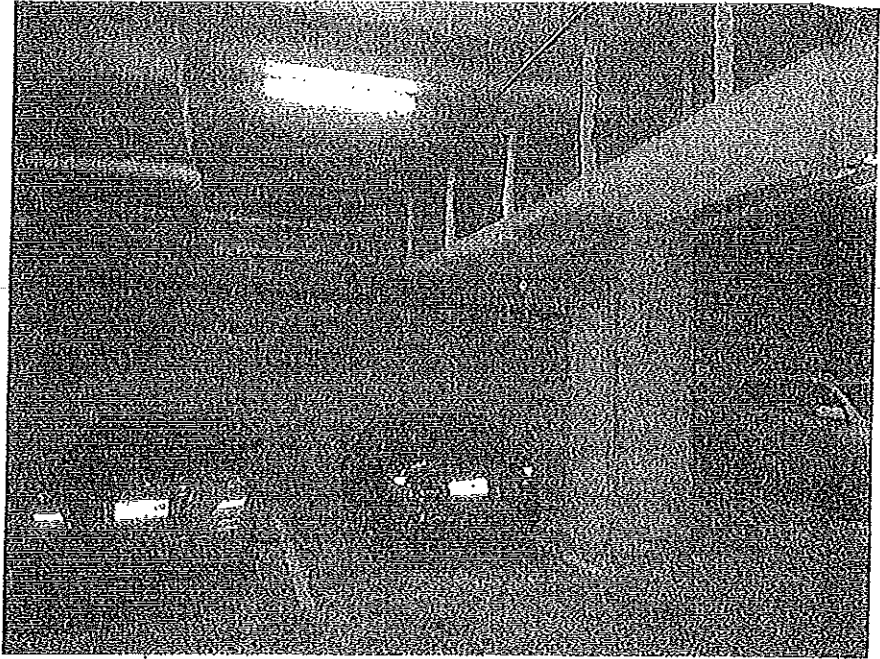
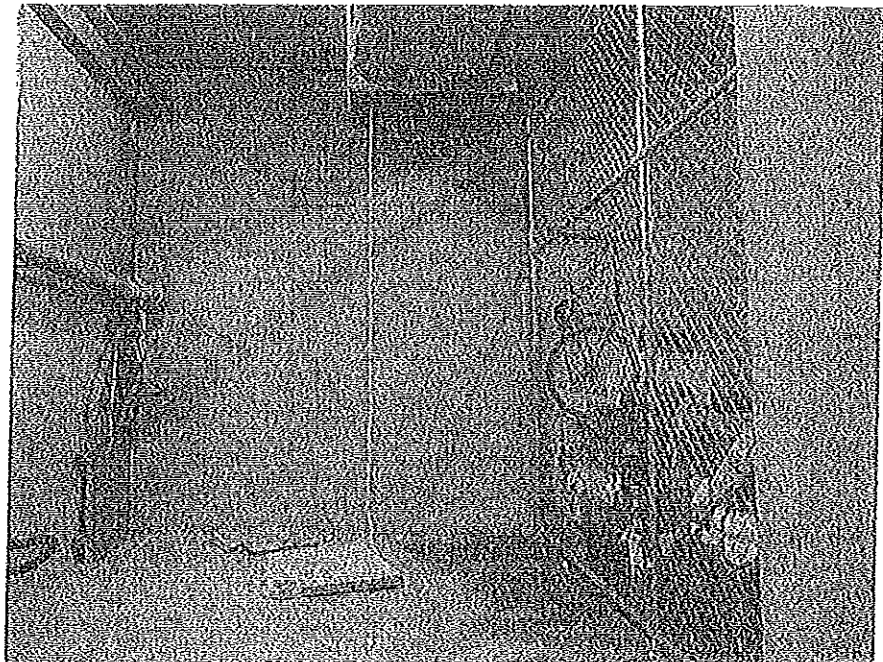
The source of the water inundation is believed to be at the incoming electricity mains to the building on the Charlotte Street Frontage. Marked up drawings are attached and photographs follow for identification of this primary water inundation source. A "waterfall" from this location was observed by staff on site during the event. The water staining on the vermiculite encasing of the incoming conduits and failed fire proofing of the entry location boxing soffit also confirm the likelihood of this location being the main source of water entry into the basement.

Other services entries to the basement show signs of seepage but as noted above are not considered to have contributed to the water inundation of the basement. All seepage sources are long term sources and are catered for by the buildings drainage and sump pumping system. The sump pumps are expected to have operated to minimise the effects of the high water inflow volume from the energex cable entry until such time as the power was cut off to the building or the water level reached the pump controllers causing a failure of the pumps. In any case the rate of pump outflow would not have been able to cope with the rate of water inflow from the energex cable entry source.

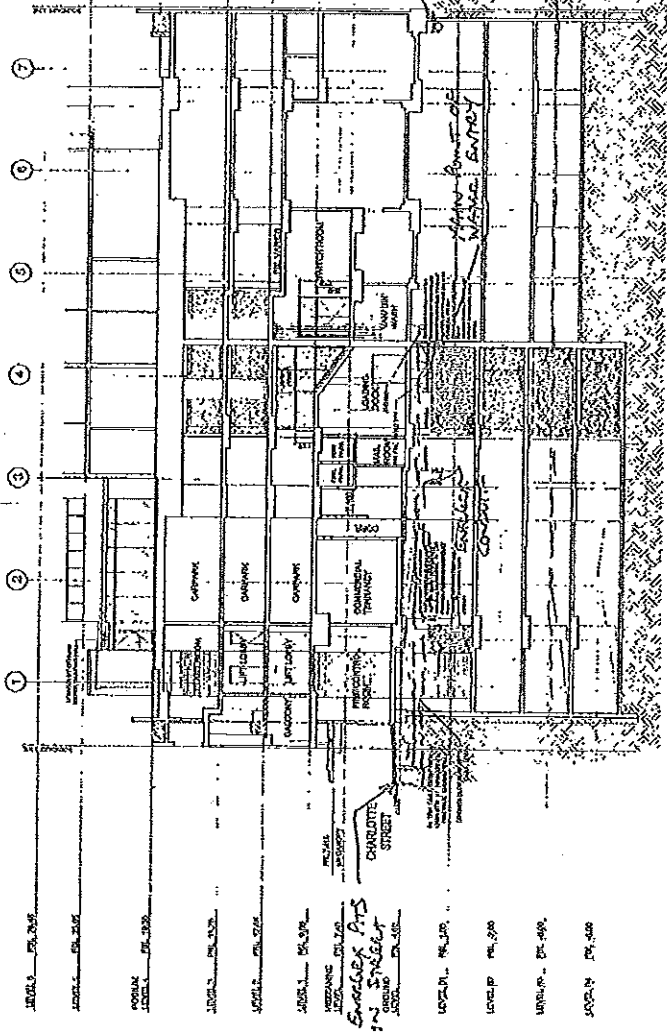
Stairwell Deck
LEVEL OF APPROXIMATE
TOP OF WATER PENETRATION
