STATEMENT OF DR BRUCE ABERNETHY

Brisbane River Flood, January 2011

REPORT ON RIVER BANK EROSION

- Final
- 6 October 2011

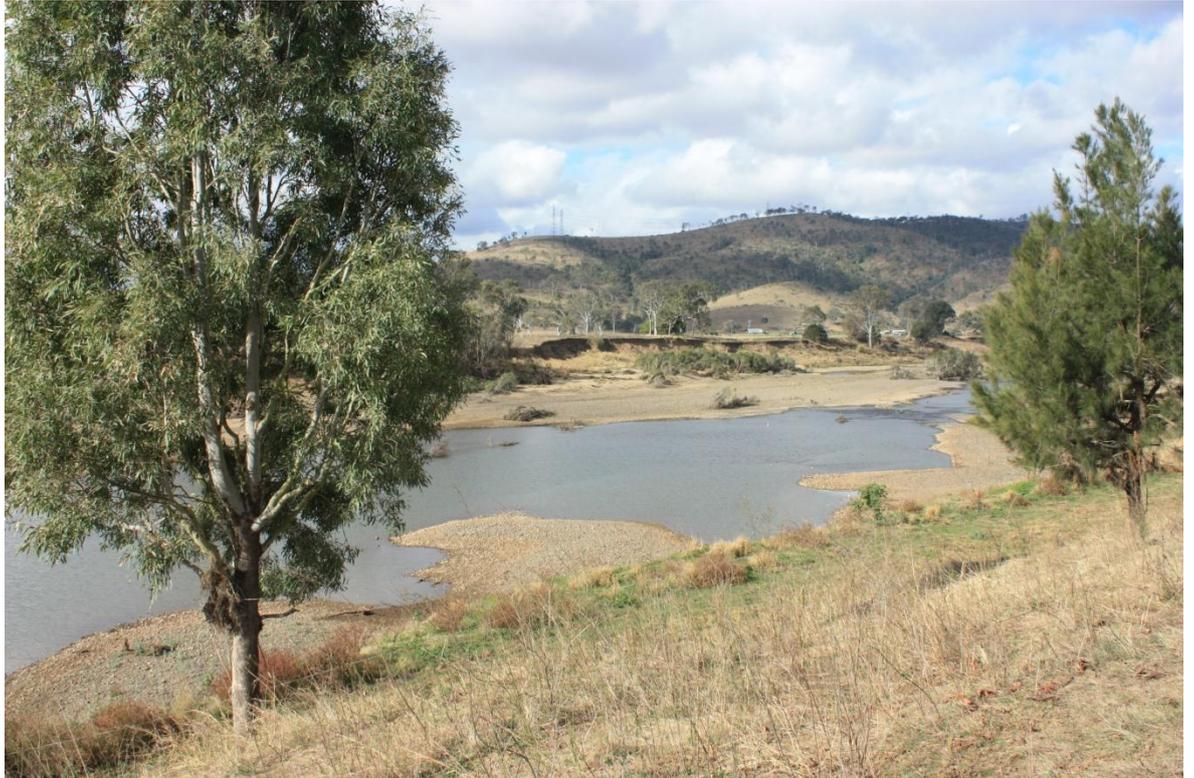
Dramatic channel change occurred as a result of the 2011 flood at Harlin. Comparison between a photo tendered to the Commission by Jenny Moore and Figure 2 shows dramatic stripping of the active floodplain and channel metamorphosis. Where previously a narrow sinuous channel meandered from side to side within the palaeochannel, depositing an alternating active floodplain within the confines of the channel, there now exists a wide shallow channel that almost fills the breadth of the palaeochannel.

Figure 2: Channel at Harlin, post flood.

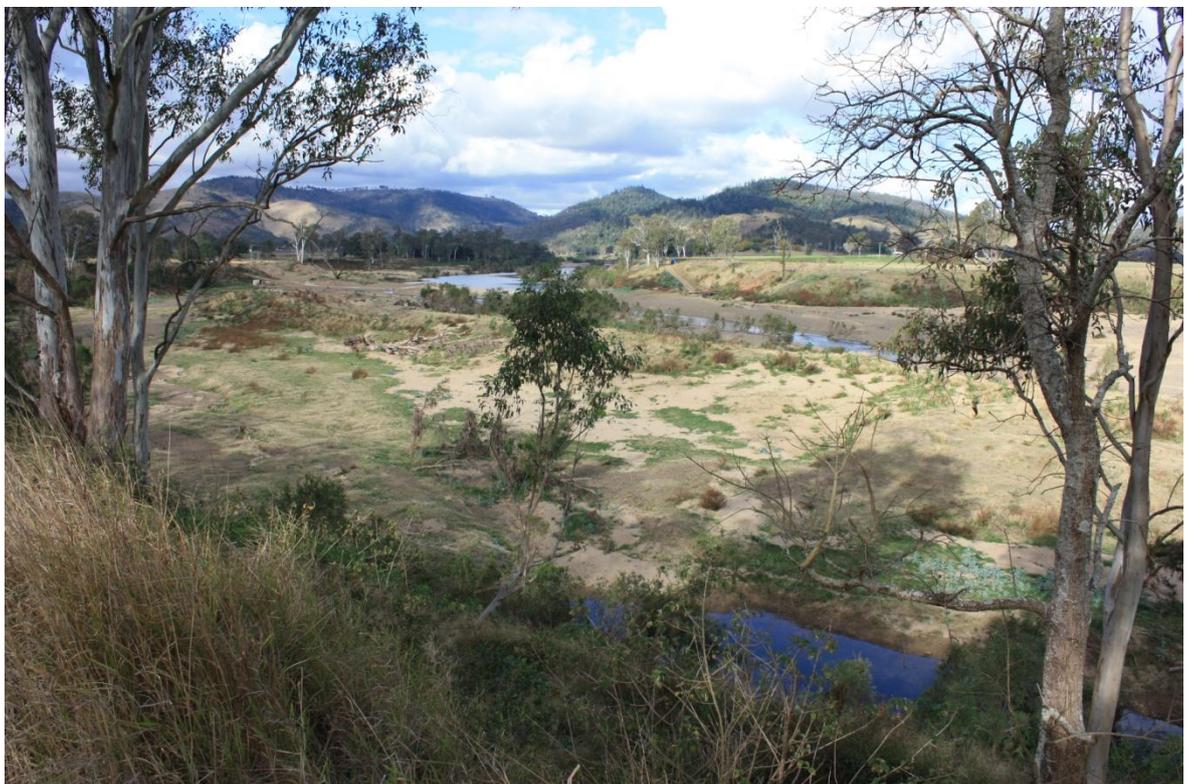
Figure 3: Channel downstream from Harlin, showing active floodplain aggradation.

Over time, the channel will re-create its former pattern but there are no guarantees that floodplains will be aggraded in their former locations and the process will take a very long time – assuming there are no intervening large floods capable of further floodplain stripping. Ironically, the active floodplain renewal process was initiated elsewhere in the upper Brisbane by the same flood in January 2011 that scoured the floodplain at Harlin. Downstream (near Gregors Creek Road), the active floodplain has been aggraded by sand transported to the site from upstream during the flood (Figure 3).

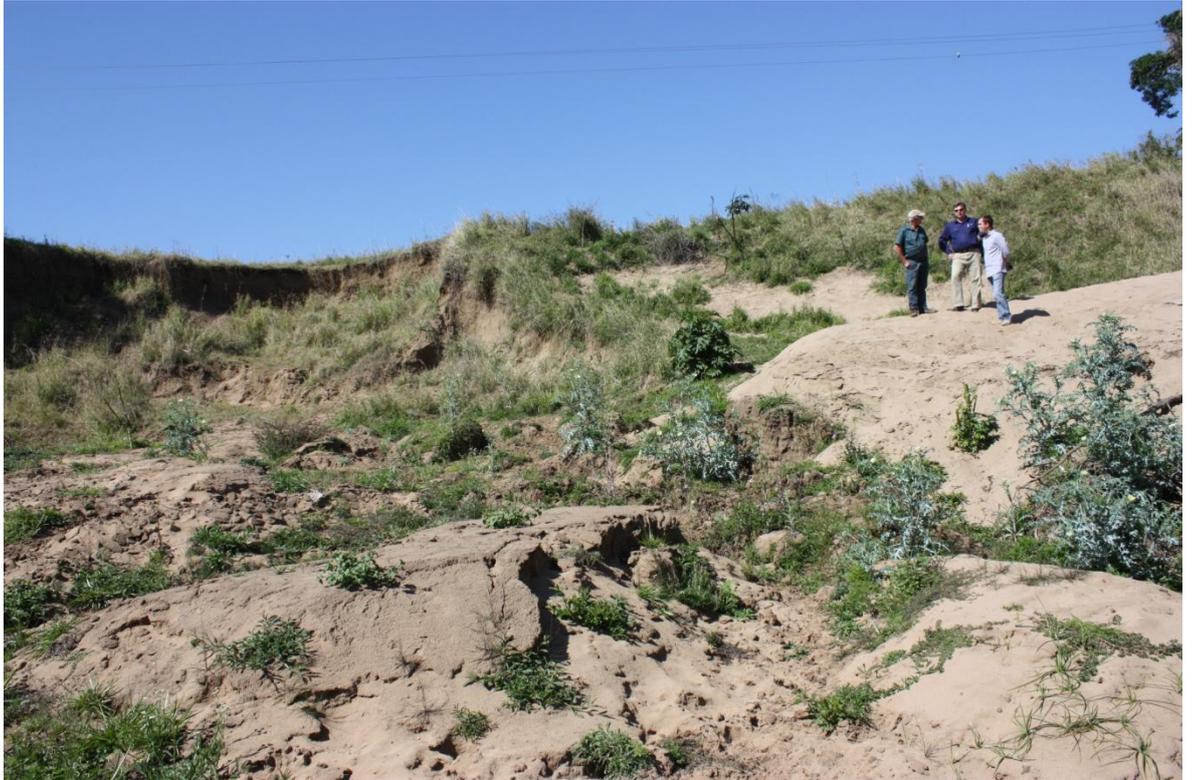
Figure 5, particularly, shows the complexity of process that occurs at any given point. Here, there is a very large failure (shown to the left of the photograph) and large overbank deposits of fine sand (foreground and right, where the people are standing) that all resulted from the same flood. Figure 6 depicts the left bank cut into the higher terrace on the outside of a right-hand bend. Seen in the foreground are uprooted trees aligned downstream on the toe of the bank and a series of shallow failures on the bank face. Even though the trees have been downed, they and the coarse material they are rooted in (gravels and cobbles) have protected the toe of the bank and have likely prevented the deep-seated failures observed just upstream (Figure 5).

Figure 5: Mass failure of right bank at Fernvale and overbank deposition.

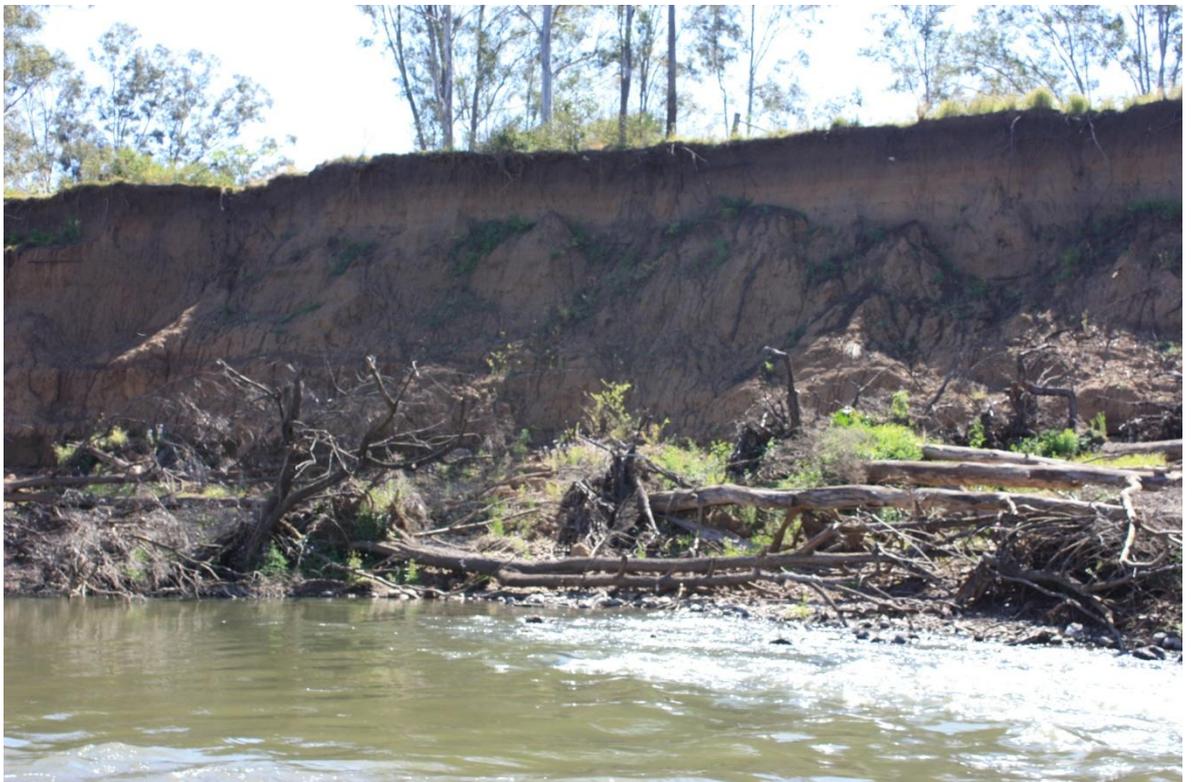
At Noel Schmidt's place at Fernvale the valley bottom is wide and the river runs in high banks though a broad floodplain. Downstream from the site, the terrain closes in again and probably produces a backwater effect over the floodplain during flood flows. At any rate, at Noel Schmidt's property, the flood well and truly inundated the higher terrace and deposited a swathe of sand over the floodplain. River bank erosion that resulted from the flood is still very clearly evident with large slumps and downed trees all along the reach (Figure 5 and Figure 6). The bank material is fine sandy loam (field estimate) and only weakly cohesive.

Figure 6: High outer left bank at Fernvale.

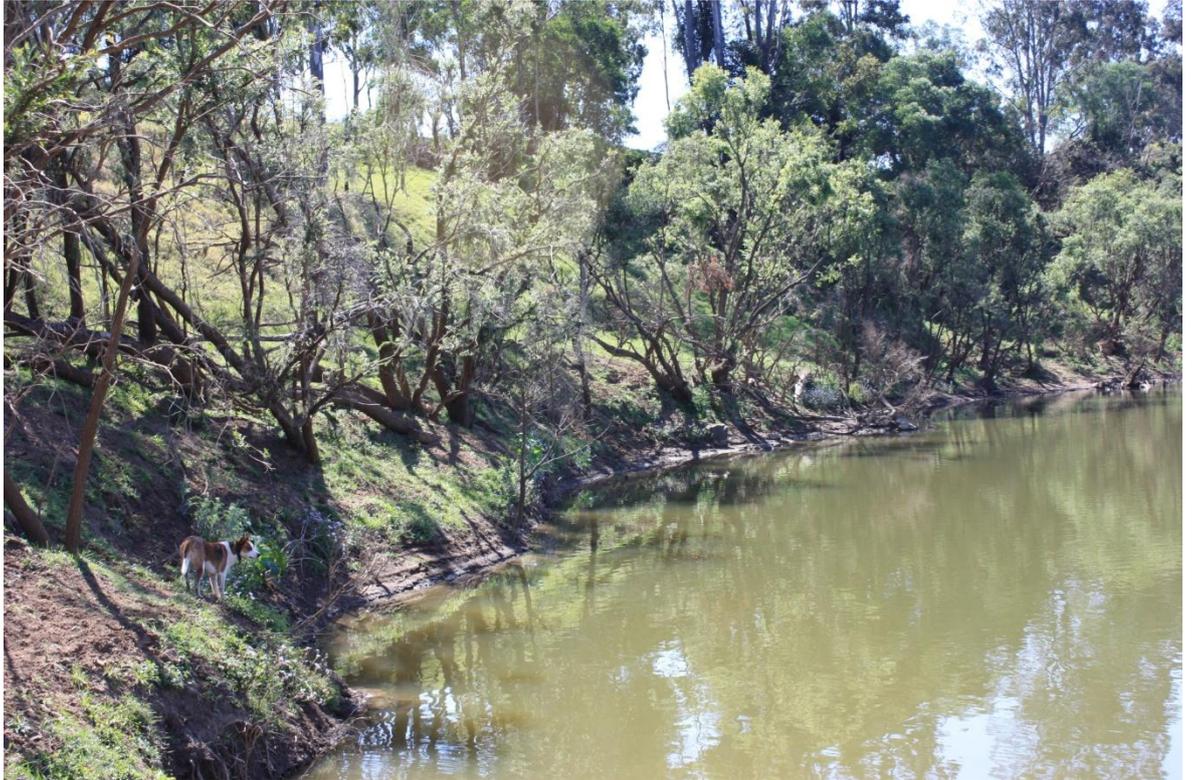
At Jocelyn Bailey's place at Pine Mountain the river is confined within a narrow valley. Here the river generally flows at the base of the valley sides but the occasional small alluvial flat is apparent, typically only developed on one side or other of the river. Again, a variety of processes have given rise to bank erosion. Figure 7 shows an intact bank section on Jocelyn Bailey's property where the bank has been protected by a bed-rock outcrop. Elsewhere along this reach minor failures have occurred but the banks had been re-battered prior to my visit, so it was difficult to infer process or extent of failure.

Figure 7: Relatively intact right bank section at Pine Mountain.

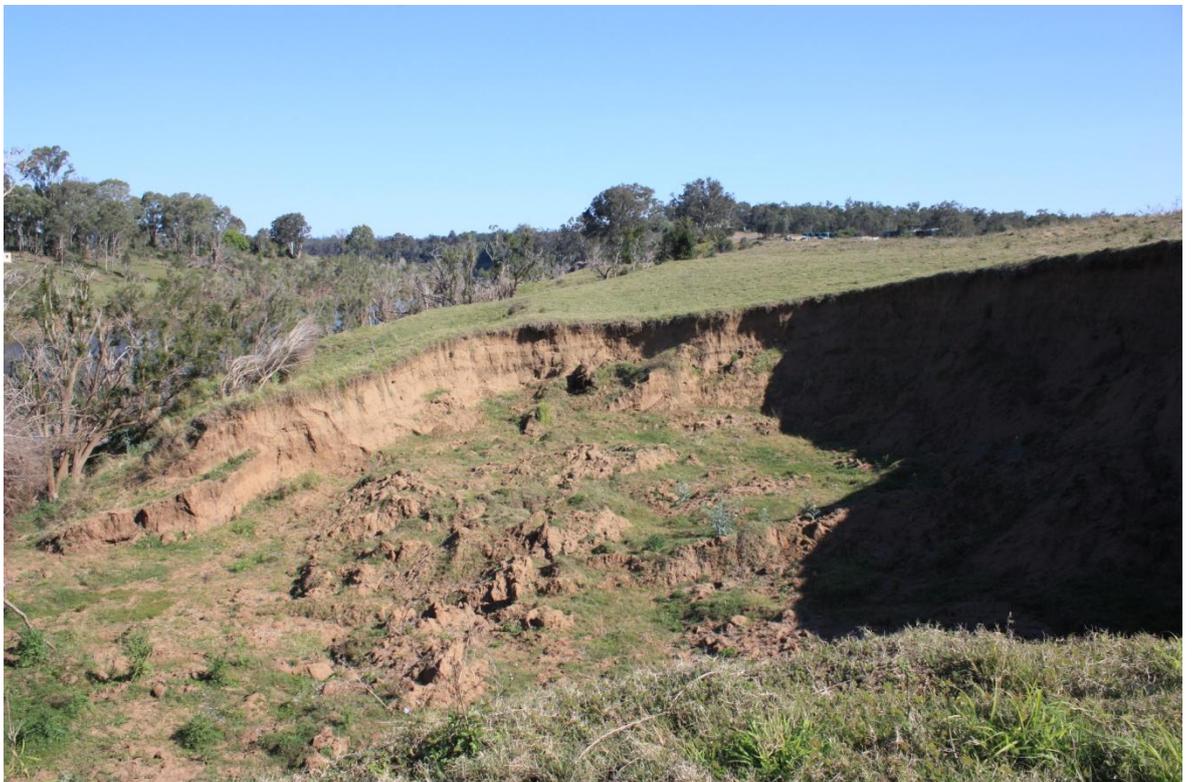
Figure 8 shows a very dramatic failure that occurred on Graham Bell's property. (Graham Bell is Jocelyn Bailey's downstream neighbour). It is difficult to hypothesise what occurred here, as the original topography cannot be inferred but there was certainly an interaction between hillslope and river processes. It is likely that this failure occurred on the falling limb of the flood as the soil water drained back towards the river. Perhaps the incipient failure resulted from a concentration of flow through convergent topography.

Figure 8: Massive failure on right bank at Pine Mountain.
