STATEMENT OF PETER GEORGE UNWIN IN RESPONSE TO REQUIREMENT TO PROVIDE INFORMATION ISSUED TO SUNCORP INSURANCE DATED 2 NOVEMBER 2011

Property Claim – First & Final

[REDACTED] Fairfield, QLD, 4103

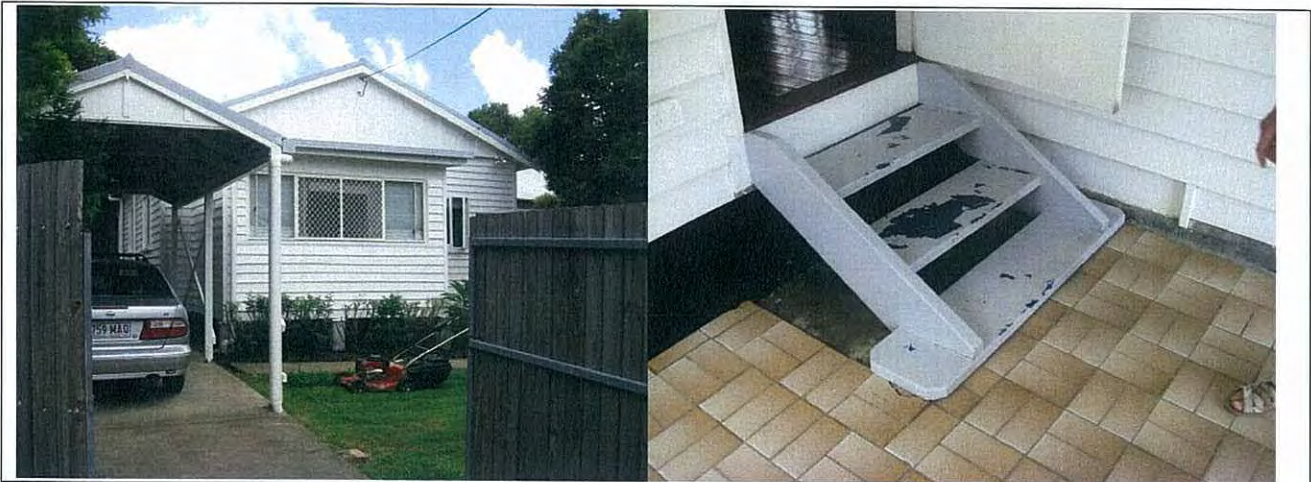
Photo 1. General view of the risk property.

Photo 2. Showing damage to steps and floors.

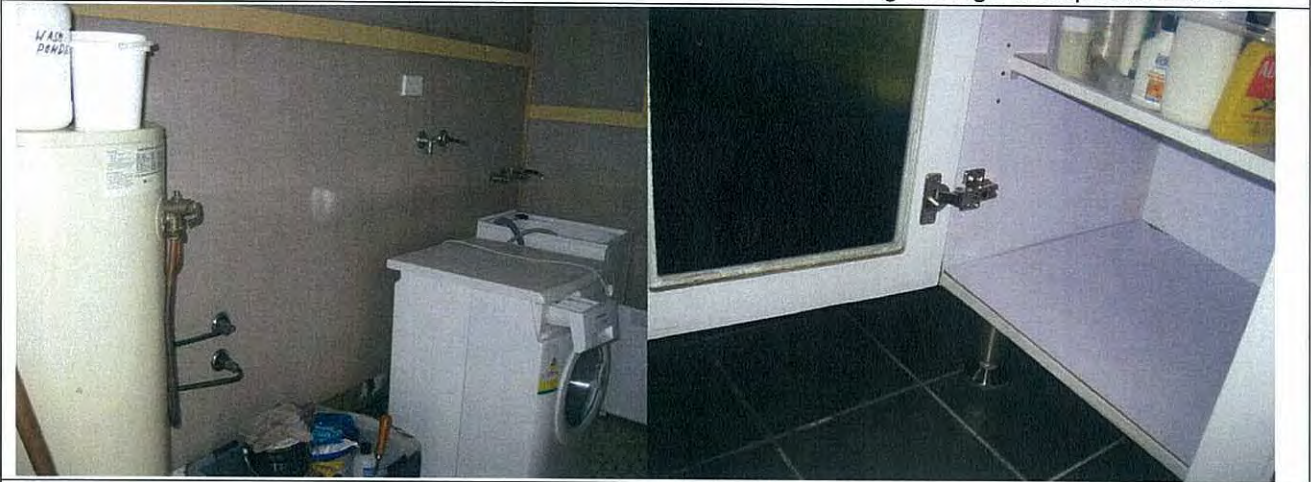
Photo 3. Showing damage to laundry and appliances.

Photo 4. Showing damage to kitchen cabinets.

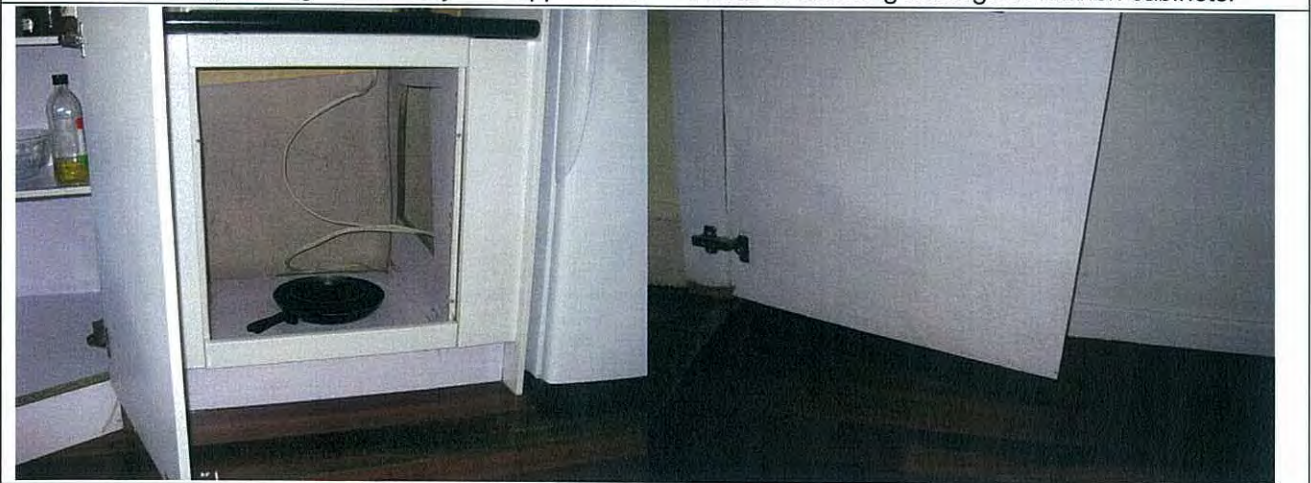
Photo 5. Showing damage to kitchen and electricals.

Photo 6. Showing water level on door.
