17 Other dam issues

17.1 Longer term review of the Wivenhoe and North Pine manuals

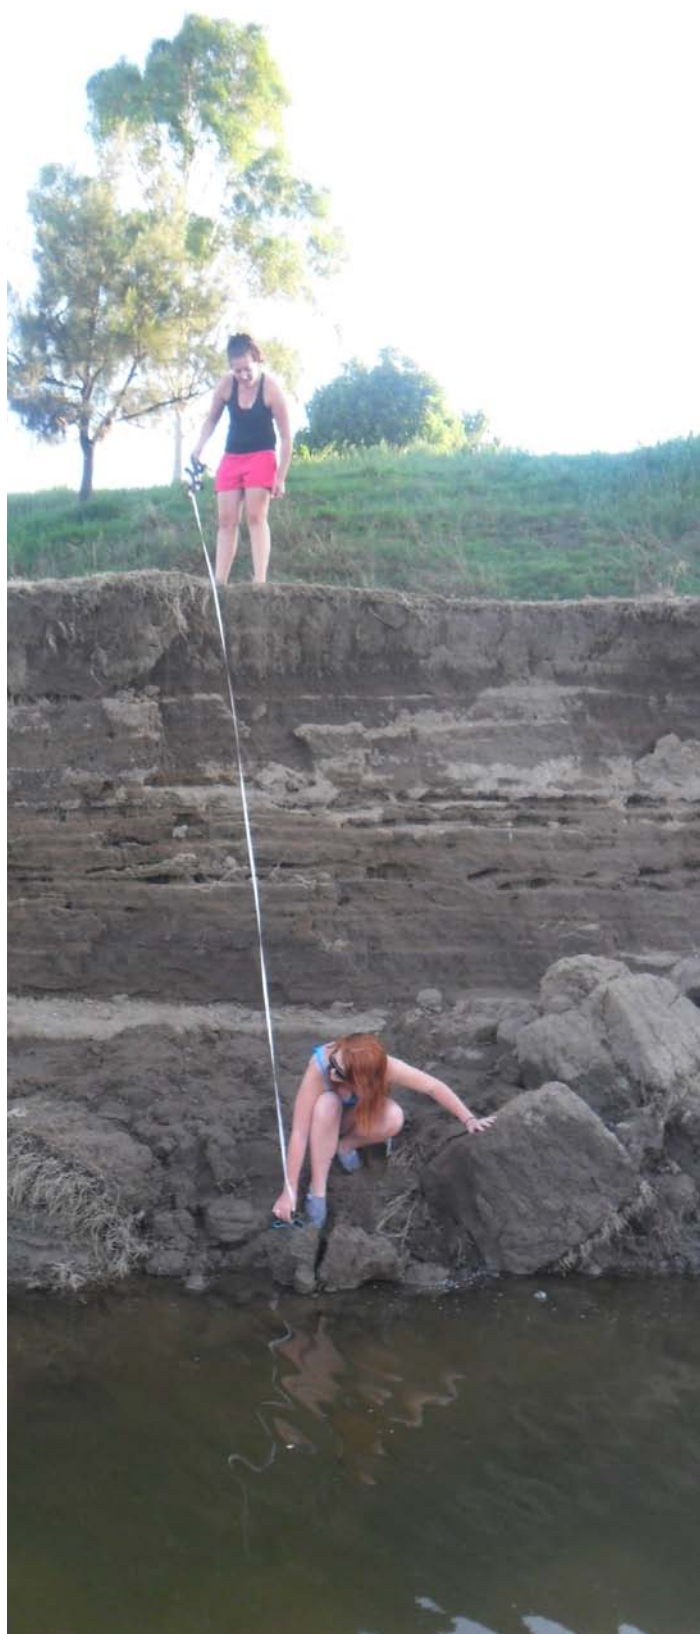
Both the upper and mid-Brisbane River regions experienced significant riverbank erosion and slumping. At Harlin, upstream of Wivenhoe Dam, for example, the river channel underwent a major transformation as large sections of the riverbank fell away.¹¹⁶ One Harlin property holder's submission indicated that some 30 acres of his property had been lost as a result of the slumping.¹¹⁷ Another reported the loss of approximately 4.5 acres.¹¹⁸ A number of photographs vividly illustrating the dramatic effects of riverbank slumping have been provided to the Commission. The photograph to the right is just one of these. It shows a 3.9 metre sheer cliff created by the slumping of bank material into the river.

*3.9 metres depth of land lost at Harlin (photo courtesy Jenny Moore)
Source: Exhibit 41, Statement of Jenny Moore, 7 April 2011 [p13]*

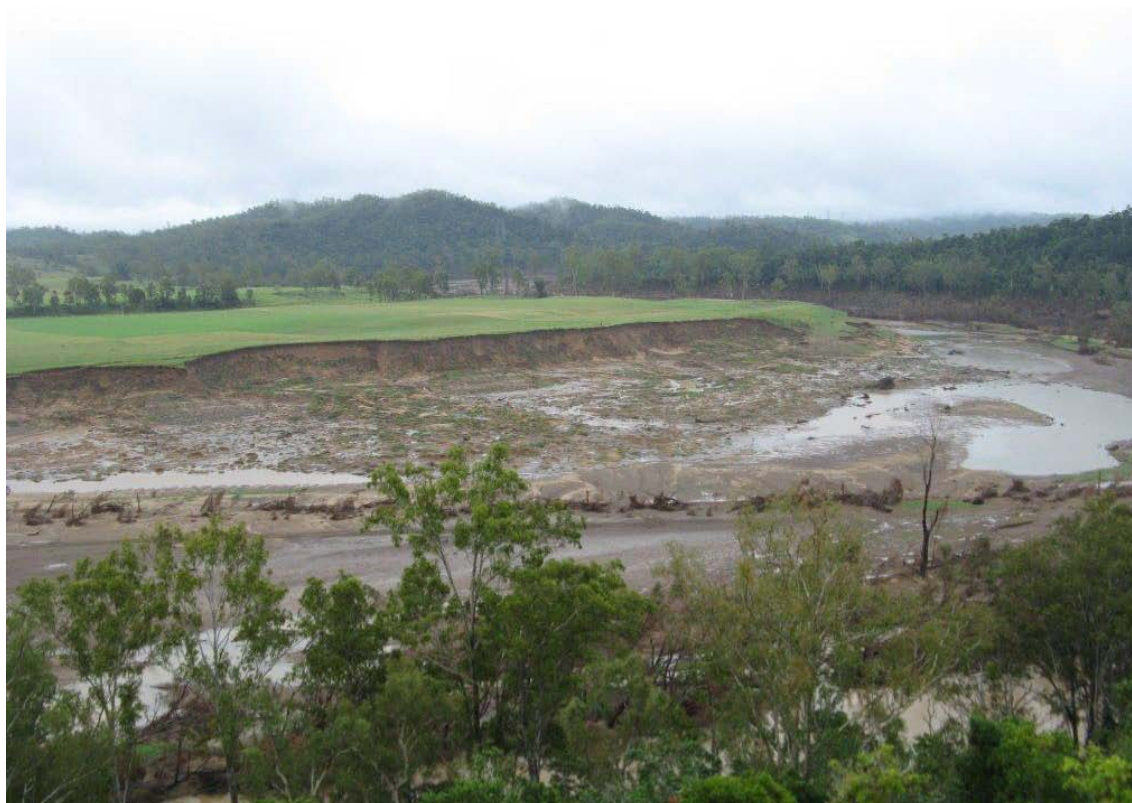
The effects of riverbank slumping were equally dramatic in the mid-Brisbane River region downstream of Somerset Dam and Wivenhoe Dam, as illustrated in the following photograph, showing the loss of approximately 8 hectares of land from a farm in the mid-Brisbane River region.

Approximately eight hectares of farm washed away

In many instances, the damage caused by the slumping cannot feasibly be repaired by landholders. While nature will eventually take its course, and restore the riverbanks to some extent, that process is likely to take many years.¹¹⁹

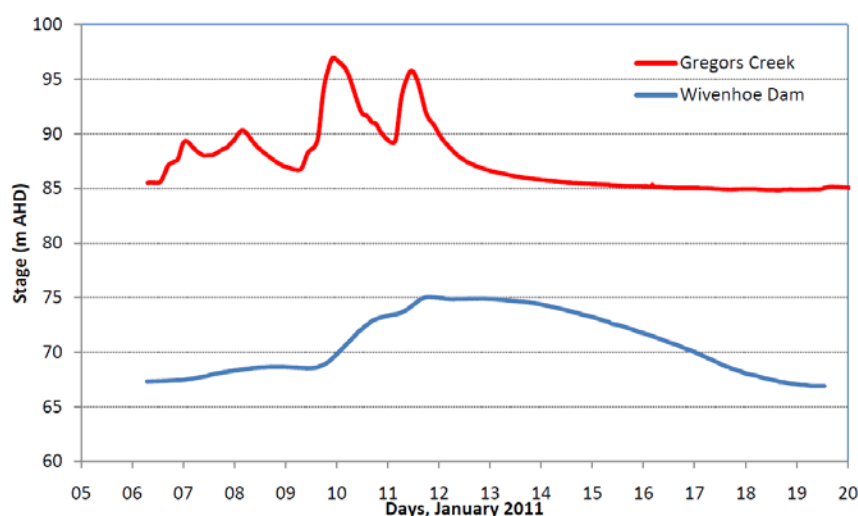
Figure 17(a)

The lack of correlation between the water levels at Gregors Creek and Wivenhoe Dam led Dr Abernethy to conclude that the river flow and, in turn, bank slumping at Harlin was controlled by local channel conditions; the operation of Wivenhoe Dam during the flood was not responsible for the damage to the riverbanks observed at and around Harlin.¹³⁵ The force of that reasoning is obvious, and the Commission accepts the conclusion as correct.

Stage heights at Gregors Creek and Wivenhoe Dam gauges

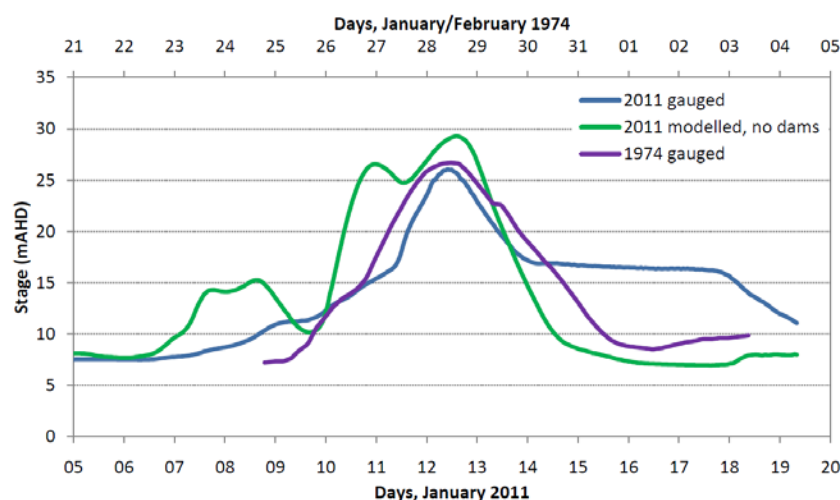
Figure 17(b) below sets out a comparison between the level of the Brisbane River at Mt Crosby Weir during the 2011 flooding as compared to the observed 1974 levels, and a calculation of the levels that would have been experienced in 2011 if Wivenhoe Dam had not been built. The graph demonstrates that the management of releases from Wivenhoe Dam in 2011 led to a lower peak and more gradual recession than would have occurred in the absence of the dam.¹³⁷ It also reveals that the process of drawing down Wivenhoe Dam to full supply level resulted in the river level remaining elevated for longer than it did in 1974. On those bases, Dr Abernethy concluded that the operation of the Wivenhoe and Somerset dams between 7 and 14 January 2011 did not exacerbate the riverbank damage reported in the mid-Brisbane River region.¹³⁸

Modelled and gauged hydrographs at Mt Crosby Reservoir

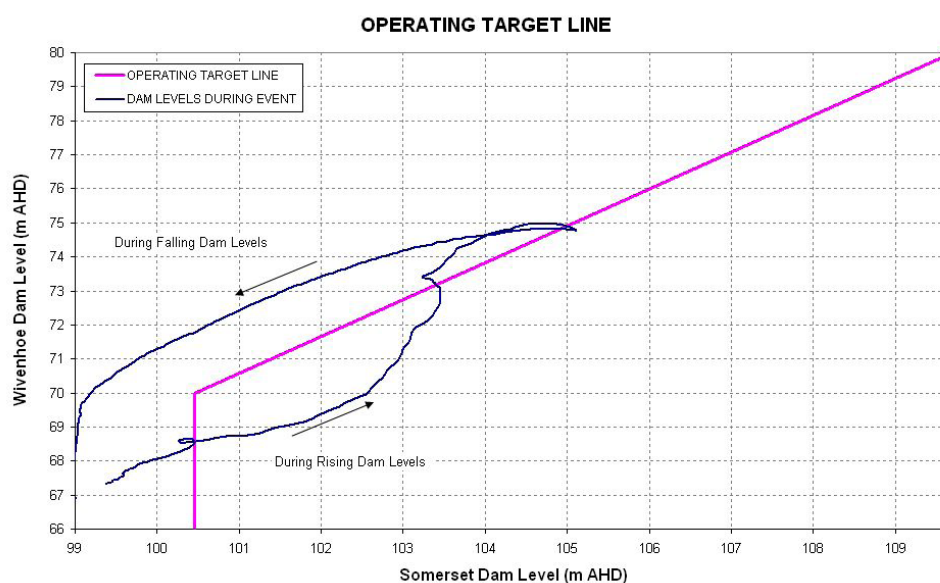
The manual includes an operating target line that provides guidance as to what the dam level at Somerset Dam should be when Wivenhoe Dam is at a particular storage level and vice versa: see Figure 17(c) below, which sets out the operating target line relative to the water levels at Wivenhoe and Somerset dams during the flood event.²⁴⁹ This target line was developed on the basis of an assumption that the maximum storage capacity prior to dam collapse at Wivenhoe is EL 80 metres and at Somerset Dam it is EL 109.7 metres.²⁵⁰ The critical level adopted for the purposes of Somerset Dam accords with the findings of the Department of Commerce report; it has not been reduced, at least since 2005, on account of stability concerns. It should be noted that the Commission has not investigated whether Seqwater has ever considered the water level at which the dam will fail to have been higher or lower than EL 109.7.

Wivenhoe/Somerset Operating Target Line throughout the January 2011 Flood Event
