Queensland Floods Commission of Inquiry

Statement
of
Robert Anthony
Lawrence
(Century Mine)

STATEMENT OF ROBERT (ROB) ANTHONY LAWRENCE

WITH RESPECT TO THE CENTURY MINE

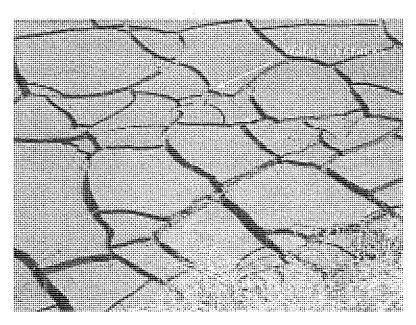
Inspection of the tailings upstream of the seepage area is desiccated and the cracks are currently filling with bleed water as shown in the photograph below. This is similar to the observations at the eastern abutment.

It is considered that the seep will continue for some time to come until fresh tailings are deposited in this area.

Desiccated tailings beach upstream of seepage. Note water within cracks.
