DRAFT REPORT

RE: TENNYSON BUILDING 34 AND 41

PROBABLE CAUSE FOR STORMWATER ENTERING BASEMENTS PRIOR TO STAIRWELL THRESHOLD BEING BREACHED

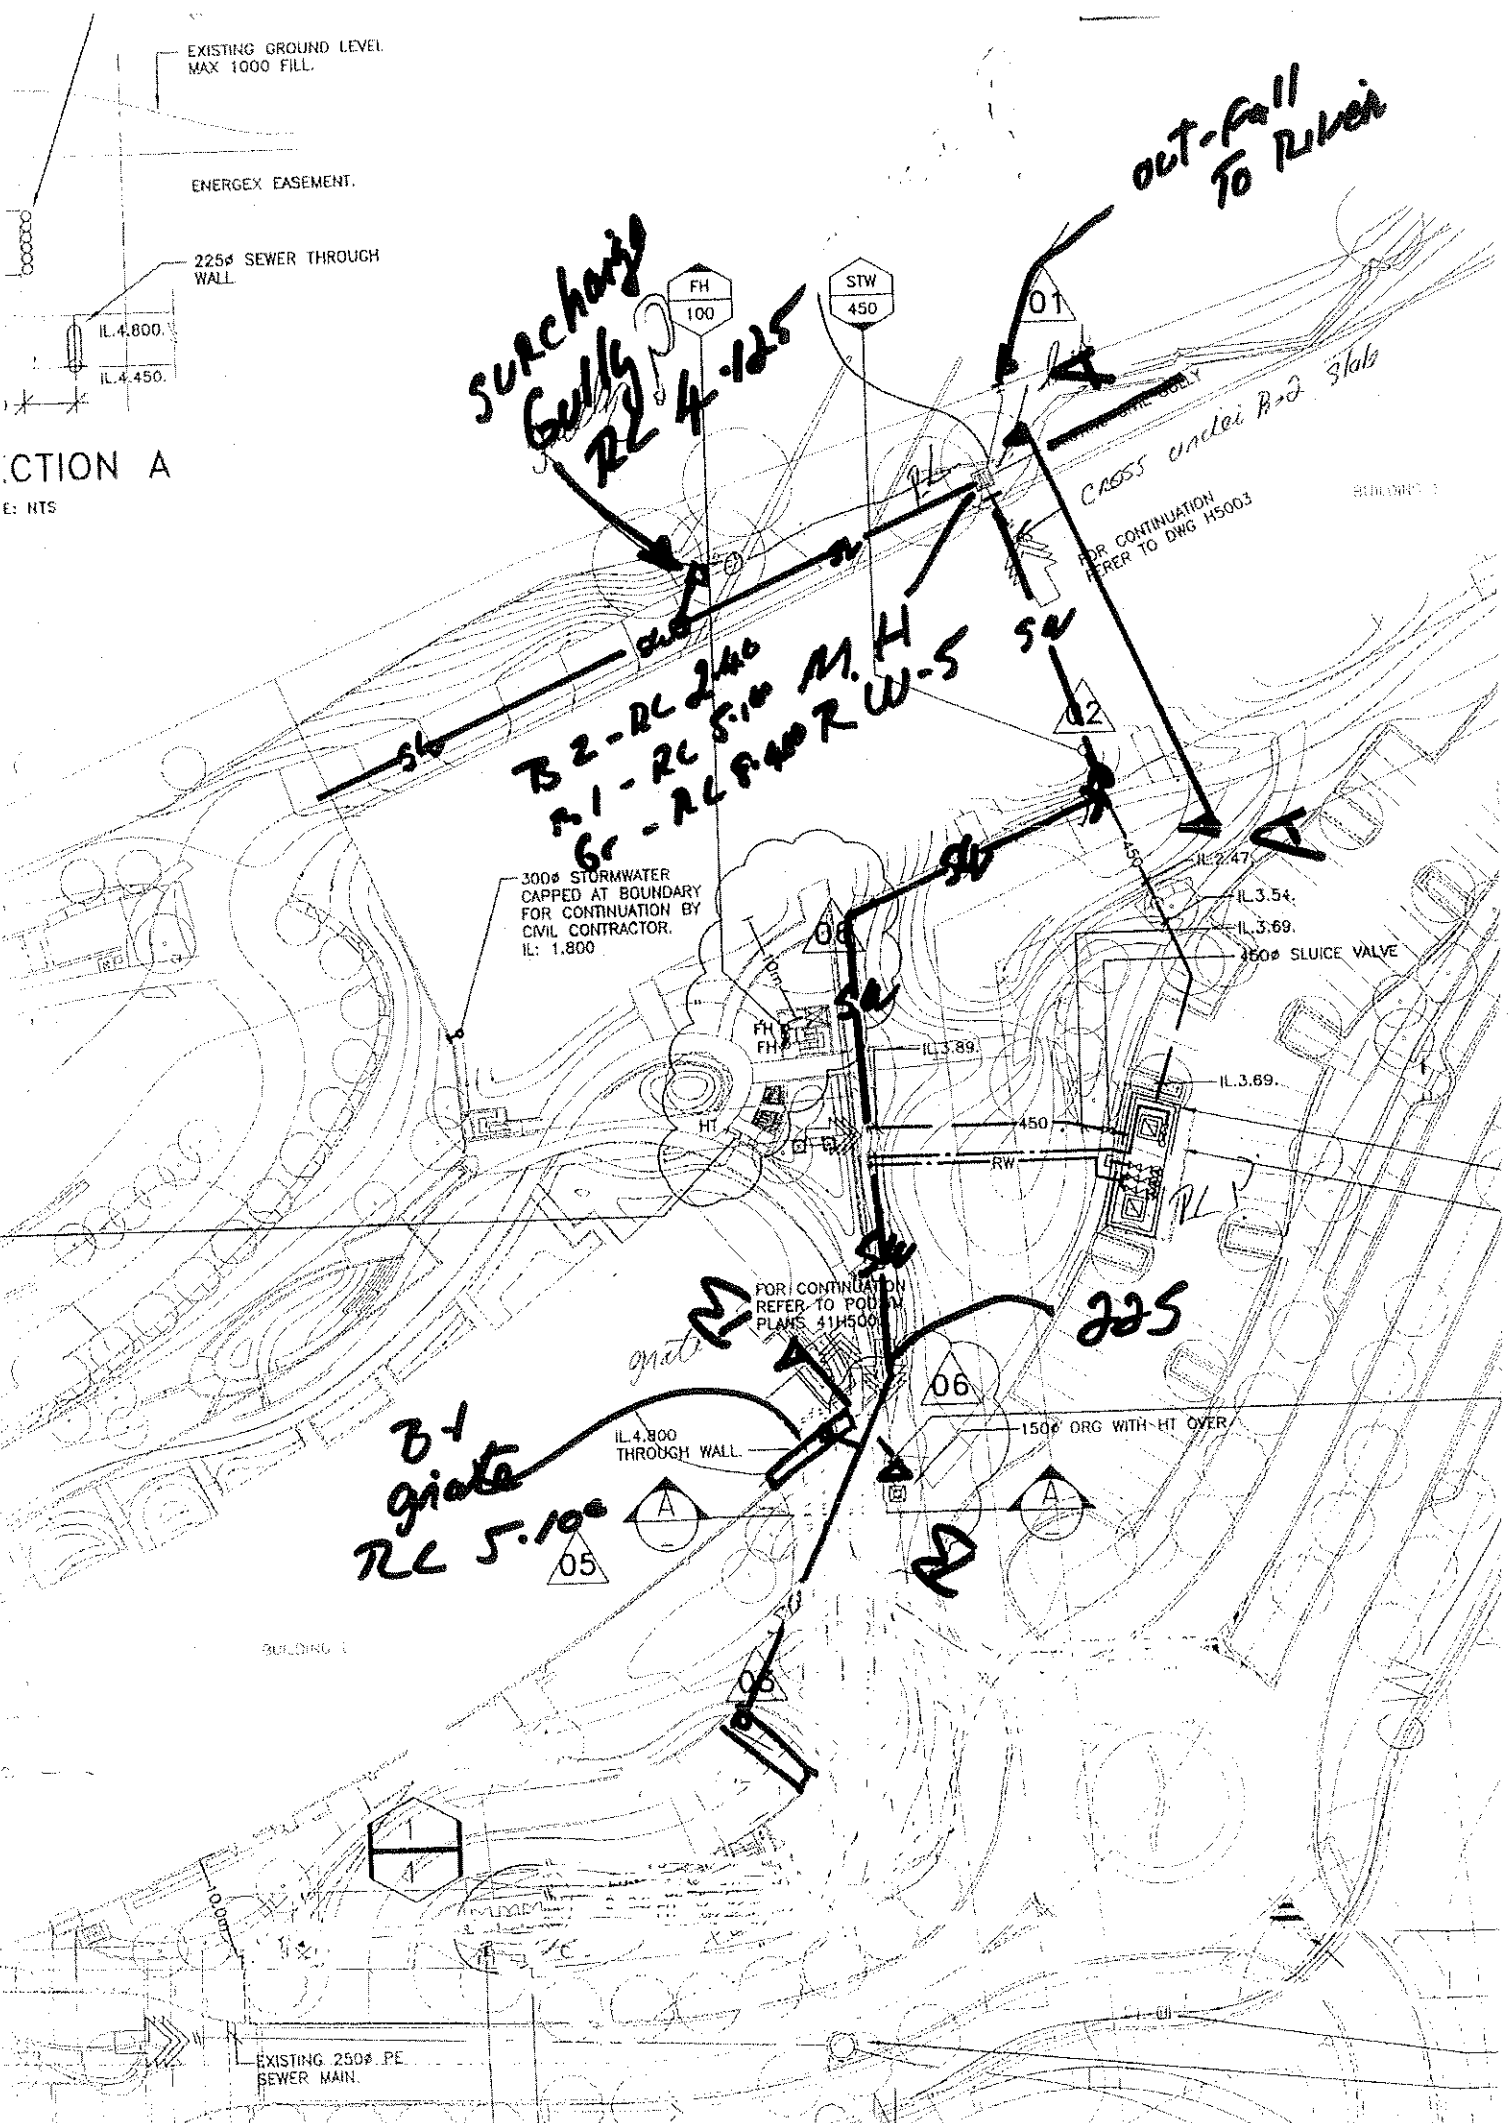
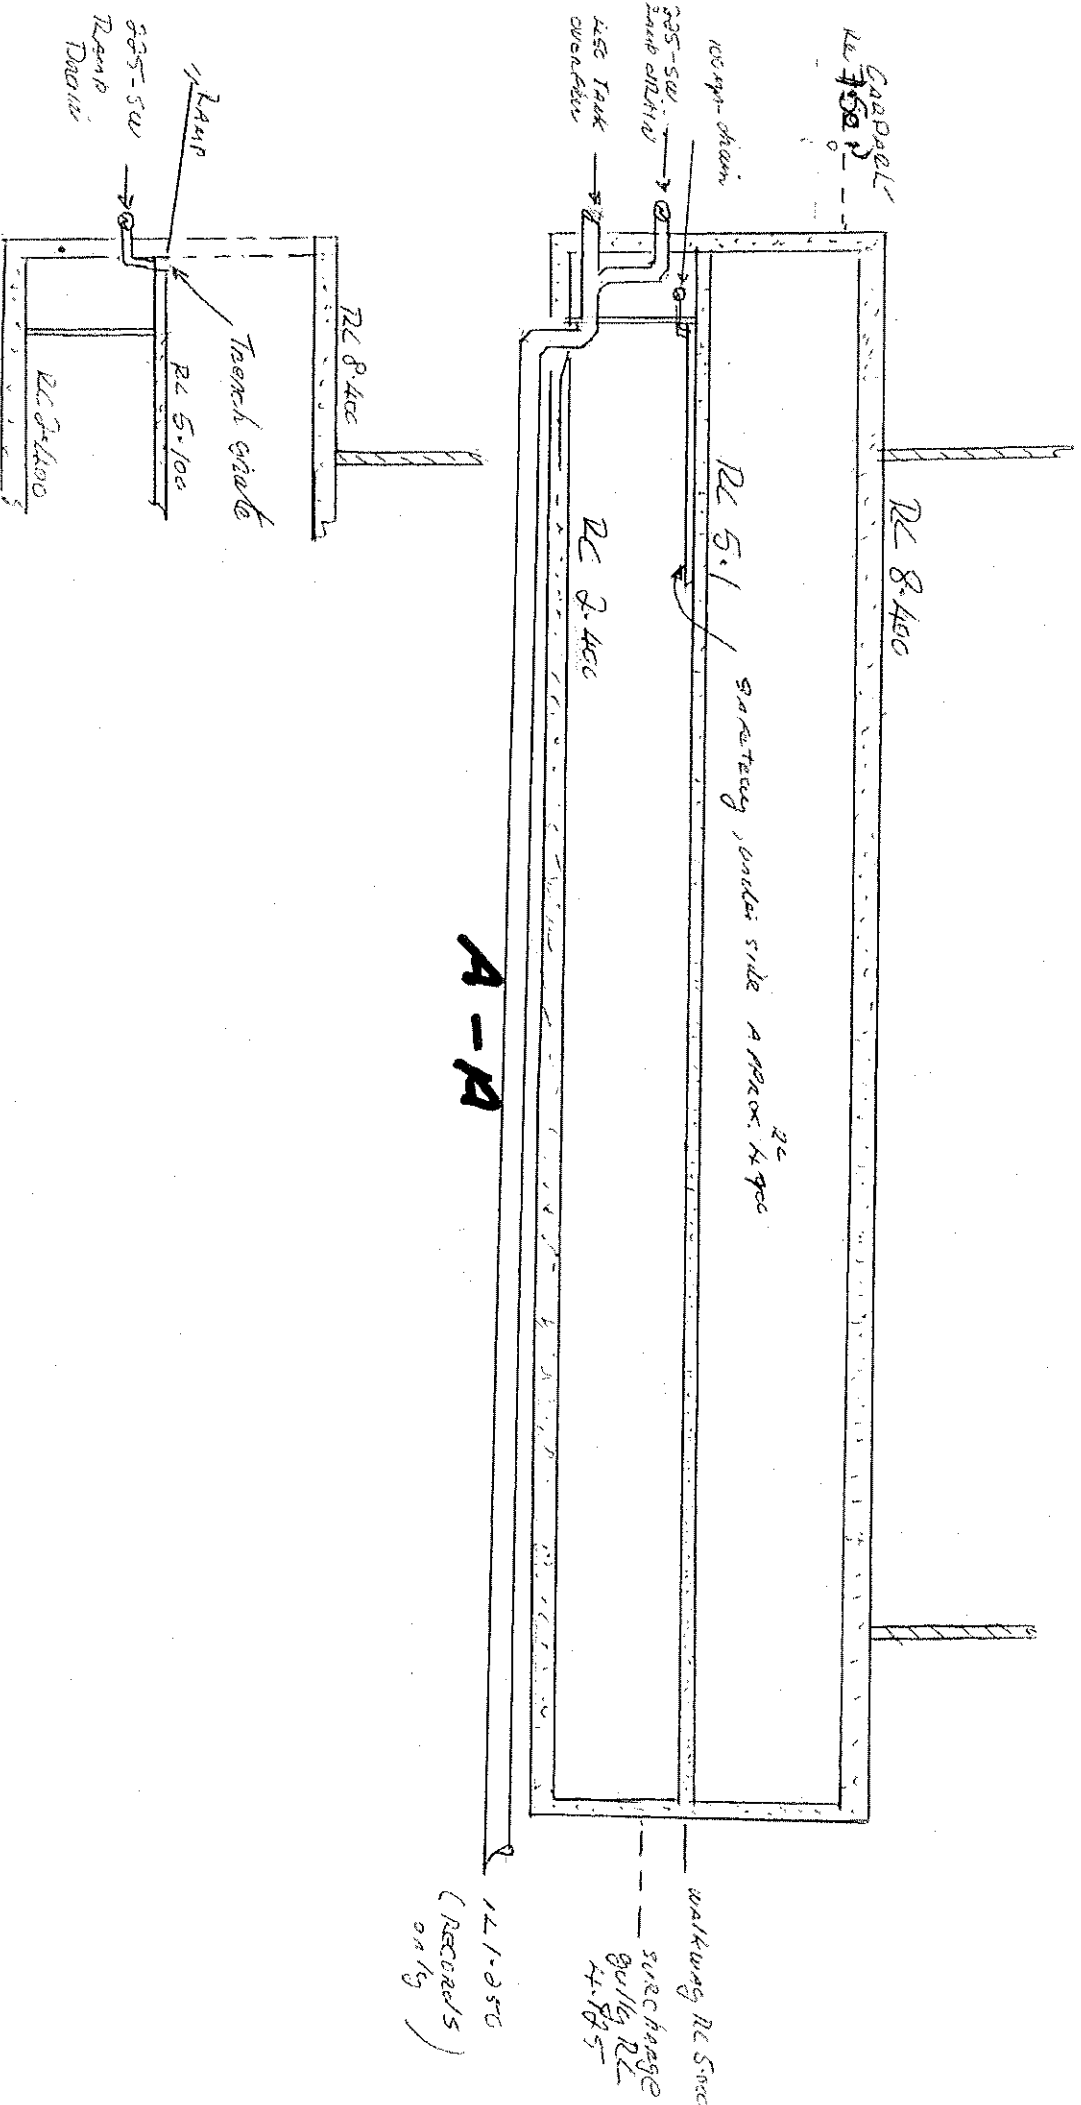
Refer the attached sketches H2 for further information.

There are a number of drain points within the basement, eg basement 1 ramp grate and safetray drains located under basement 1 that are directly connected to the stormwater discharge line. Therefore as the external water level rose once it reached about RL.4.700 (safetray drain) and RL.5.1 ramp drain outlet, water would flow into the basement as these are the lowest open points.

In addition to these points once the system become flooded, that is a water level near or over the external surcharge gully, then the gravity pipe system under that RL would be under a constant static head. The system under this static head by reports developed leaks to fittings with rubber ring joints.

The joints exist to the 450 FRC stormwater bends inside the basement and the expansion joints on the 100mm drain receiving pump discharge and safetray drains. Check valves on the pump lines prevented water flowing back to the mini pump station sumps.
