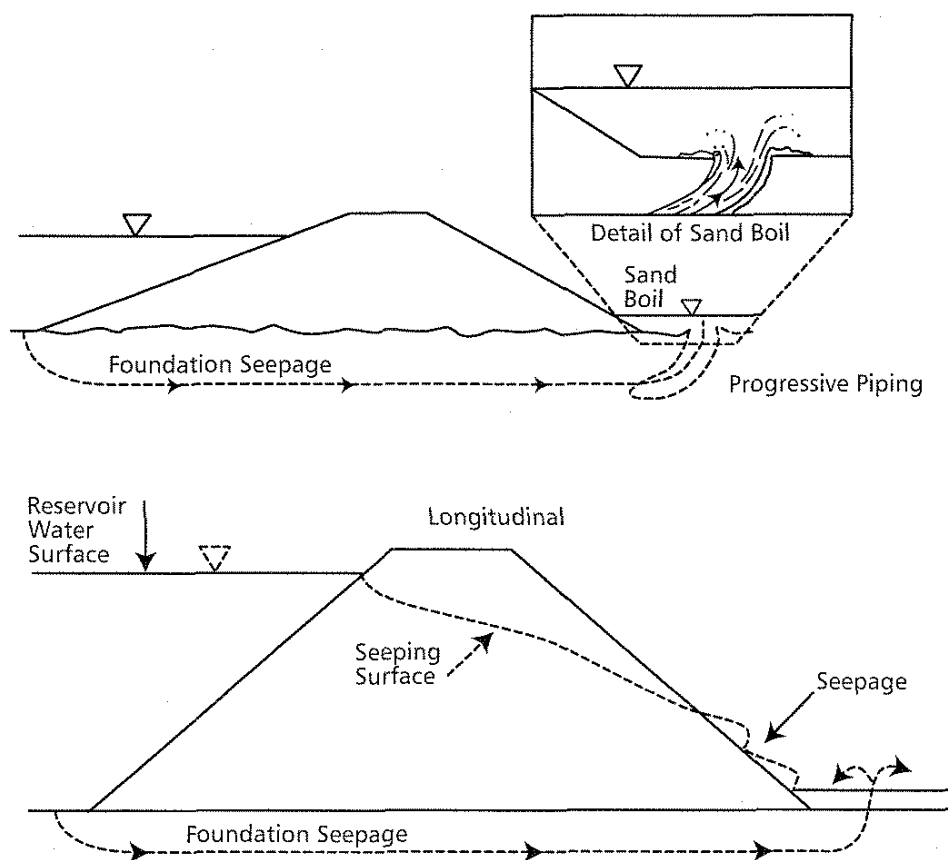
### Seepage

- A water flow or sand boil on the lower portion of the downstream slope or toe area, especially at the groins.
- Leakage around conveyance structures such as outlet works, spillway conduits, or penstocks.
- Blocked toe drains and relief wells.
- An increase in the amount of water being released from toe drains and relief wells. (Remember to take into account changes in the reservoir level, or the effects of rainfall on the downstream face and abutments).
- Wet areas or area where the vegetation appears greener or more lush on the embankment slope or toe area.
- Turbidity or cloudiness of the seepage.

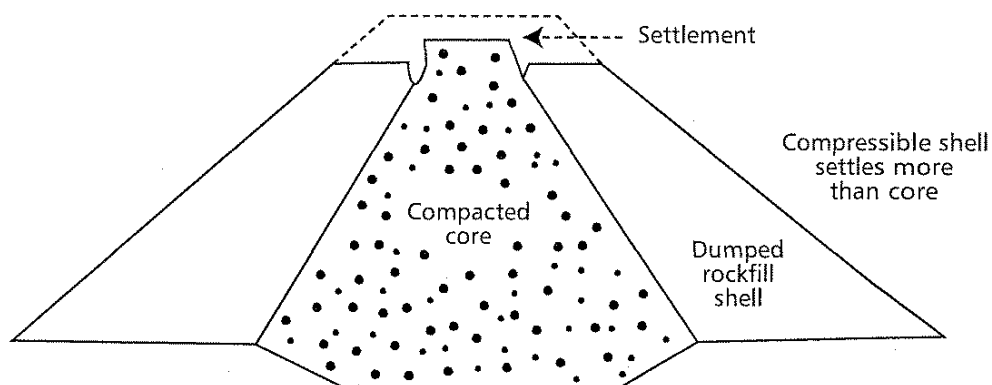
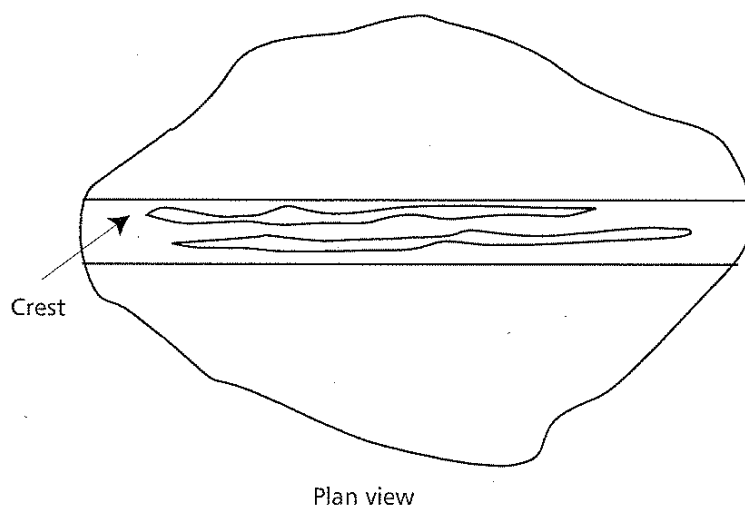
### Cracking

- **Desiccation Cracking:** A random honeycomb pattern of cracks usually found on the crest and the downstream slope.
- **Transverse Cracking:** Cracks that are perpendicular to the length of the dam usually found on the crest.
- **Longitudinal Cracking:** Cracks that are parallel to the length of the dam. Longitudinal cracks may be associated with stability problems in the slopes.

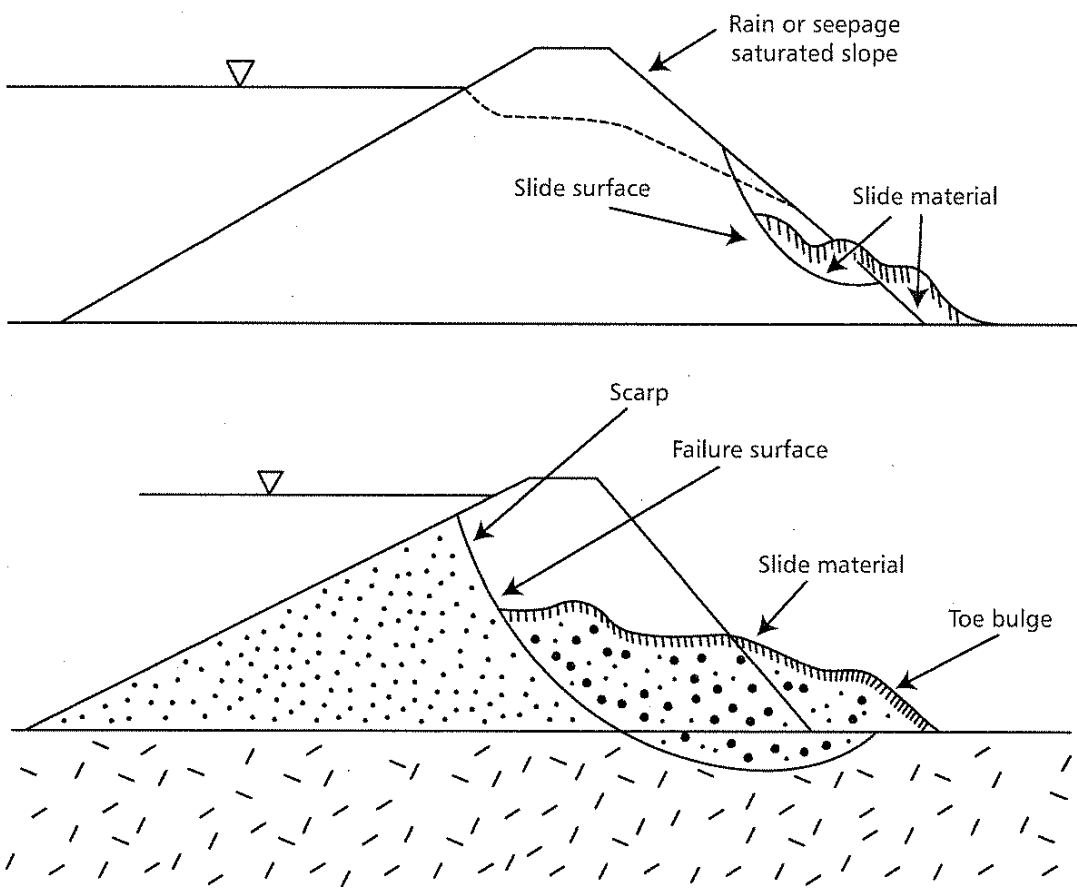
### Instability

- Slides on the upstream and downstream slopes.
- Bulging, especially at the toe of the dam.
- Misalignments in the crest and embankment slopes found by sighting along fixed points.

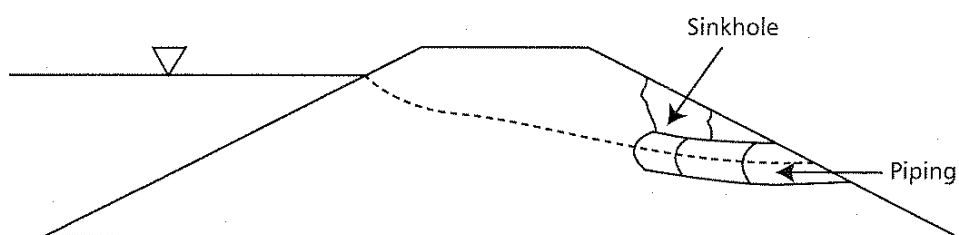
### Depressions

- Sinkholes found by checking and probing each depression. Remember, sinkholes have steep, bucket-like sides while minor depressions have gently sloping, bowl-like sides. These are initiated by settlement or migration of materials in the embankment.

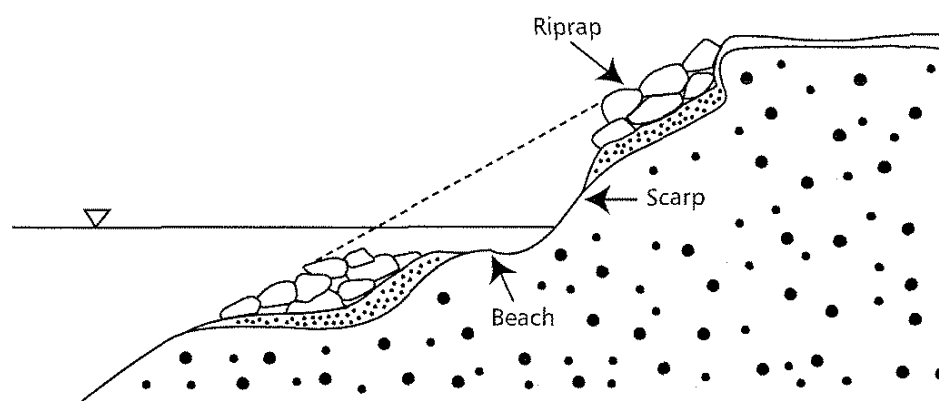
### Maintenance Concerns

- Inadequate Slope Protection: Check for bald areas or areas where the protection is sparse or damaged.
- Surface Runoff Erosion: Check for gullies or other signs of erosion. Make sure to check the low points along the upstream and downstream shoulders and groins since surface runoff can collect in these areas.
- Inappropriate Vegetative Growth: Check for excessive and deep-rooted vegetative growth, especially trees.
- Debris: Check for debris on and around the dam, especially debris that could clog or choke outlet-works or spillway inlets.
- "Animal Burrows": Check for damage caused by burrowing animals.

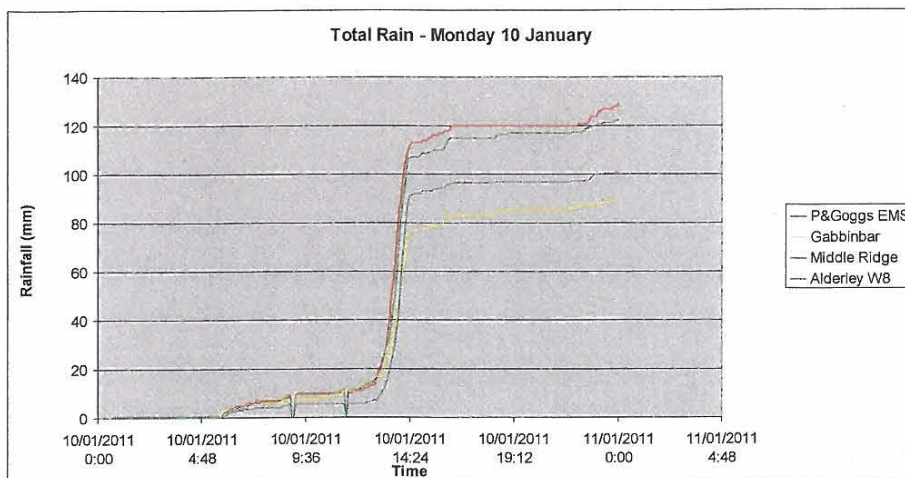
Figure 1 Pluviograph Record of Storm

On 10/1/2011 a storm cell passed slowly in a South Westerly direction over the Southern suburbs of Toowoomba, dumping up to 120 mm of rainfall in a short period of time (less than 40 minutes). The resultant flows in both East Creek and West Creek exceeded the capacity of culverts and storm drains in the CBD with resultant flooding of property, damage to cars and high risk to persons, including loss of life.

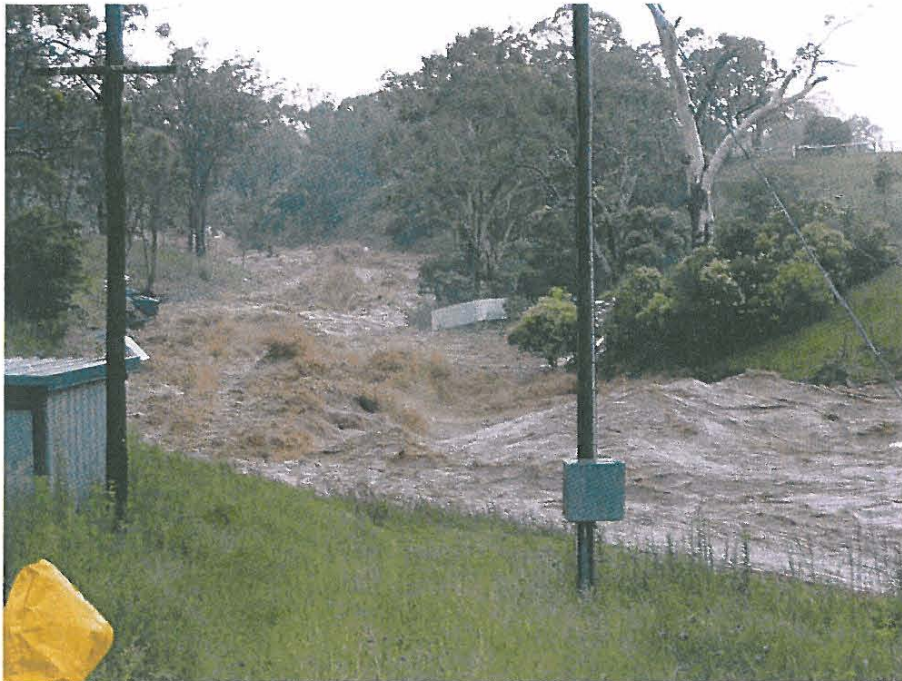
**Figure 2 Gowrie Creek in Flood**

The hydraulic behaviour of the flood in the CBD (refer Appendix B) contained standing waves and other hydraulic features associated with high energy flows which are sometimes associated with dam break floods.

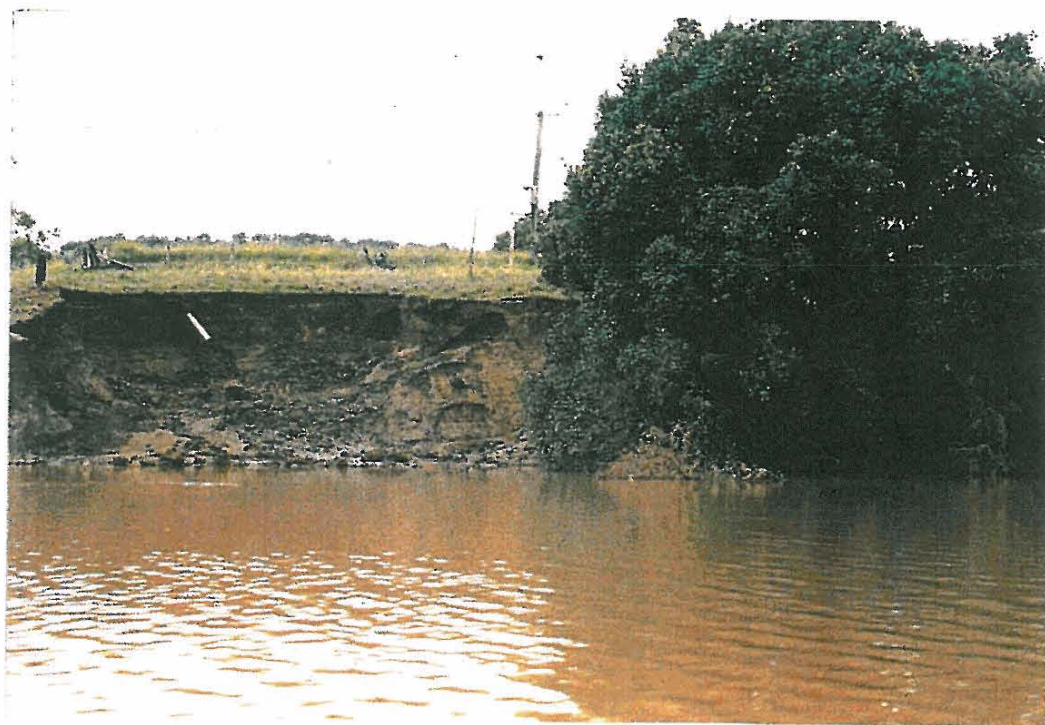
LOCATION 1

BANK SLIPS BRISBANE RIVER
