Submission to the Queensland Floods Commission of Inquiry

Restoring Ecological Infrastructure for Flood Resilience: The 2011 Southeast Queensland Floods and Beyond

Simon Warner
Chief Executive Officer
SEQ Catchments
183 North Quay
Brisbane

March 2011

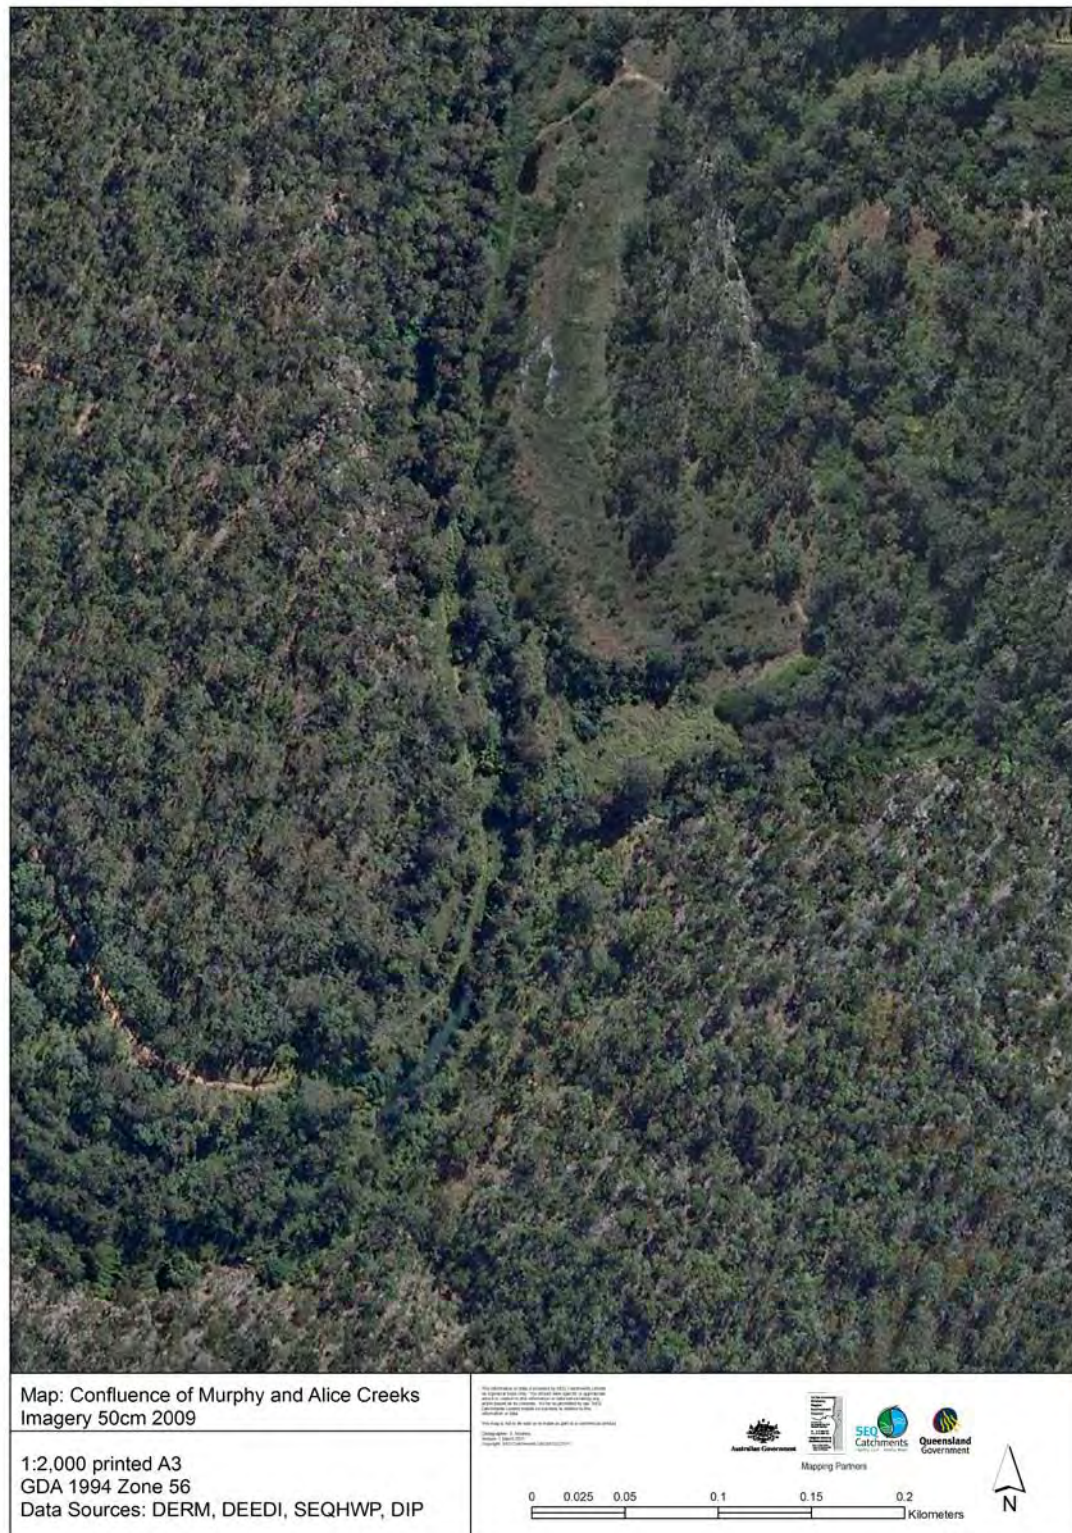
Figure 2 Confluence of Murphy and Alice Creeks pre-flood

Figures 2 – 5 on the following pages provide a graphic representation of the importance of vegetation in riparian zones. Figure 2 shows the confluence of Murphy and Alice Creek before the flood, while Figure 3 shows the same area after the event. While there has been an extensive loss of in-stream vegetation the surrounding riparian vegetation has retained its integrity. Figure 4 shows the Flagstone Creek at Helidon pre flood and the lack of riparian

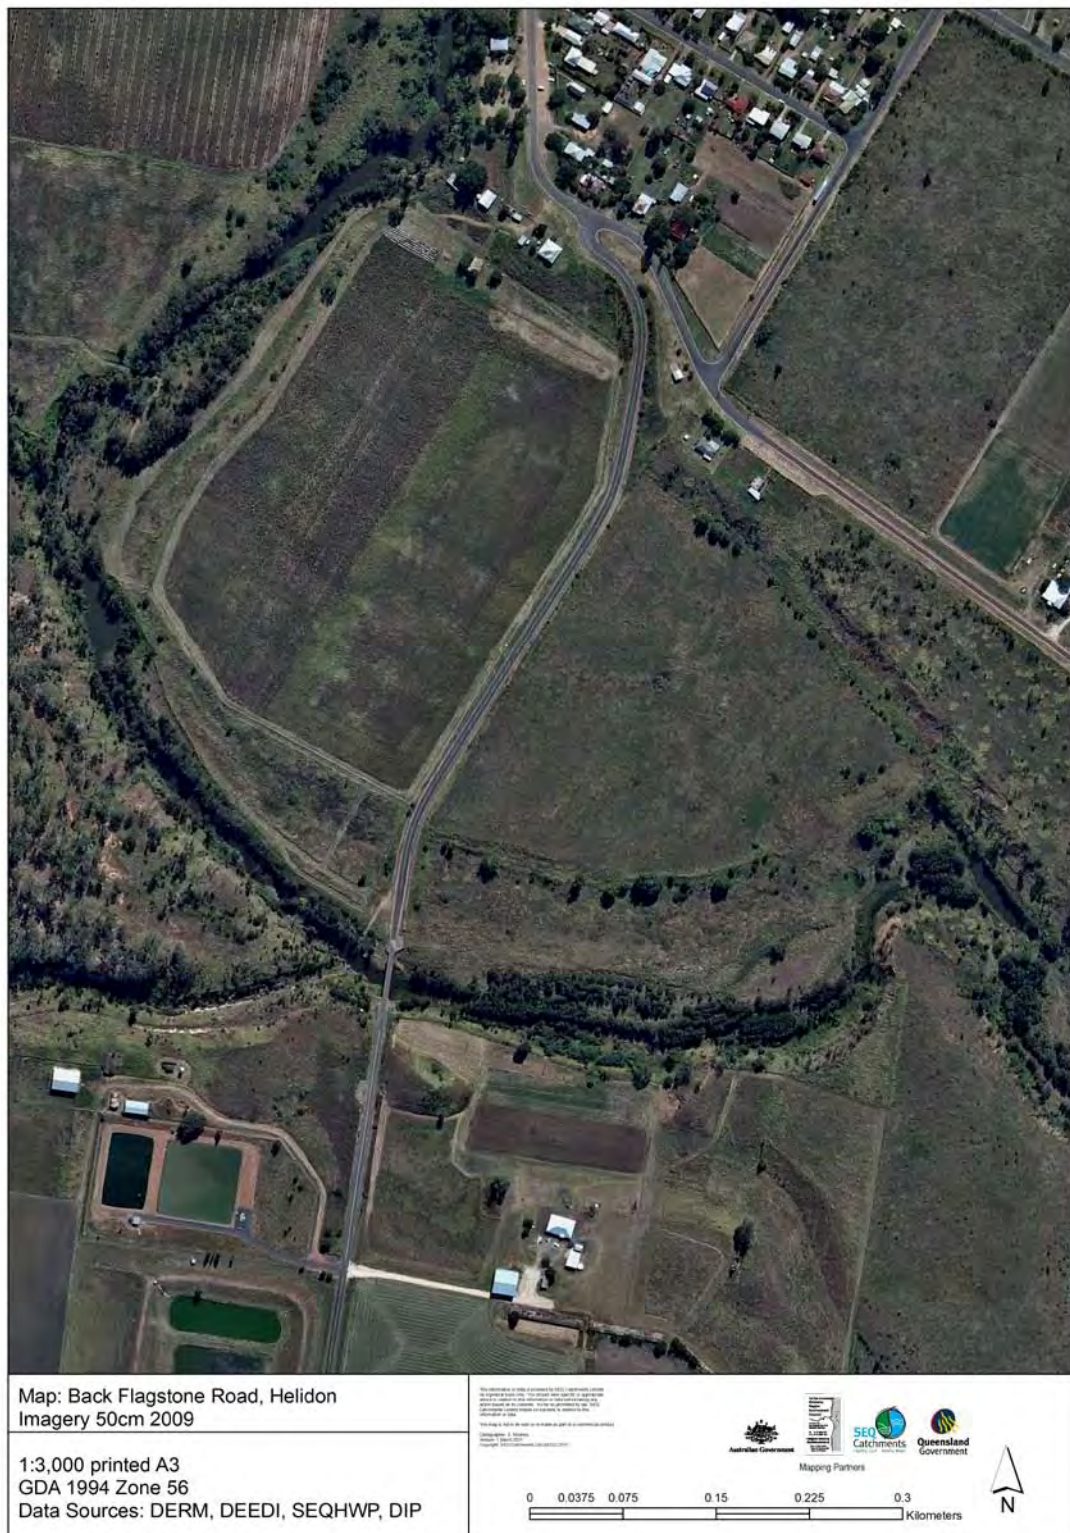
Figure 4 Lockyer Creek at Helidon pre-flood

coverage can be seen. Figure 5 shows the same area after the event and widescale erosive damage can be clearly seen.

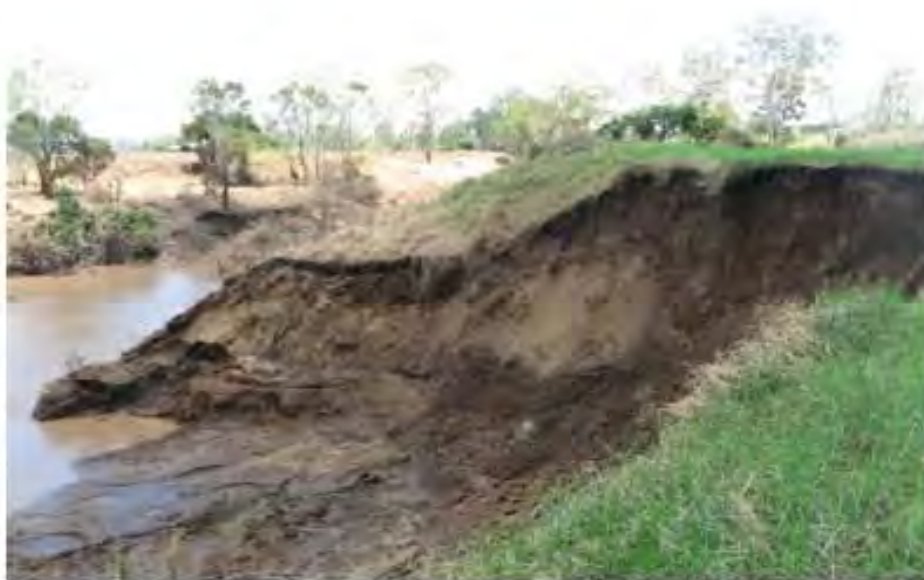
Figure 6 Bank erosion in the lower Lockyer after the 2011 flood

The following images from the Lockyer Catchment provide photographic evidence of the extensive sediment and erosion mobilisation that occurred in the 2011 flood event.

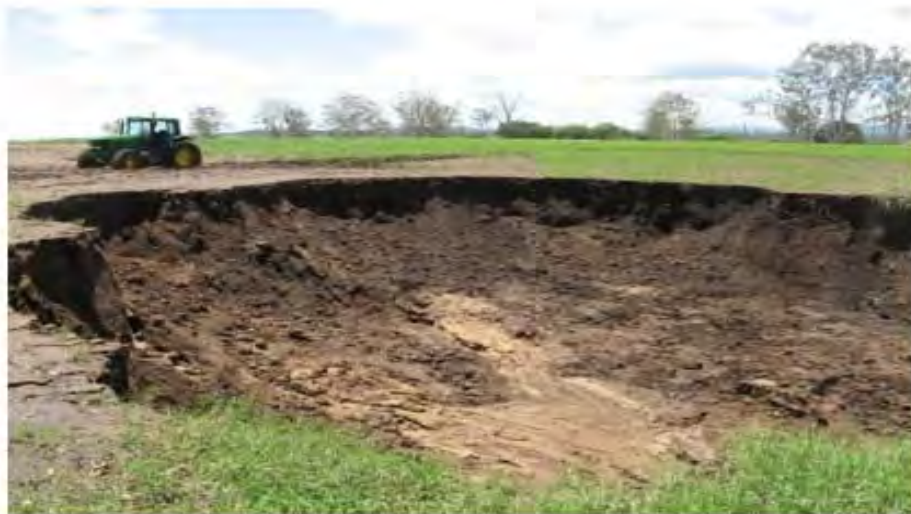
Figure 7 Gully erosion in the lower Lockyer after the 2011 flood

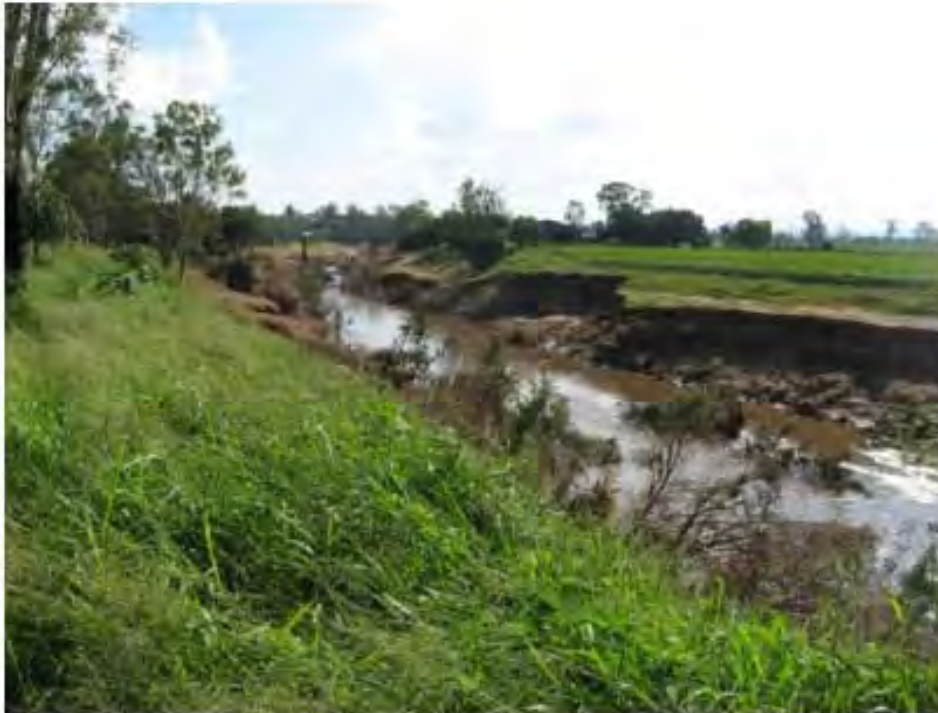
Figure 8 Lockyer Creek at Gatton after the 2011 flood showing extensive bank erosion

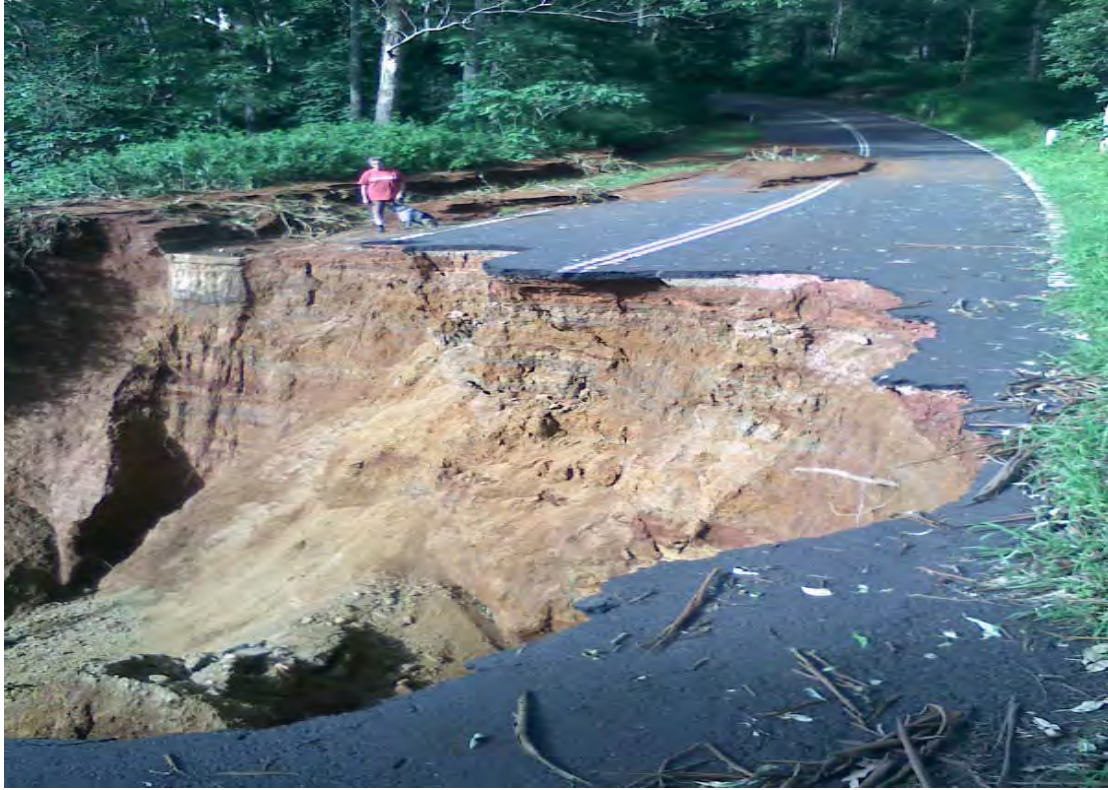
Figure 11 Main Esk Hampton Road post flood showing significant damage.

The 2011 flood event caused extensive damage to existing riparian areas. Bank erosion and slumpage was extensive across the catchment. Numerous landslips were recorded, particularly in areas cleared of native vegetation.

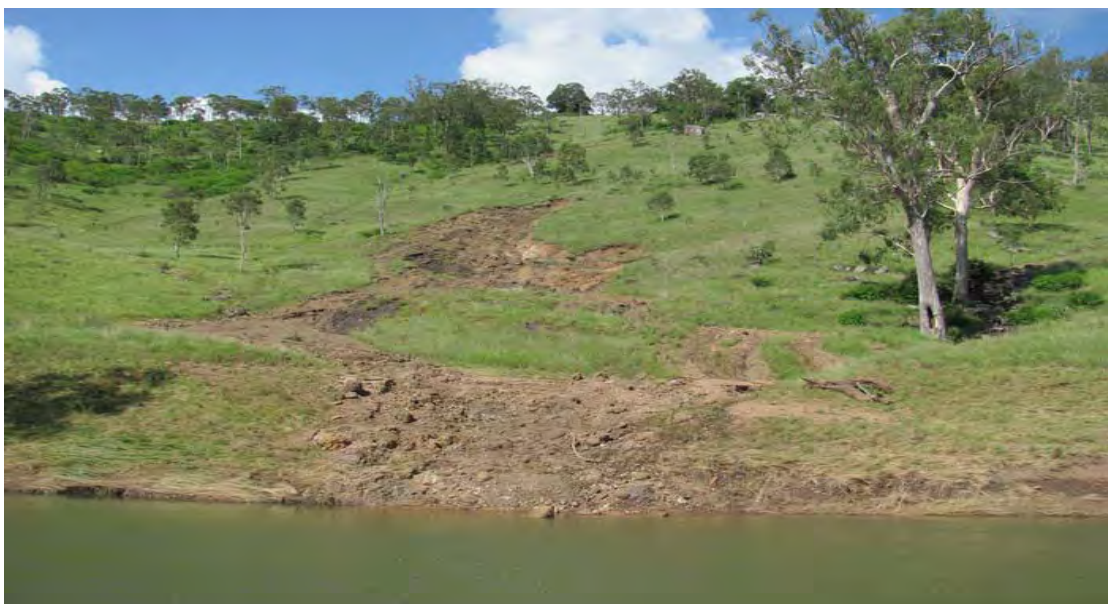
Figure 12 Landslip near Mt Stanley Upper Brisbane River

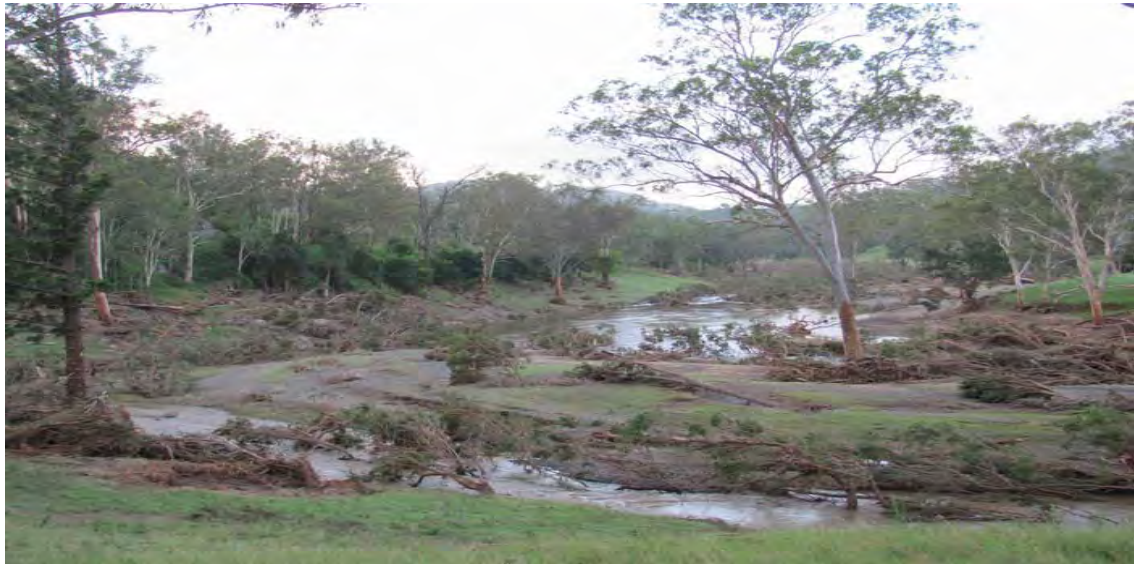
Figure 13 Creek damage near Linville

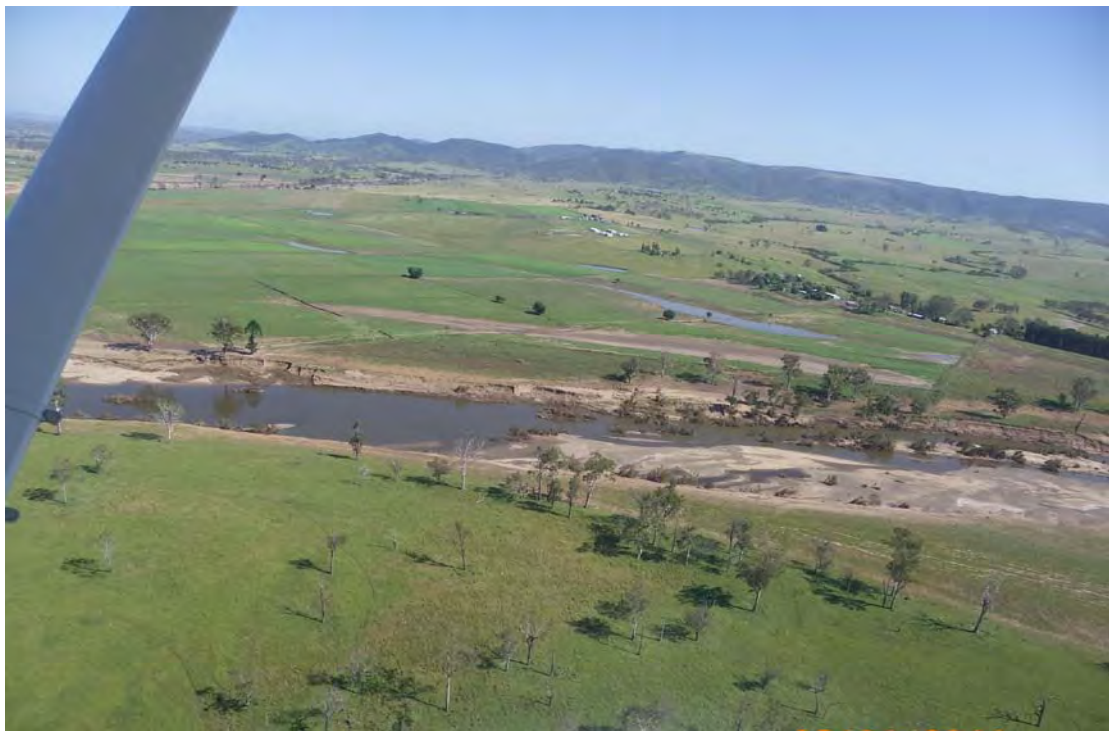
Figure 14 Aerial view of riparian erosion in Upper Brisbane Catchment

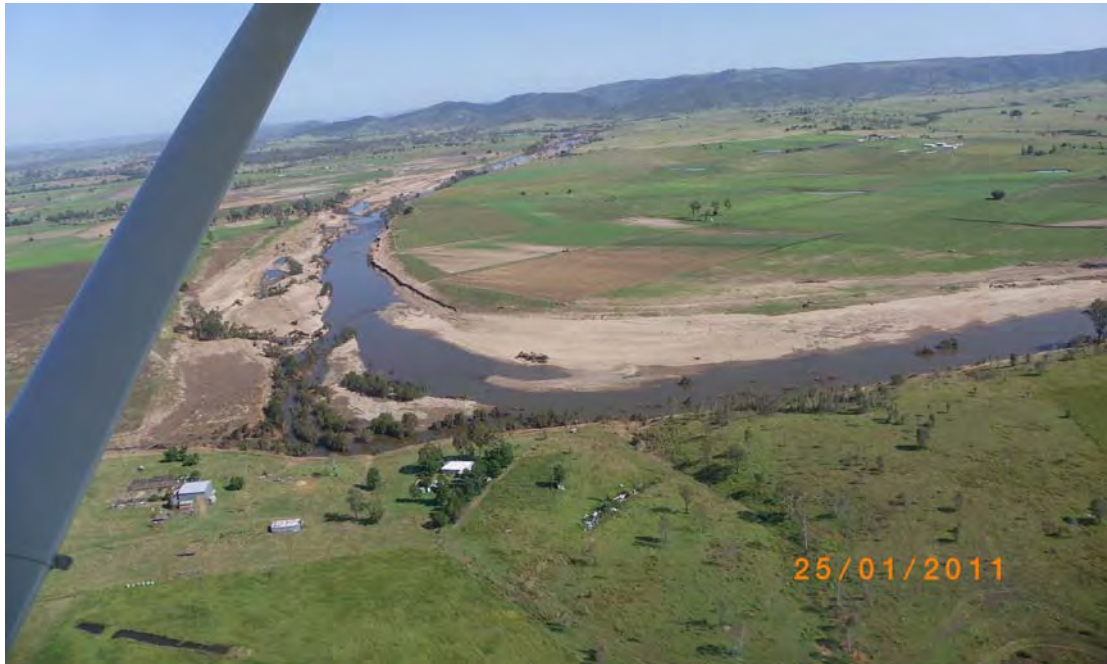
Figure 15 Aerial view of riparian erosion in Upper Brisbane Catchment

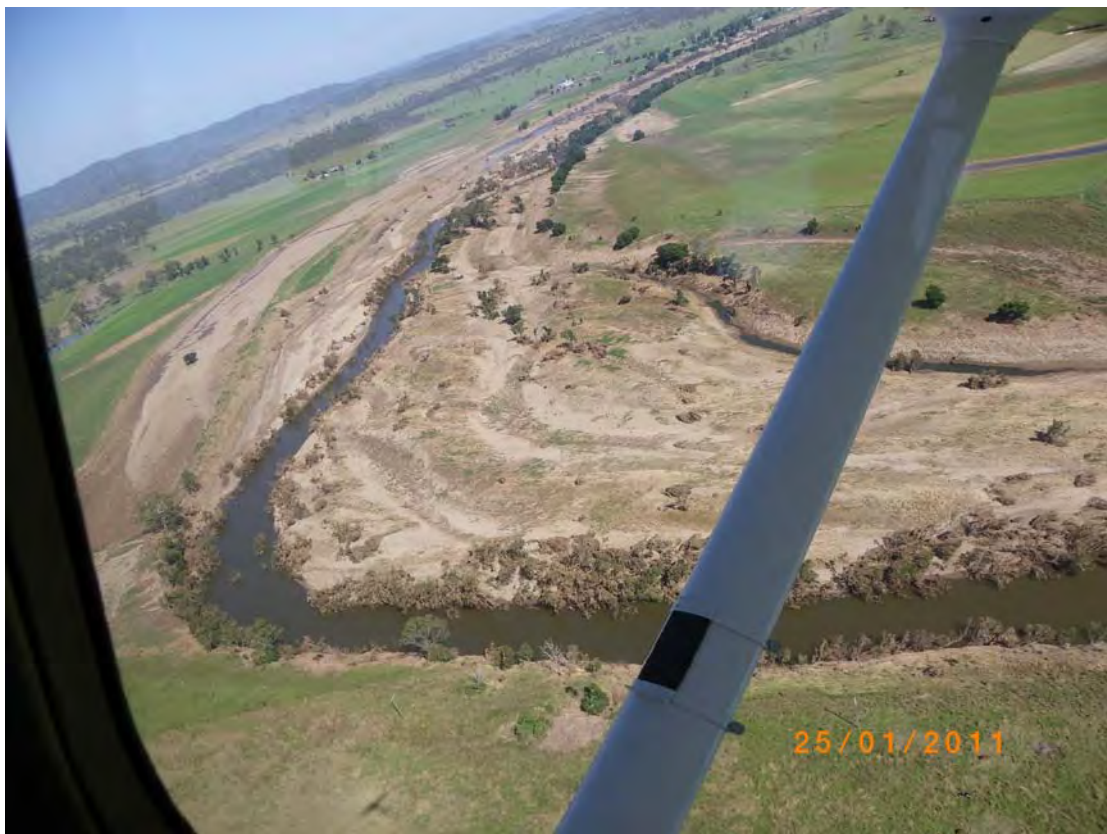
Figure 16 Aerial view of riparian erosion in Upper Brisbane Catchment

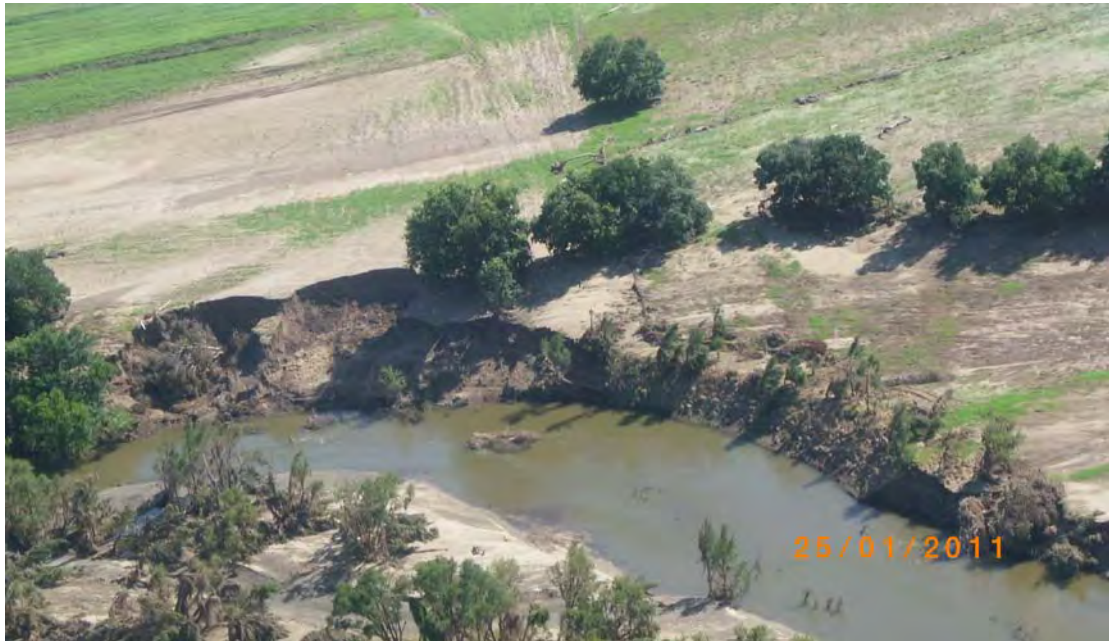
Figure 17 Aerial view of streambank erosion in Upper Brisbane Catchment

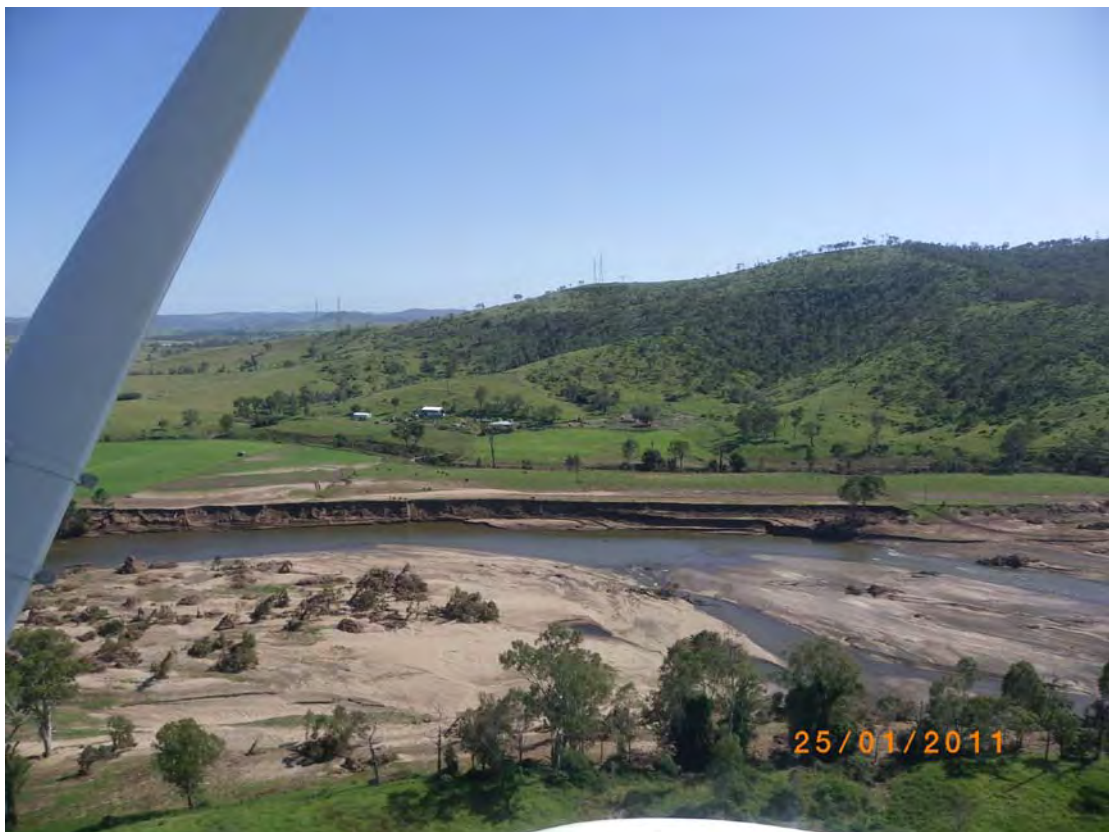
Figure 18 Aerial view of streambank erosion in Upper Brisbane Catchment

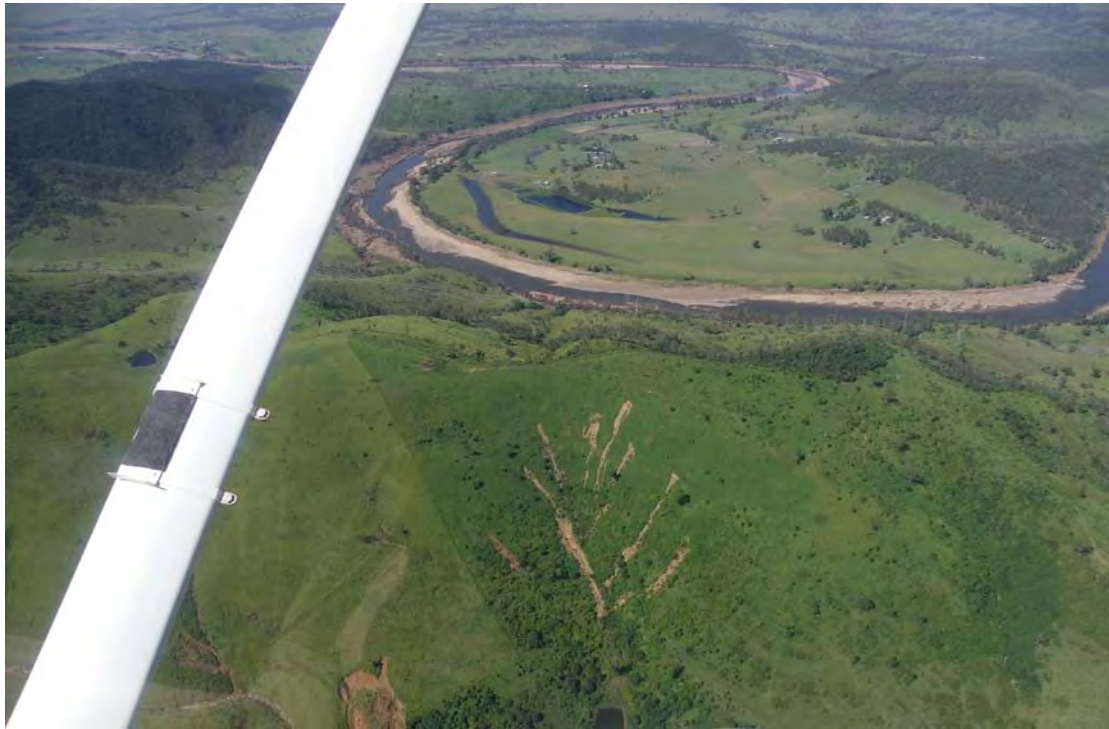
Figure 19 Aerial view of hillslope erosion in Upper Brisbane Catchment

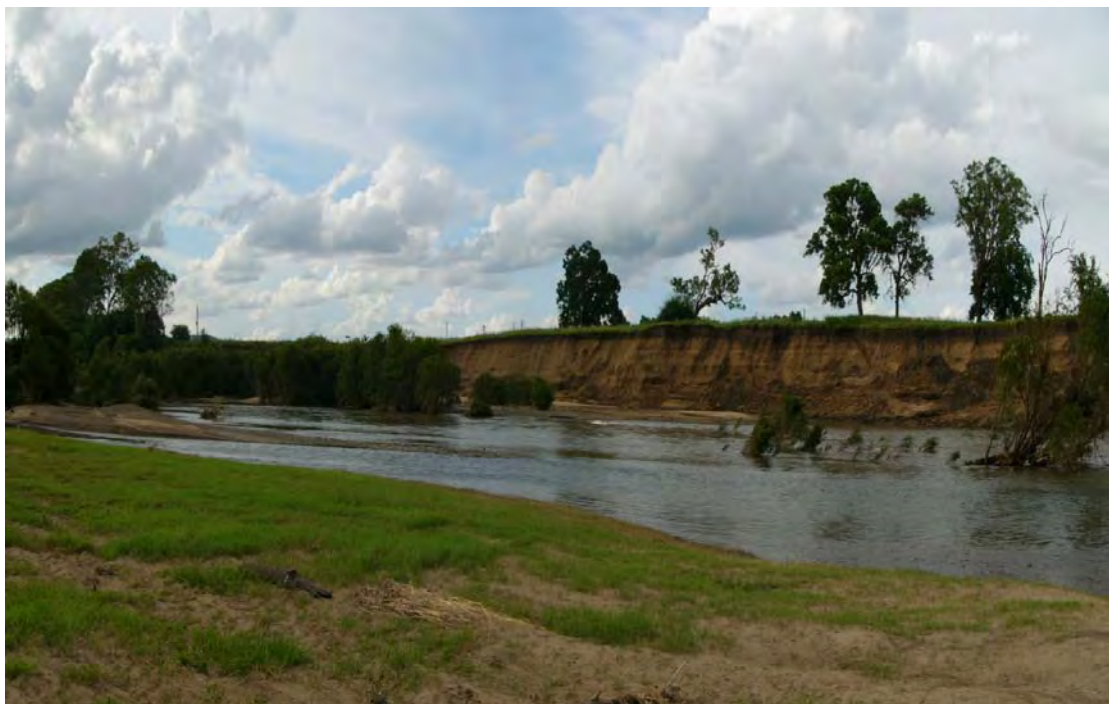
Figure 20 Bank erosion at mining site in the Upper Brisbane Catchment

Fieldwork by SEQ Catchments staff in the aftermath of the recent flood event indicates that sites of sand extraction have contributed significantly to ecological degradation. The Harlin reach of the Upper Brisbane has a long history of instability due to ongoing large scale extraction immediately downstream over many years. Following the flood event this reach shows classic symptoms of bed lowering, removal of nearly all instream features (vegetated bars, terraces), channel widening, severe bank erosion up to 10 m high and realignment of primary flow channel. It is now in a severely degraded state and there appears to have been degradation of all sites on the River visited to date.

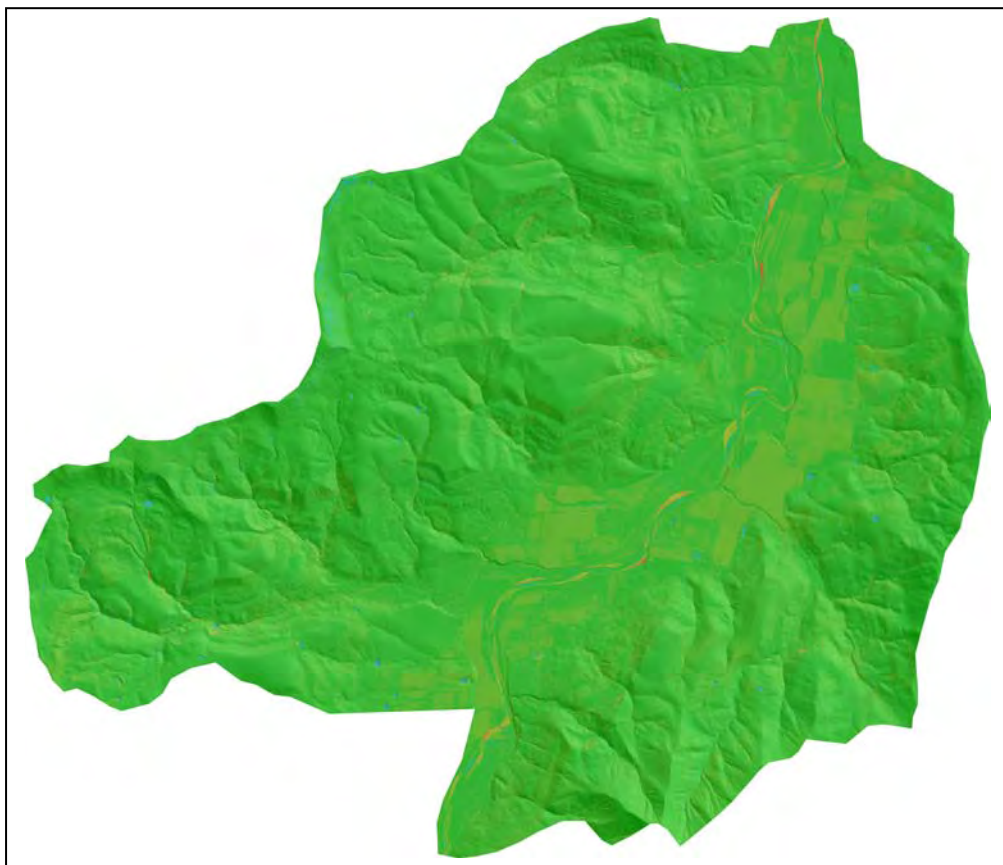
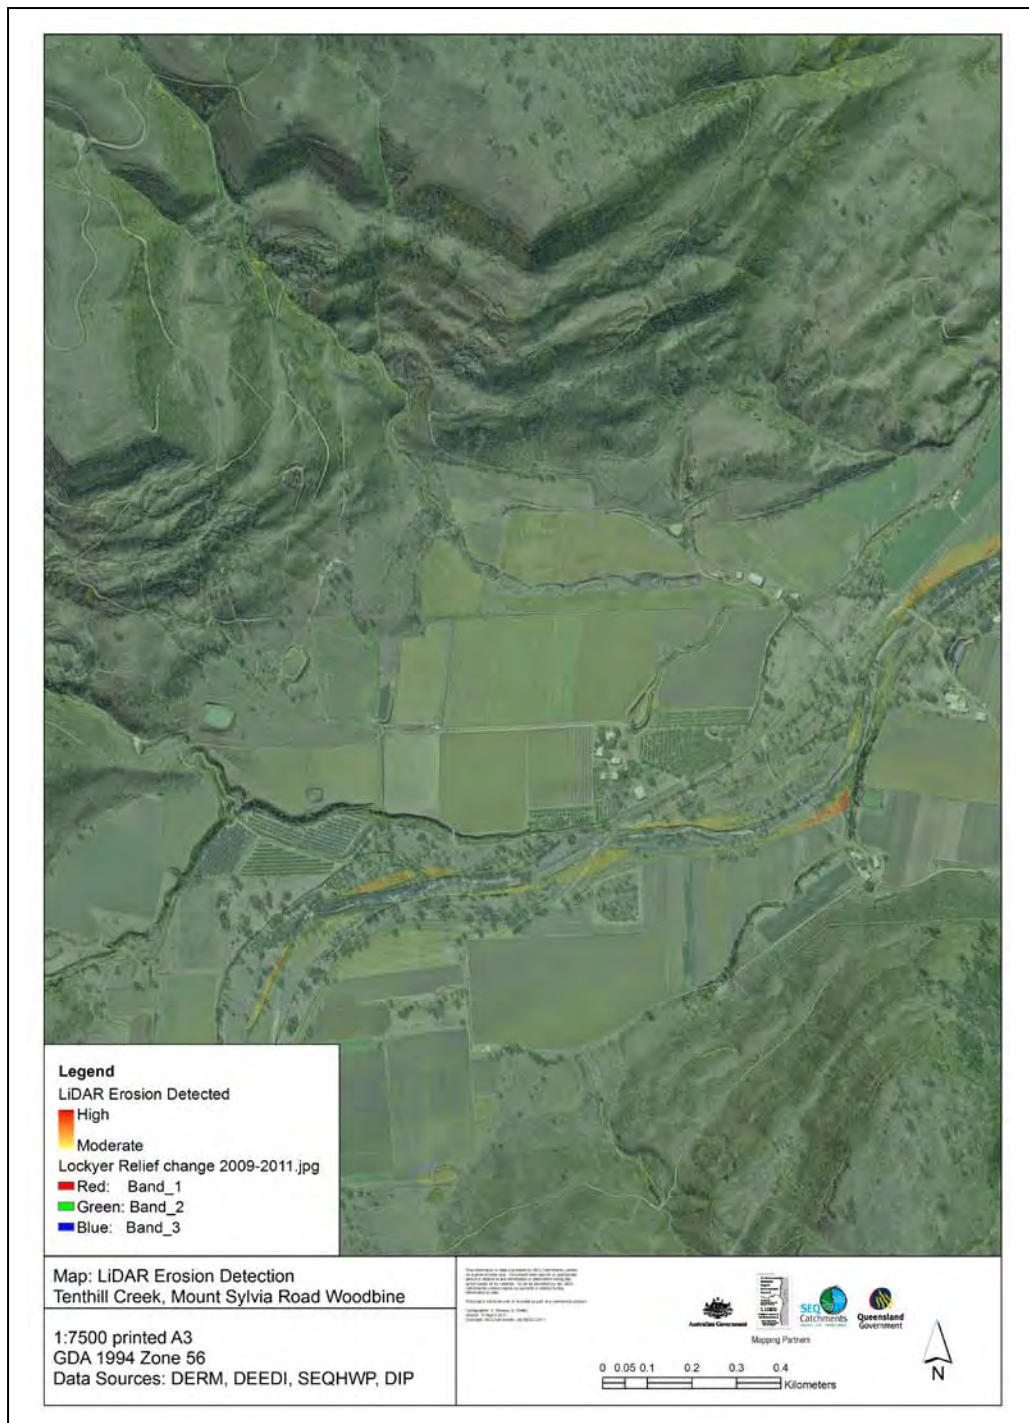
LiDAR allows for a landscape assessment of flood damage and prioritising of recovery work and proactive planning to mitigate or avoid future damage.

Red	High Erosion - Sediment Loss
Yellow	Moderate Erosion – Sediment Loss
Blue	Deposition - Sediment Gain
Green	Background Colour

SEQ Catchments experience in the pre and post flood is that new technologies such as LiDAR (Light Detection and Ranging) are invaluable tools for the planning and management of floodplains (Appendix 1). As such it is recommended that LiDAR surveying of the catchments of South East Queensland be undertaken as a priority where it has not occurred.
