WIVENHOE POWER STATION

January 2011 Exceptional Rainfall Event

Review of Event and Actions

Splityard Creek Dam

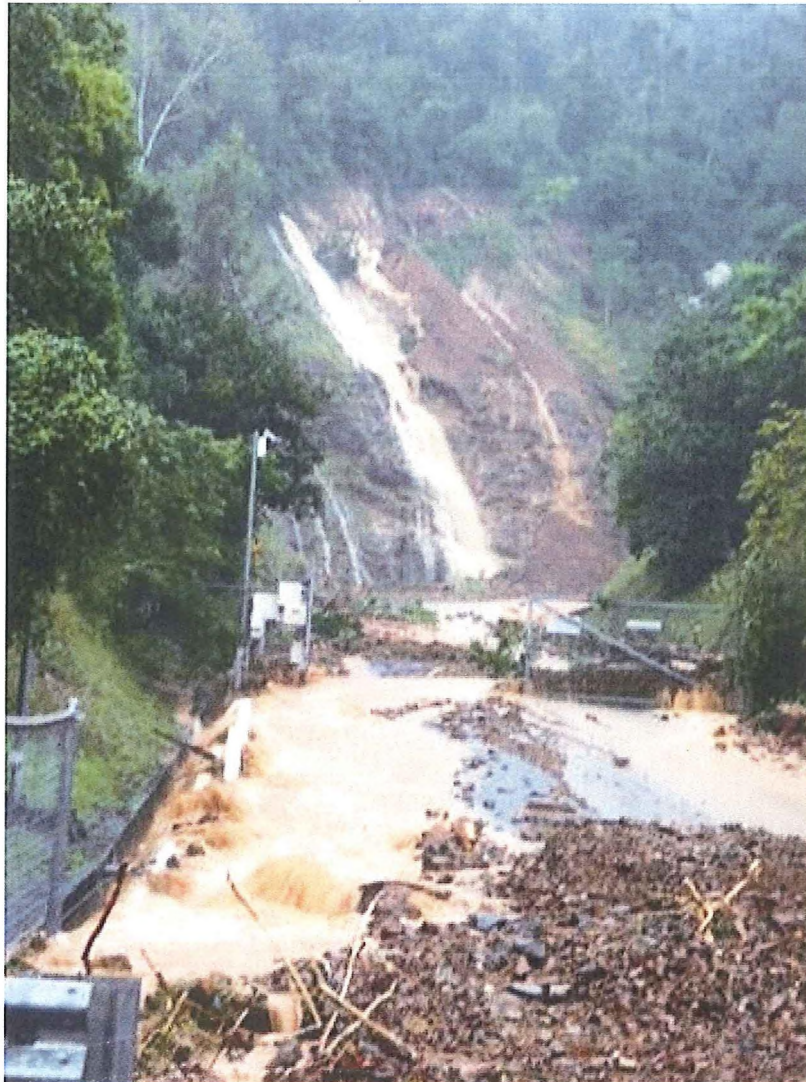
WPS - Main Access Road – 11 January 2011

On Tuesday 11 January 2011 an exceptional rainfall event occurred in the region surrounding Wivenhoe Power Station and Wivenhoe Dam. The photo below is included to demonstrate the high level approximately (RL 75), to which Wivenhoe Dam rose during this event and this report's cover photo shows the severity of rainfall runoff and slope failure that occurred on the main access road to the power station.
