<i>Name of Witness</i>	Robert Gordon ANDERSON
<i>Date of Birth</i>	██████████
<i>Address and contact details</i>	██████████ Emerald Ph. ██████████ Fax ██████████ m. ██████████ ██
<i>Occupation</i>	Farmer Cotton Grower
<i>Officer taking statement</i>	Detective Sergeant Stephen PLATZ
<i>Date taken</i>	18 August 2011

Exhibit: Submission to Queensland Floods Commission of Inquiry
by RG JM BH & RL ANDERSON dated 24th May 2011

24th May, 2011

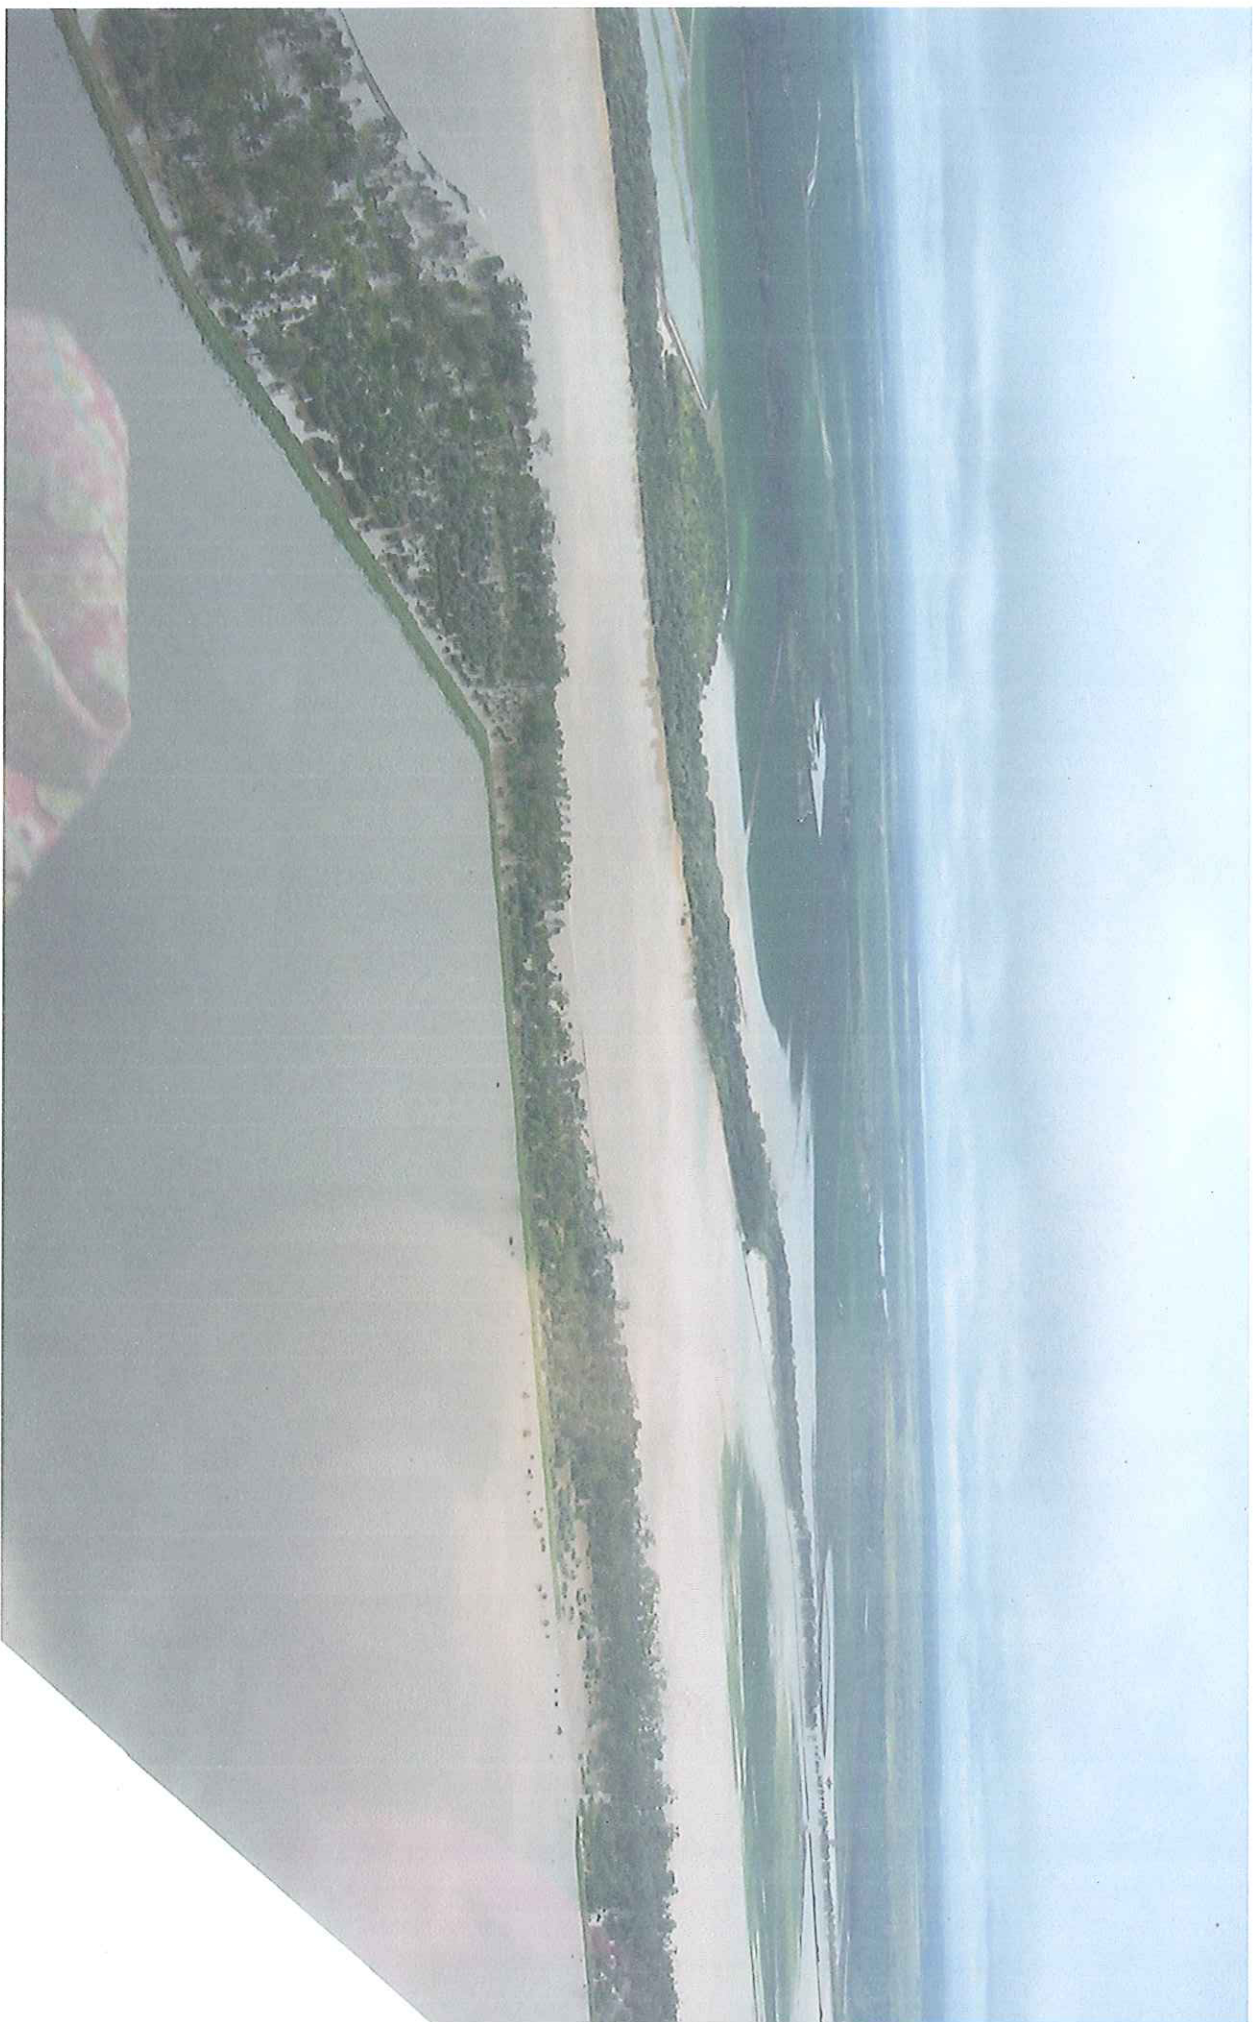
Robert ANDERSON – Photograph No.6 – Retreat creek restriction in December 2010 depicting the old and new flood plain after the levees had broke (they have since been re-built higher).

14. Photograph number 6 depicts the 200 metre restriction at Retreat Creek in the December 2010 floods. It displays the old and new flood plain after the levees had broken. I am able to produce this photograph.

Exhibit: **Photograph depicting Retreat Creek restriction in December 2010 floods.**

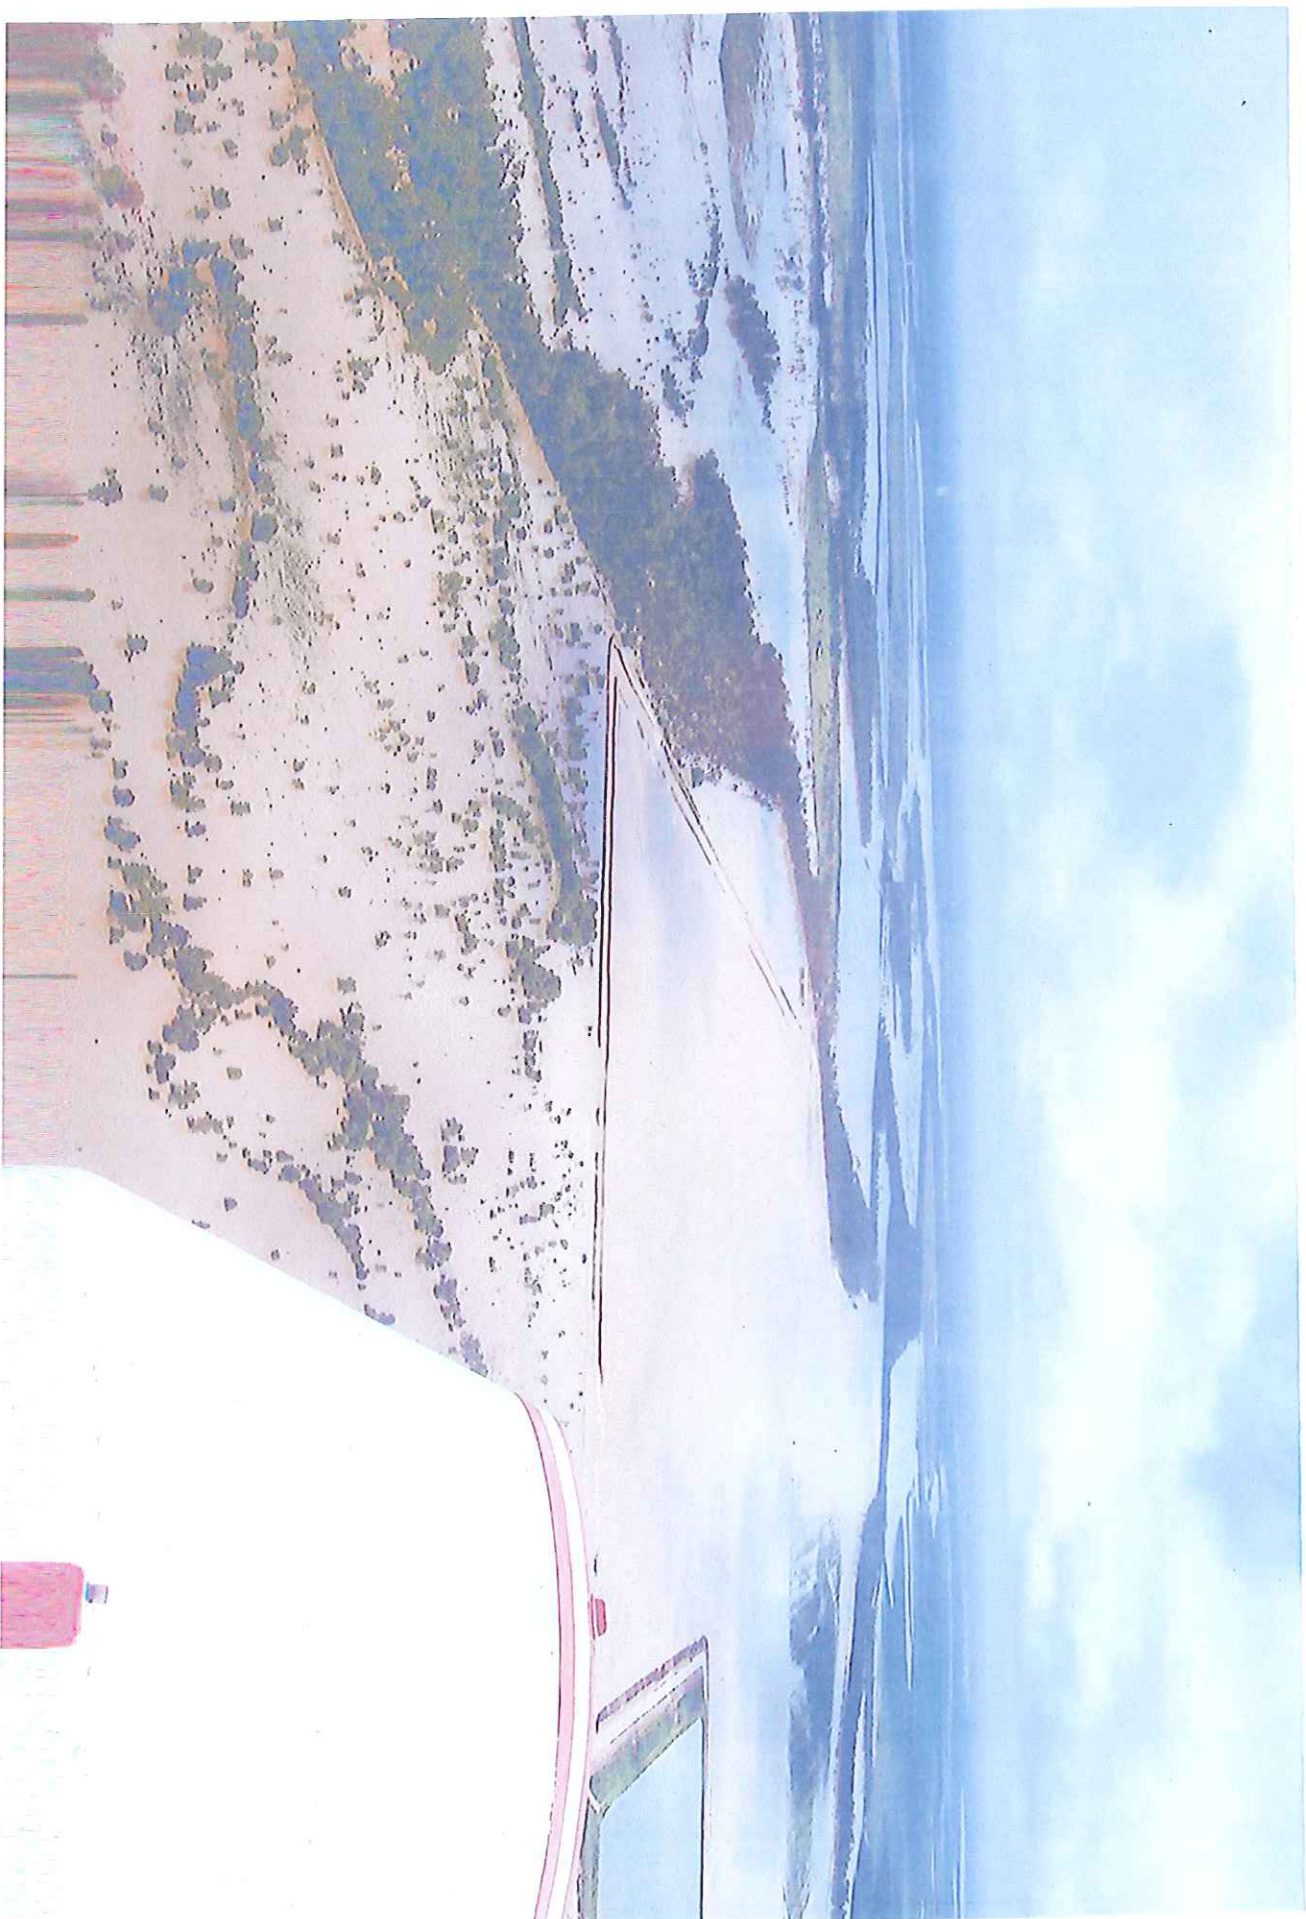
Robert AN DERSON - Photograph No. 4 - Depicts same area as mentioned in photograph 3 but during December 2010 flood (opposite side). Also shows current of water escaping from retreat creek into drain and then into Ford creek south of the dam.

12. Photograph number 4 displays flooding during the December 2010 flood within portion's [REDACTED] and surrounding properties. Flood has breached the levee banks and water is escaping into Ford Creek at the south of the dam. I am able to produce this photograph.

Exhibit: **Photograph depicting flooding in portion's [REDACTED] and surrounding properties during December 2010 flood.**

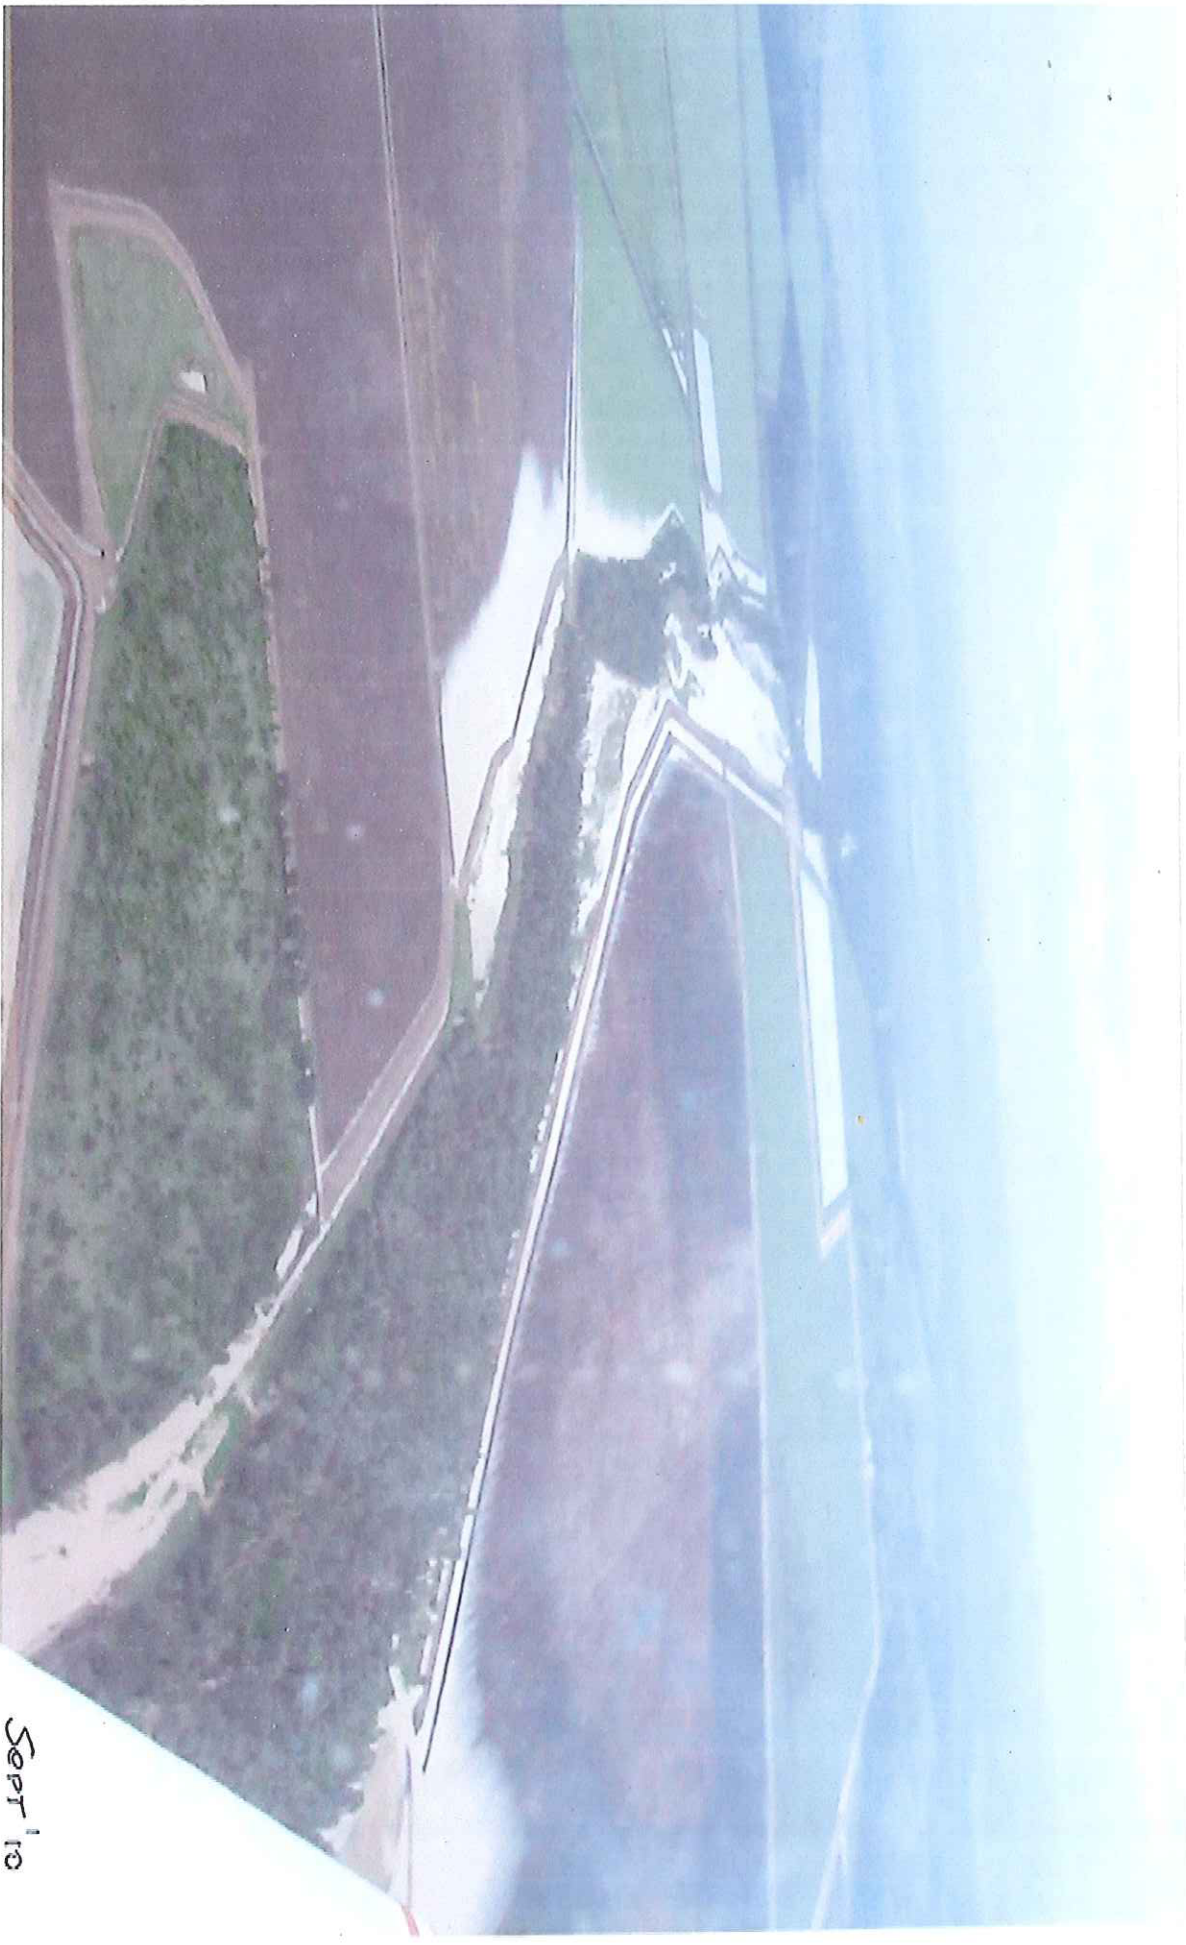
Robert AN DERSON - Photograph No. 3 - Depicts light flood in September 2010. Displays 8 m high western levee at top centre with dam to the left. Eastern levee bank (centre) forcing water onto to 157 and keeping flood plain high.

11. Photograph 3 is an aerial photograph depicting light floods in September 2010. It displays the levee wall on the western and eastern sides and the dam within portion's [REDACTED]. The levee has forced water onto portion [REDACTED]. I am able to produce this photograph.

Exhibit: Photograph of light flooding in September 2010 depicting levee banks in portion's [REDACTED] causing diversion of the flood plain

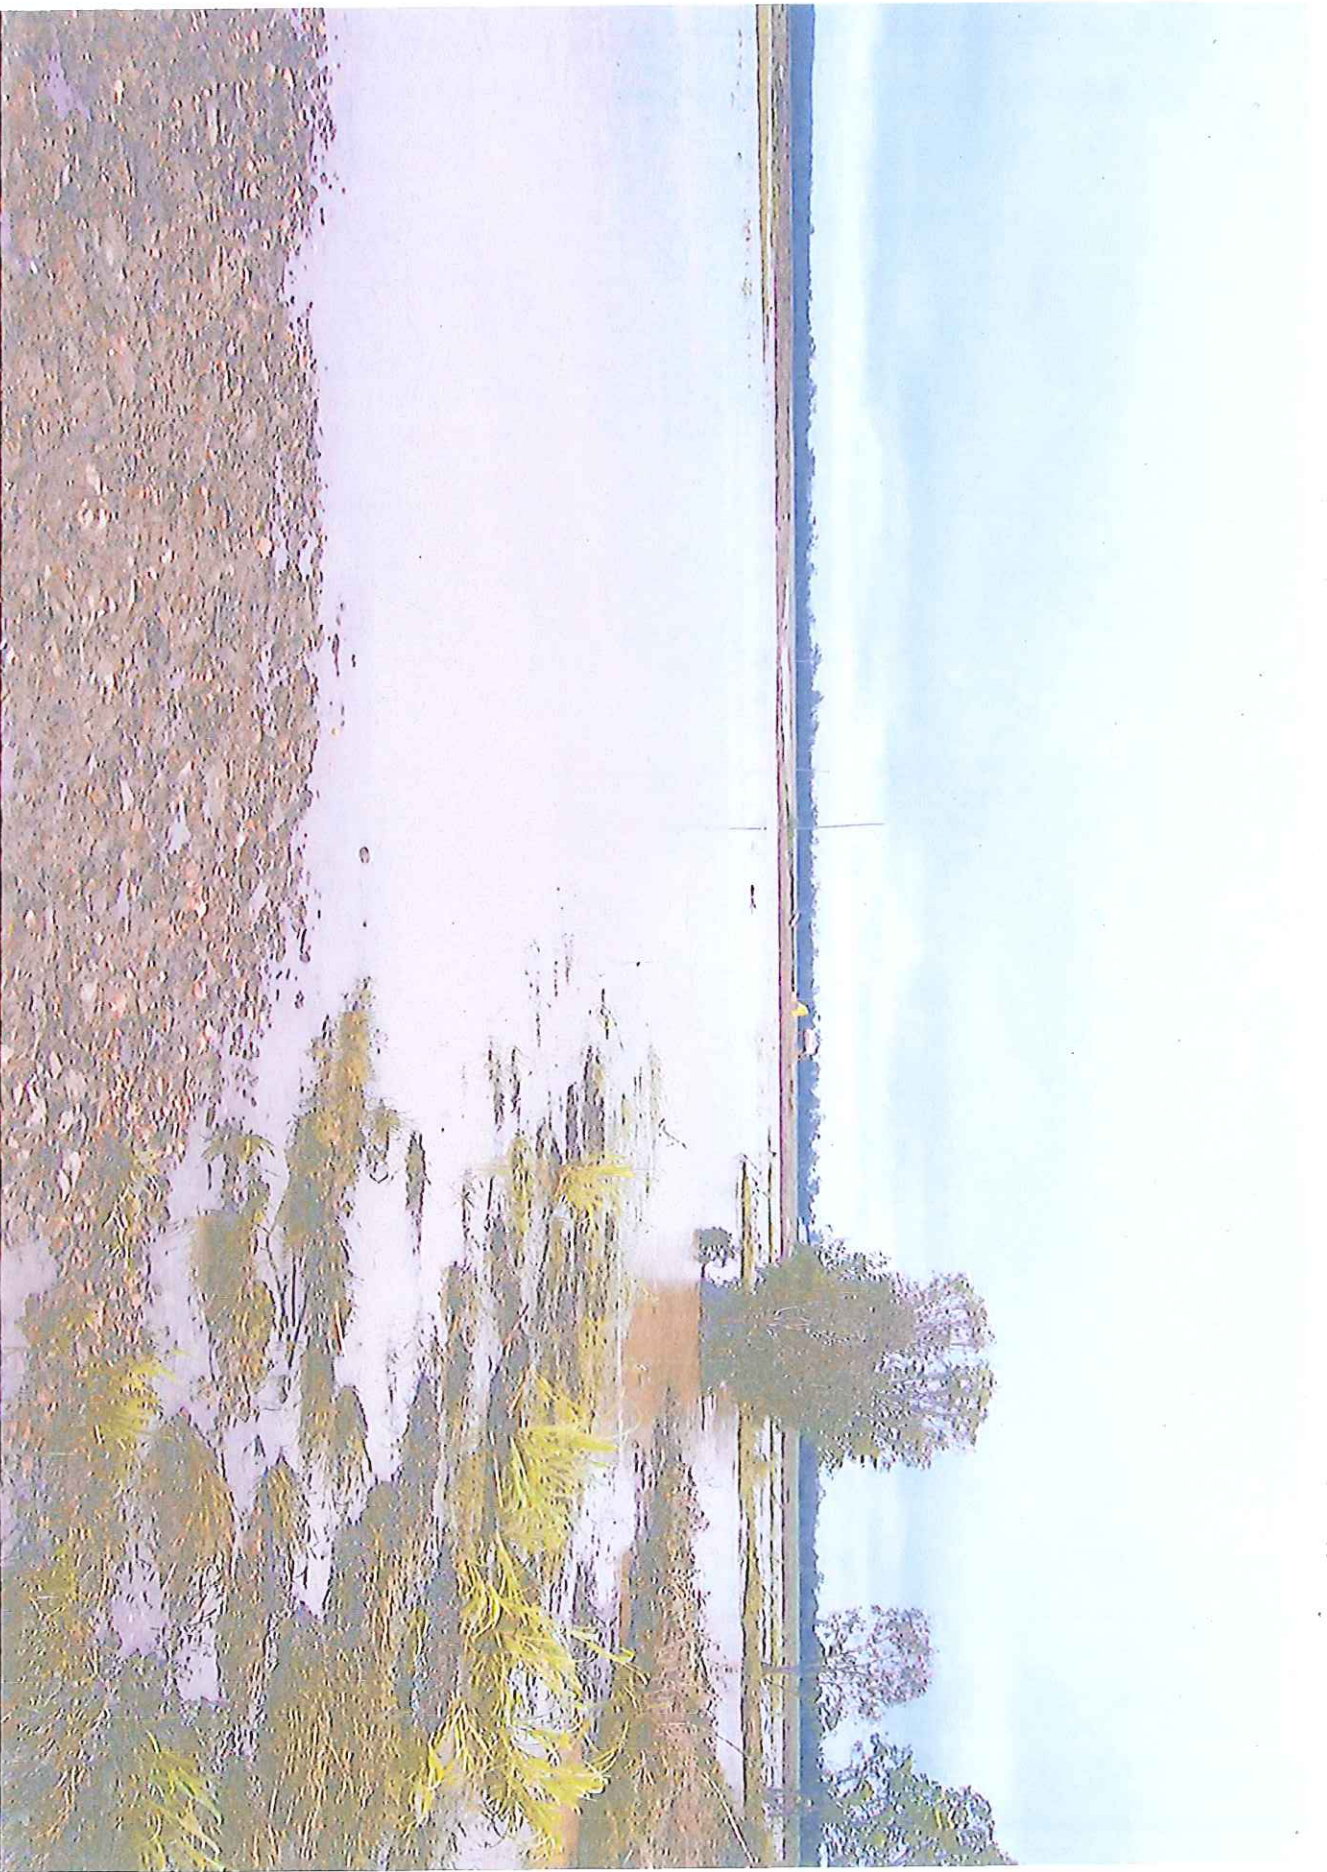
Robert ANDERSON – Photograph No. 2 – Looking across Ford Creek at the road opening and Eastern Levee Bank – across the 200m opening is a small dam on portion 158, on the left and just behind. Road opening has since been closed and filled to higher level of levee

10. Photograph number 2 displays the Eastern Levee Bank on portion [REDACTED] and Ford creek in the foreground. The 200 metre restriction between the dam on portion [REDACTED] and the levee bank is also visible. I am able to produce this photograph.

Exhibit: Photograph depicting Eastern Levee Bank on portion [REDACTED], Ford Creek and 200m restriction.

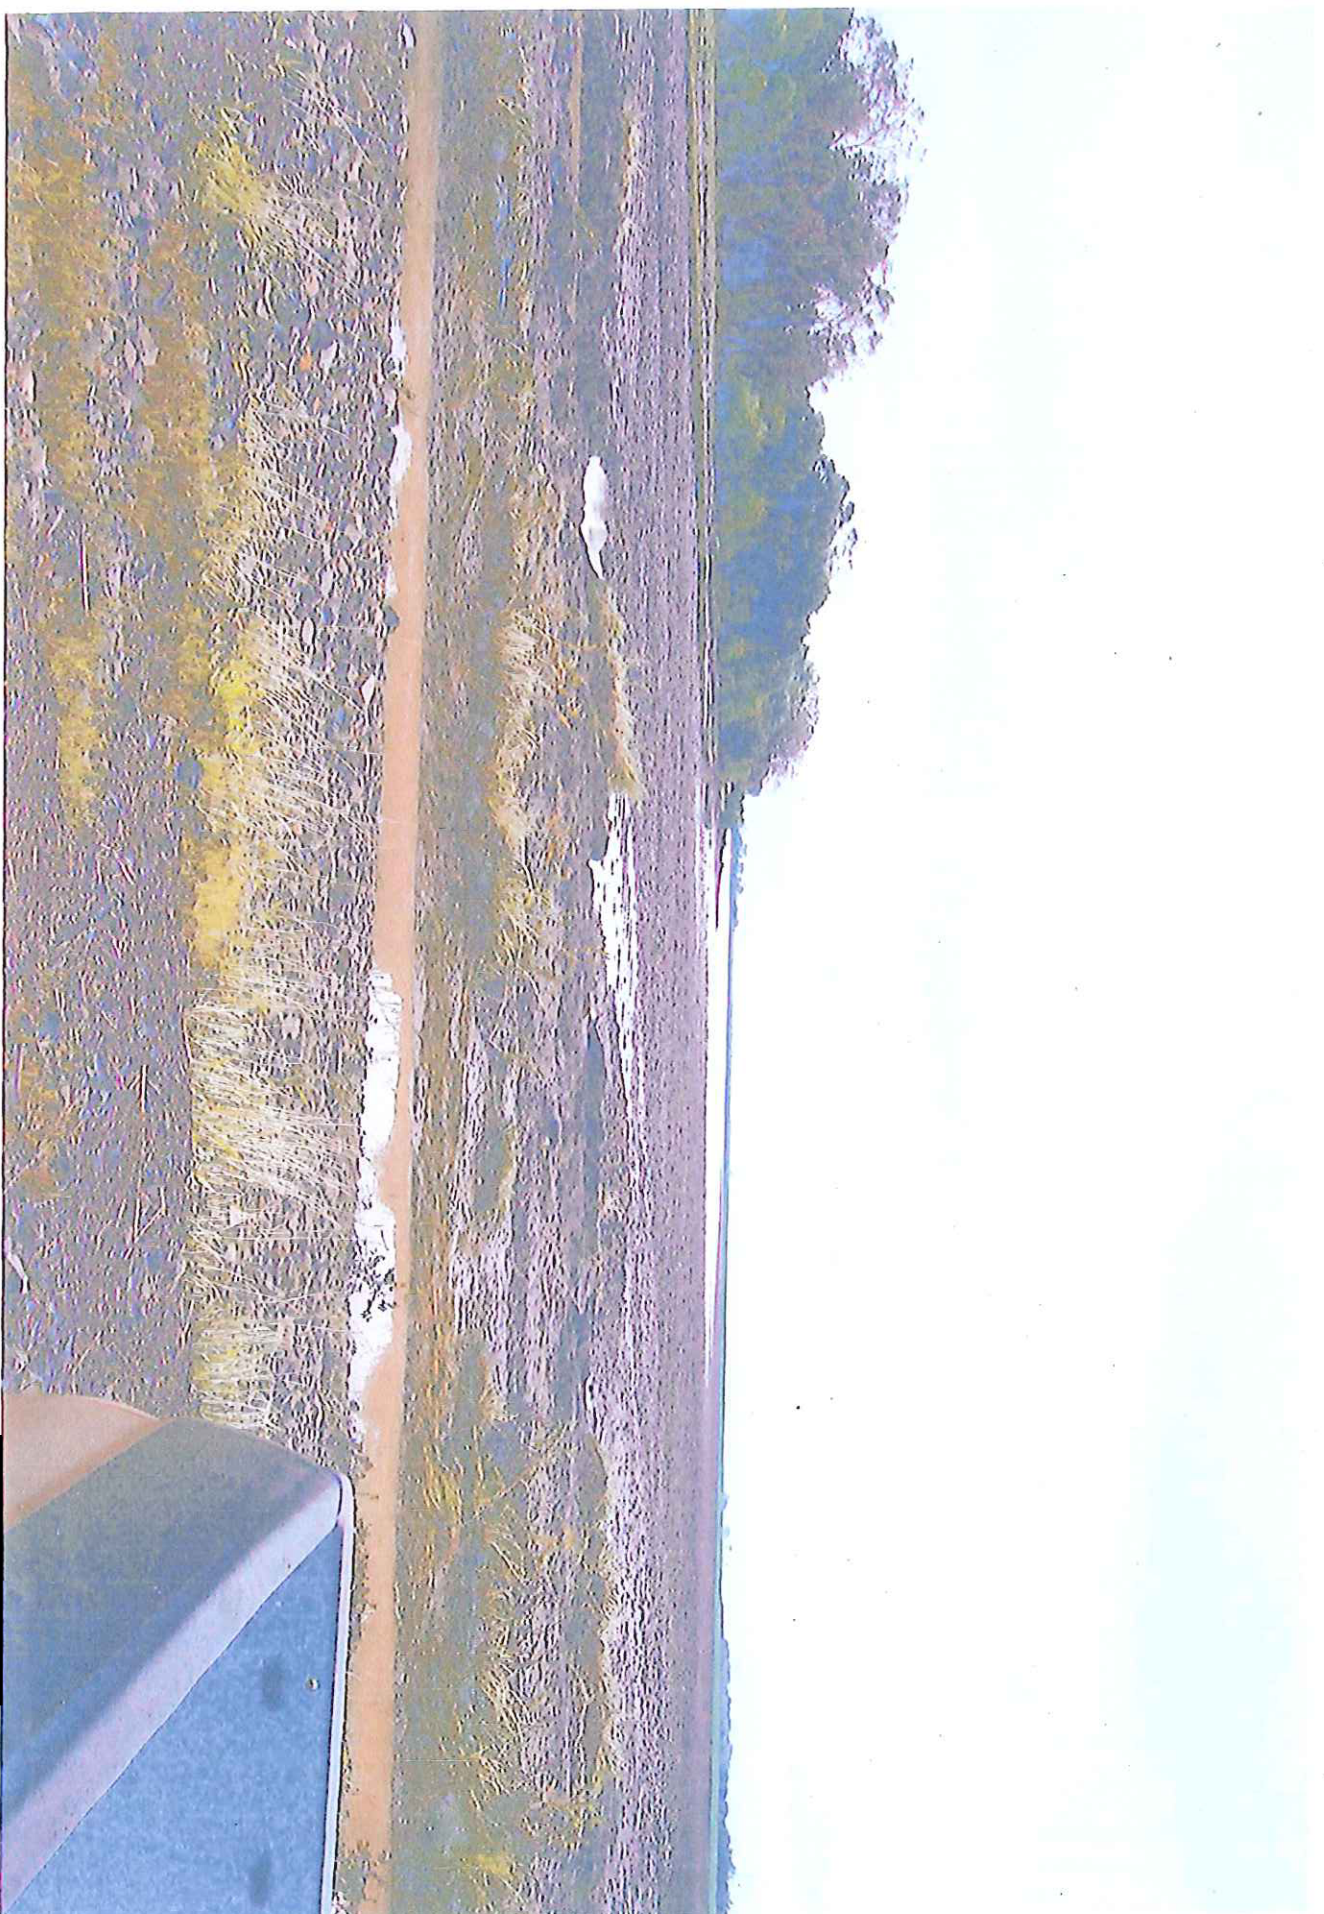
Robert ANDERSON – Photograph No. 1 – *Flood damage from swirling water at 200 metre opening after water had subsided considerably.*

9. Photograph 1 depicts flood damage caused to the ground at the site of the 200 metre restriction, portion [REDACTED], as indicated in Map 3. I am able to produce this photograph.

Exhibit: Photograph depicting flood damage at site of 200m restriction.

The old flood plain is guessed by me to be 4-5 kilometres wide. Development has narrowed this to two places of about 200 metre in one and 150 metres in the other. The 200 metre opening is immediately above my property and with the action of levee banks cause severe eddying which have taken a lot of subsoil and crops from portion 157. This water has also eroded the size of the banks of Ford Creek so that Ford Creek flows more easily onto portion 157. (with minimal falls)

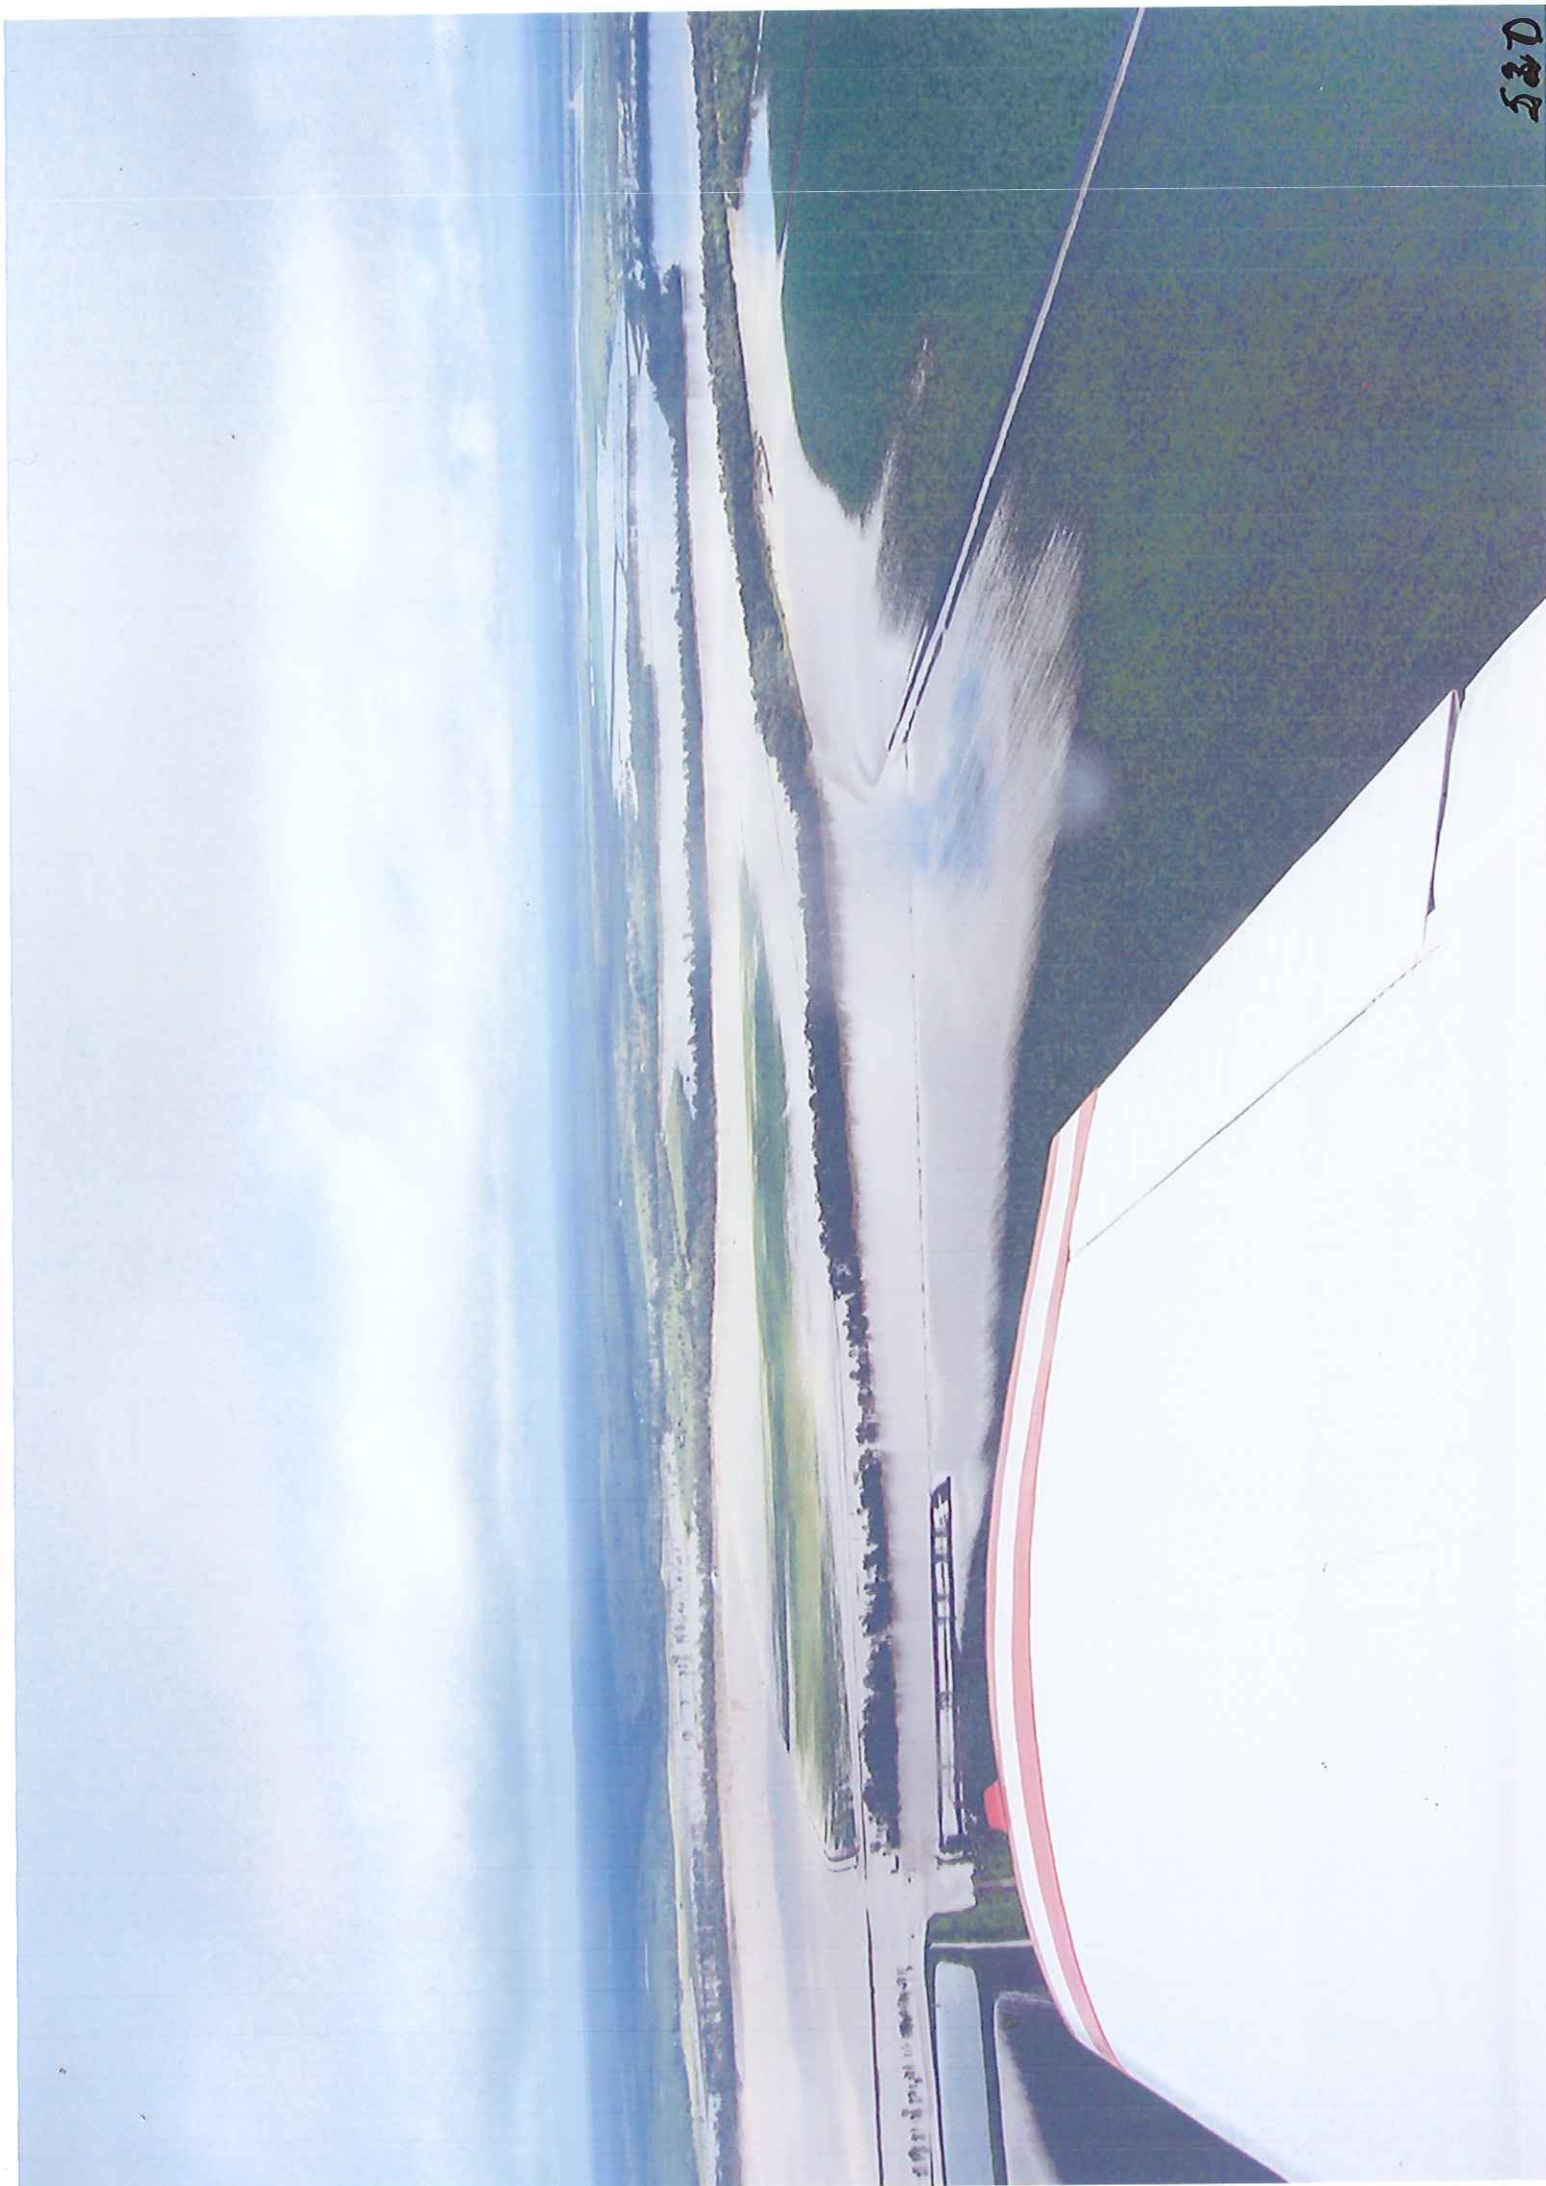
x 200 m OPENING x

Dec 2010

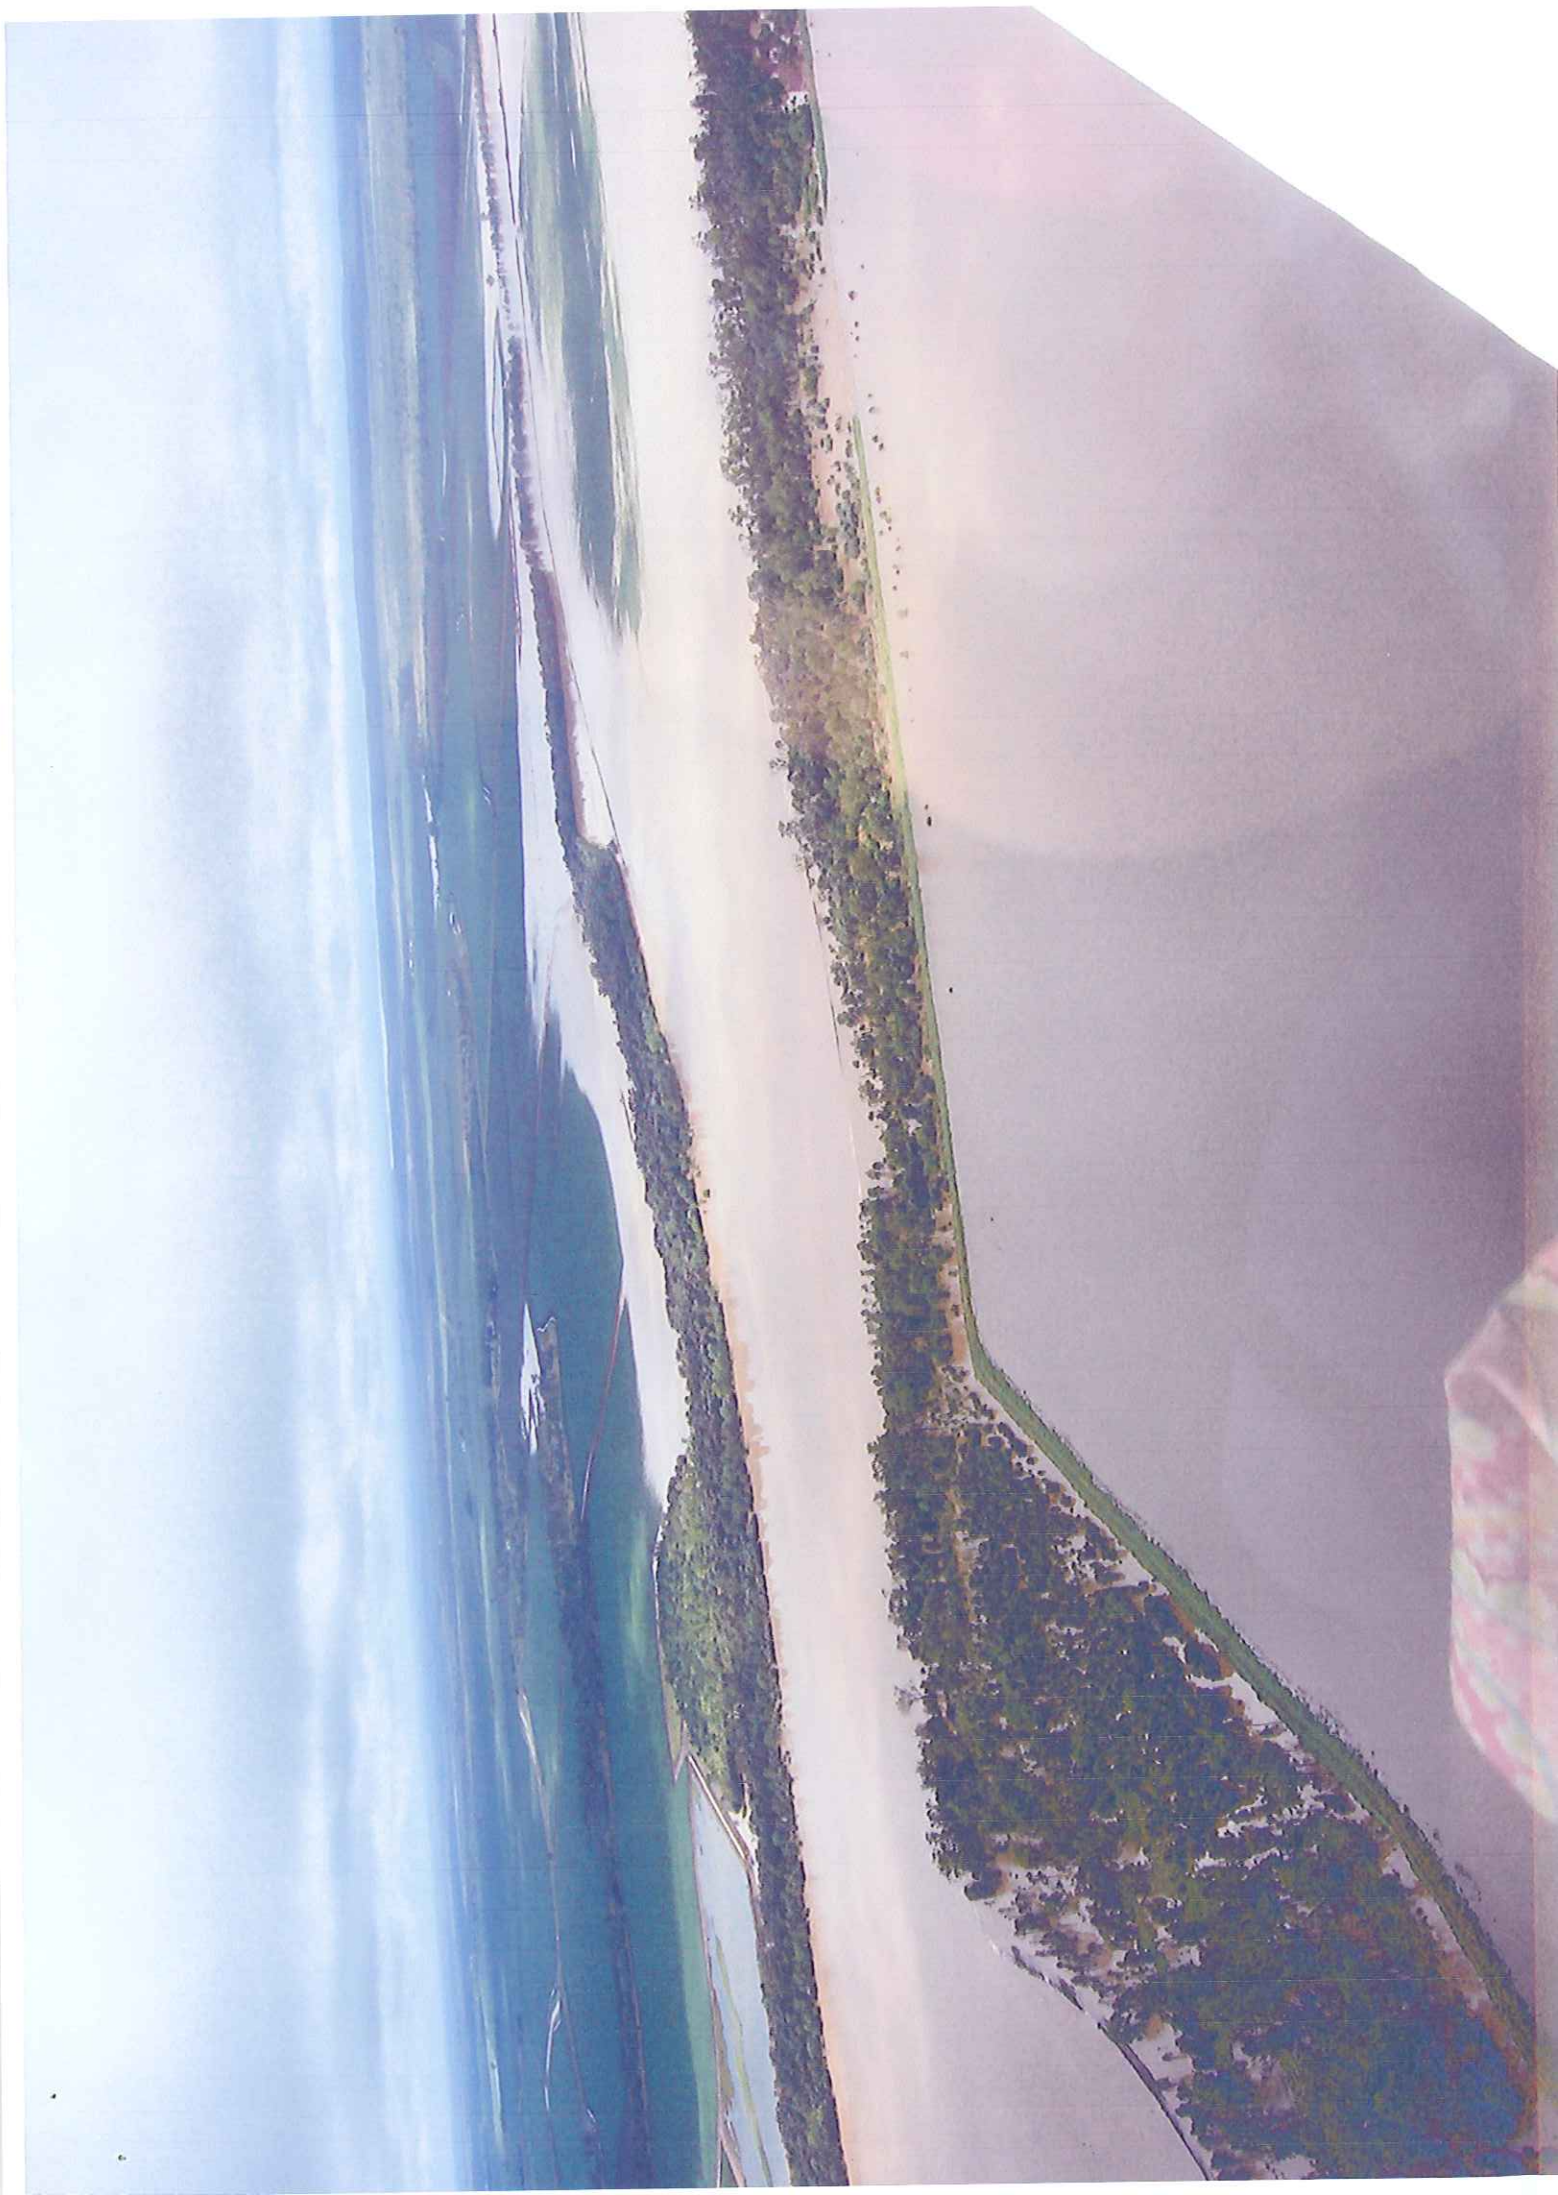
PHOTO 1

FLOOD
AT 200 M OPENING

DAMAGE
AREA
