<i>Name of Witness</i>	Robert Gordon ANDERSON
<i>Date of Birth</i>	██████████
<i>Address and contact details</i>	██████████ Emerald Ph. ██████████ Fax ██████████ m. ██████████ ██
<i>Occupation</i>	Farmer Cotton Grower
<i>Officer taking statement</i>	Detective Sergeant Stephen PLATZ
<i>Date taken</i>	18 August 2011

Exhibit: Submission to Queensland Floods Commission of Inquiry
by RG JM BH & RL ANDERSON dated 24th May 2011

24th May, 2011

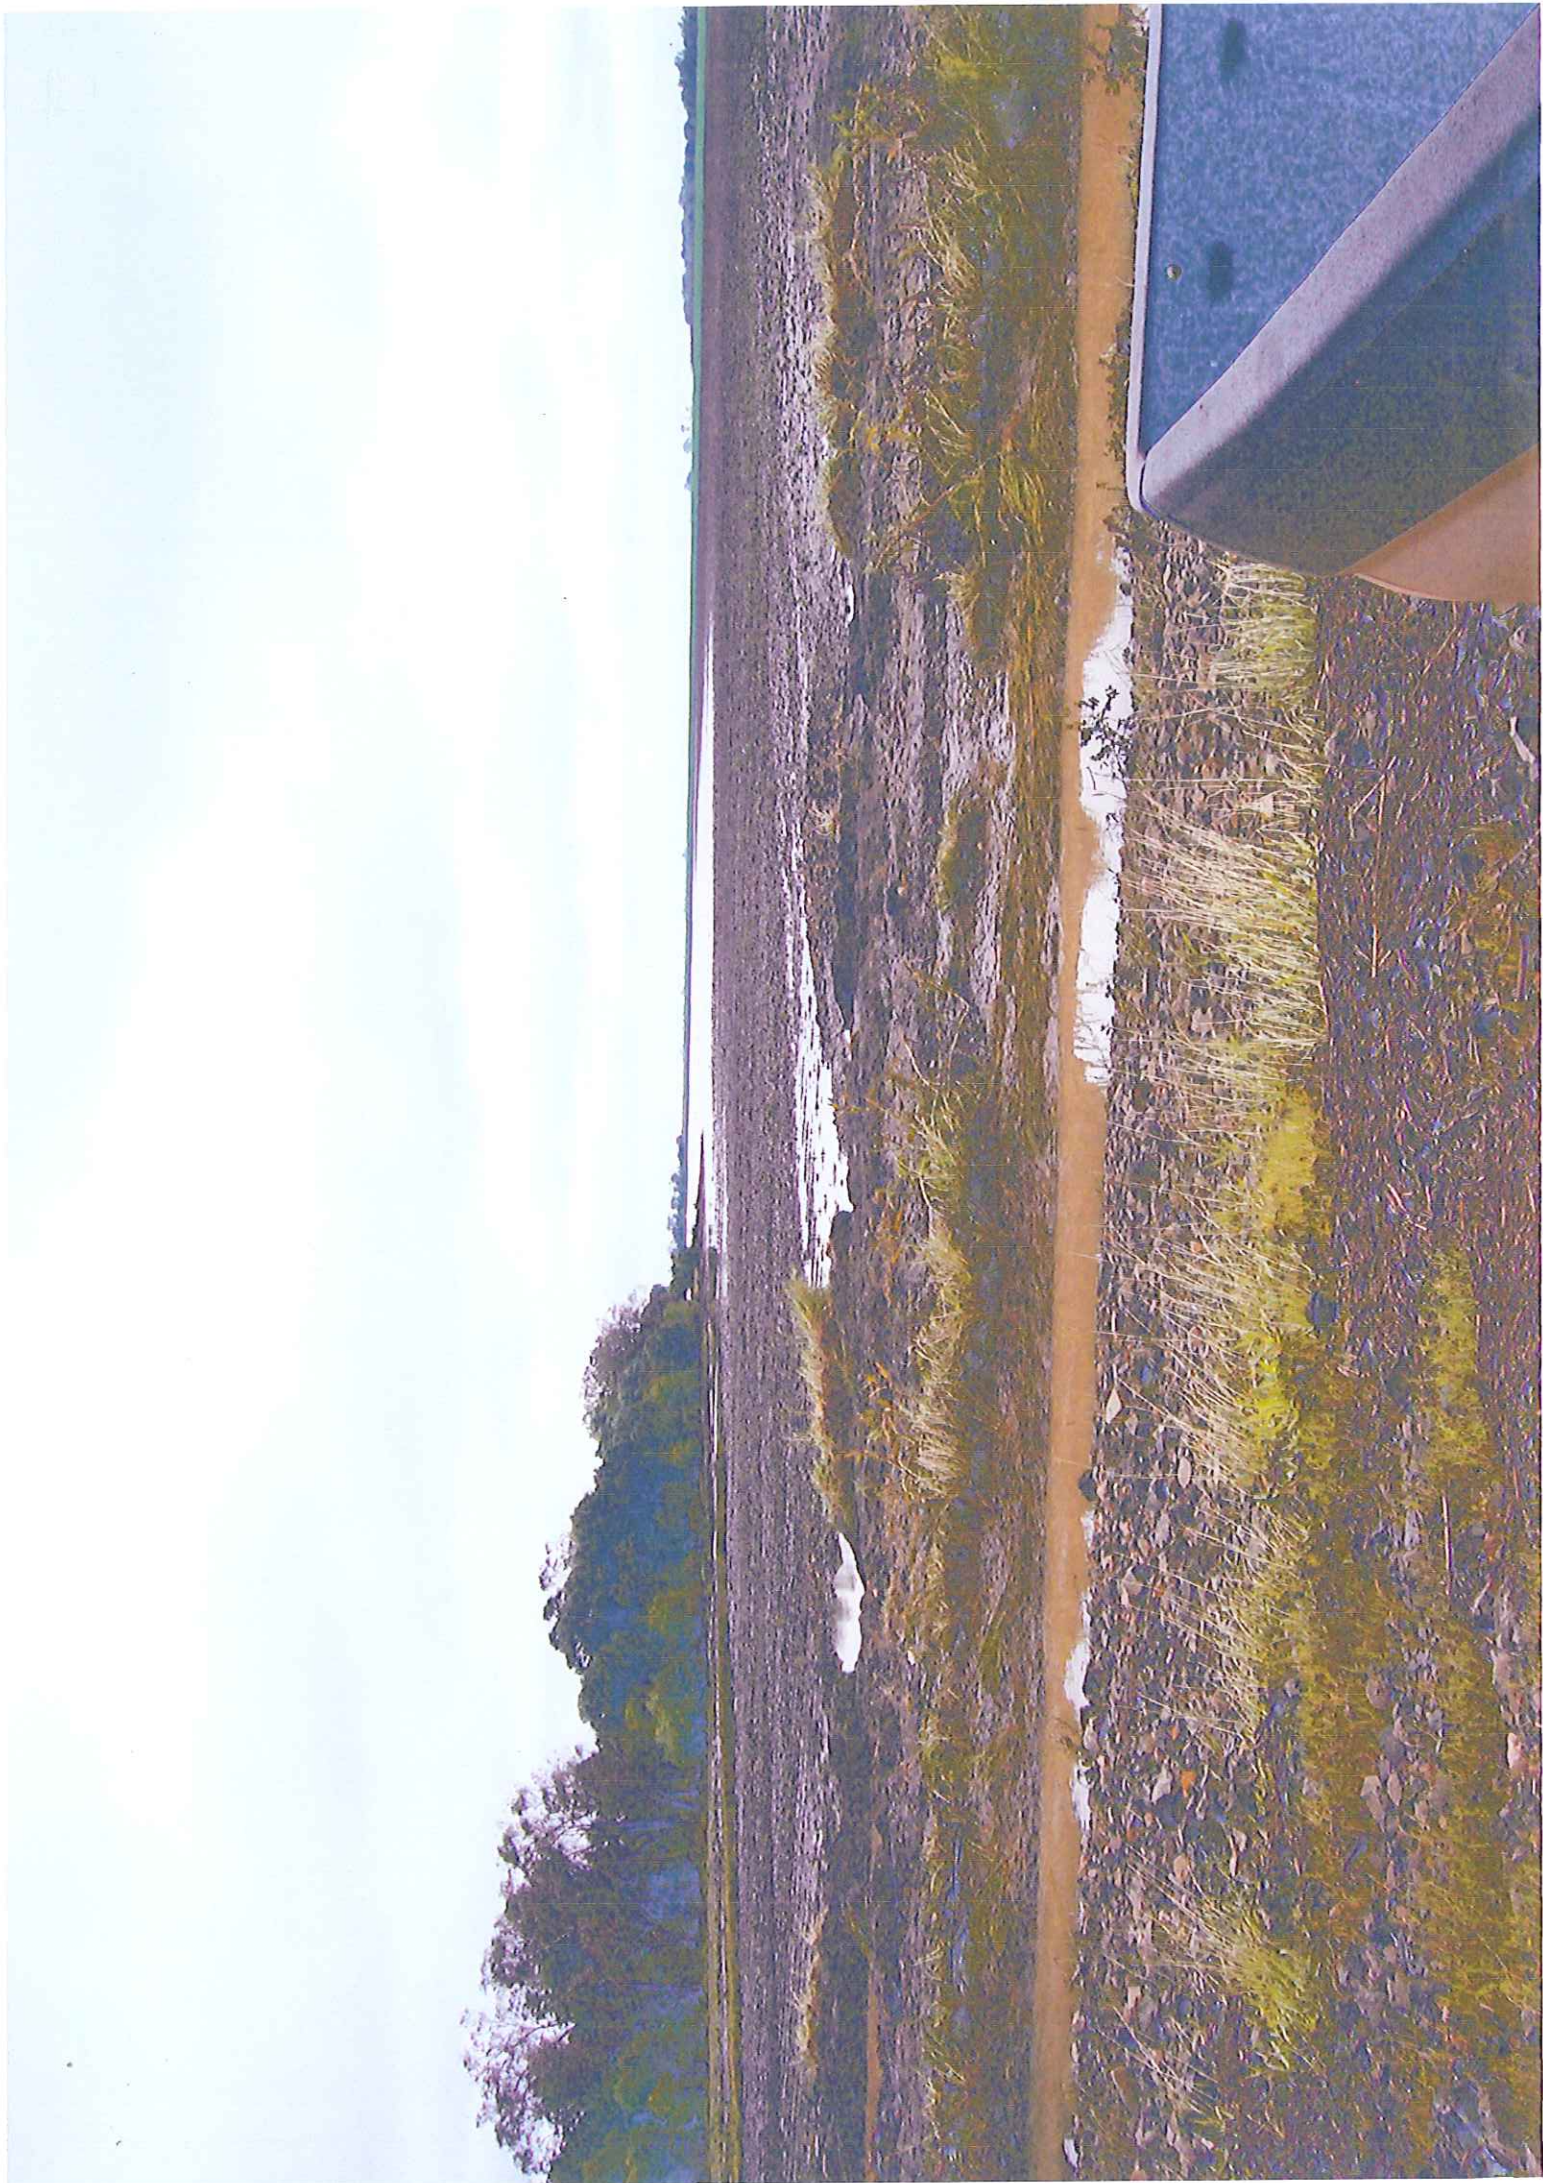
ROAD OPENING

2 EASTERN WEEBIE BANK - ACROSS 200 METRE OPENING
IS TO THE REFT - ROAD OPENING
SMALL DAM ON [REDACTED] AND FILLED TO HIGHER LEVEL
HAS SINCE BEEN CLOSED
OF WEEBIE

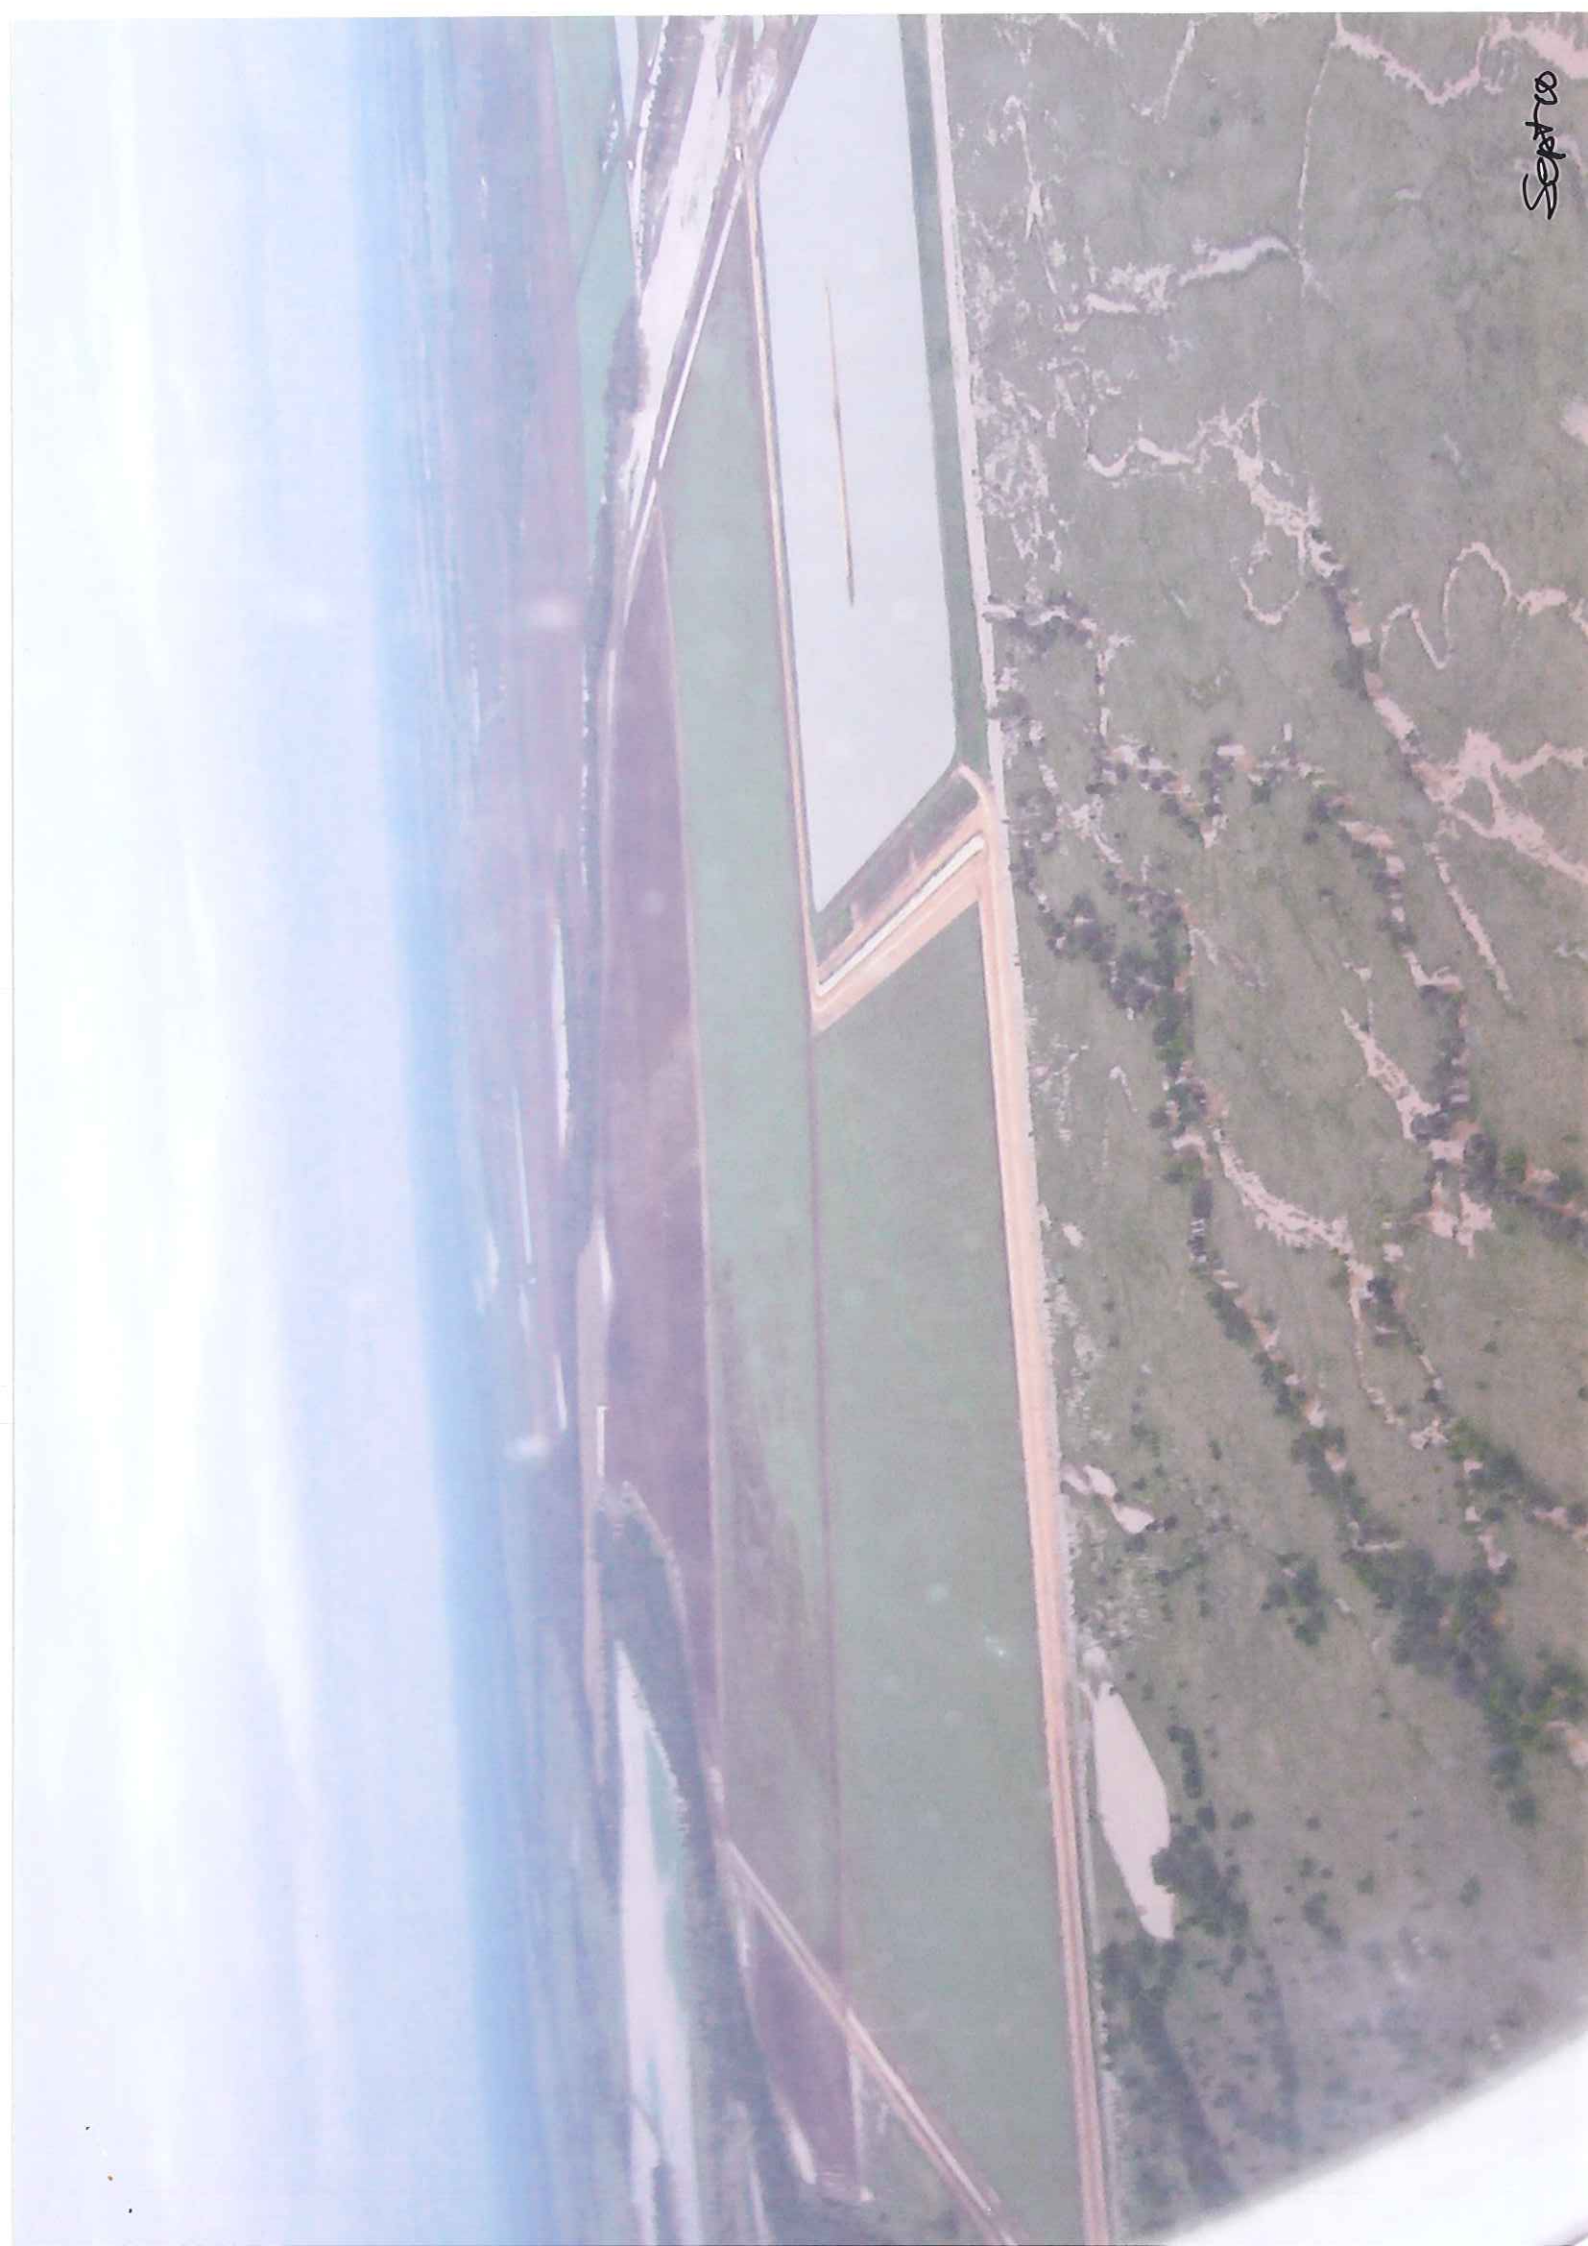
UNDEVELOPED FLOOD PLAIN SHOWING SMALLER CREEKS - STOPPING AT
LEVEE - USED TO CONTINUE RIGHT THROUGH
