**Robert Gordon ANDERSON states:**

**Exhibit: Submission to Queensland Floods Commission of Inquiry  
by RG JM BH & RL ANDERSON dated 24<sup>th</sup> May 2011**

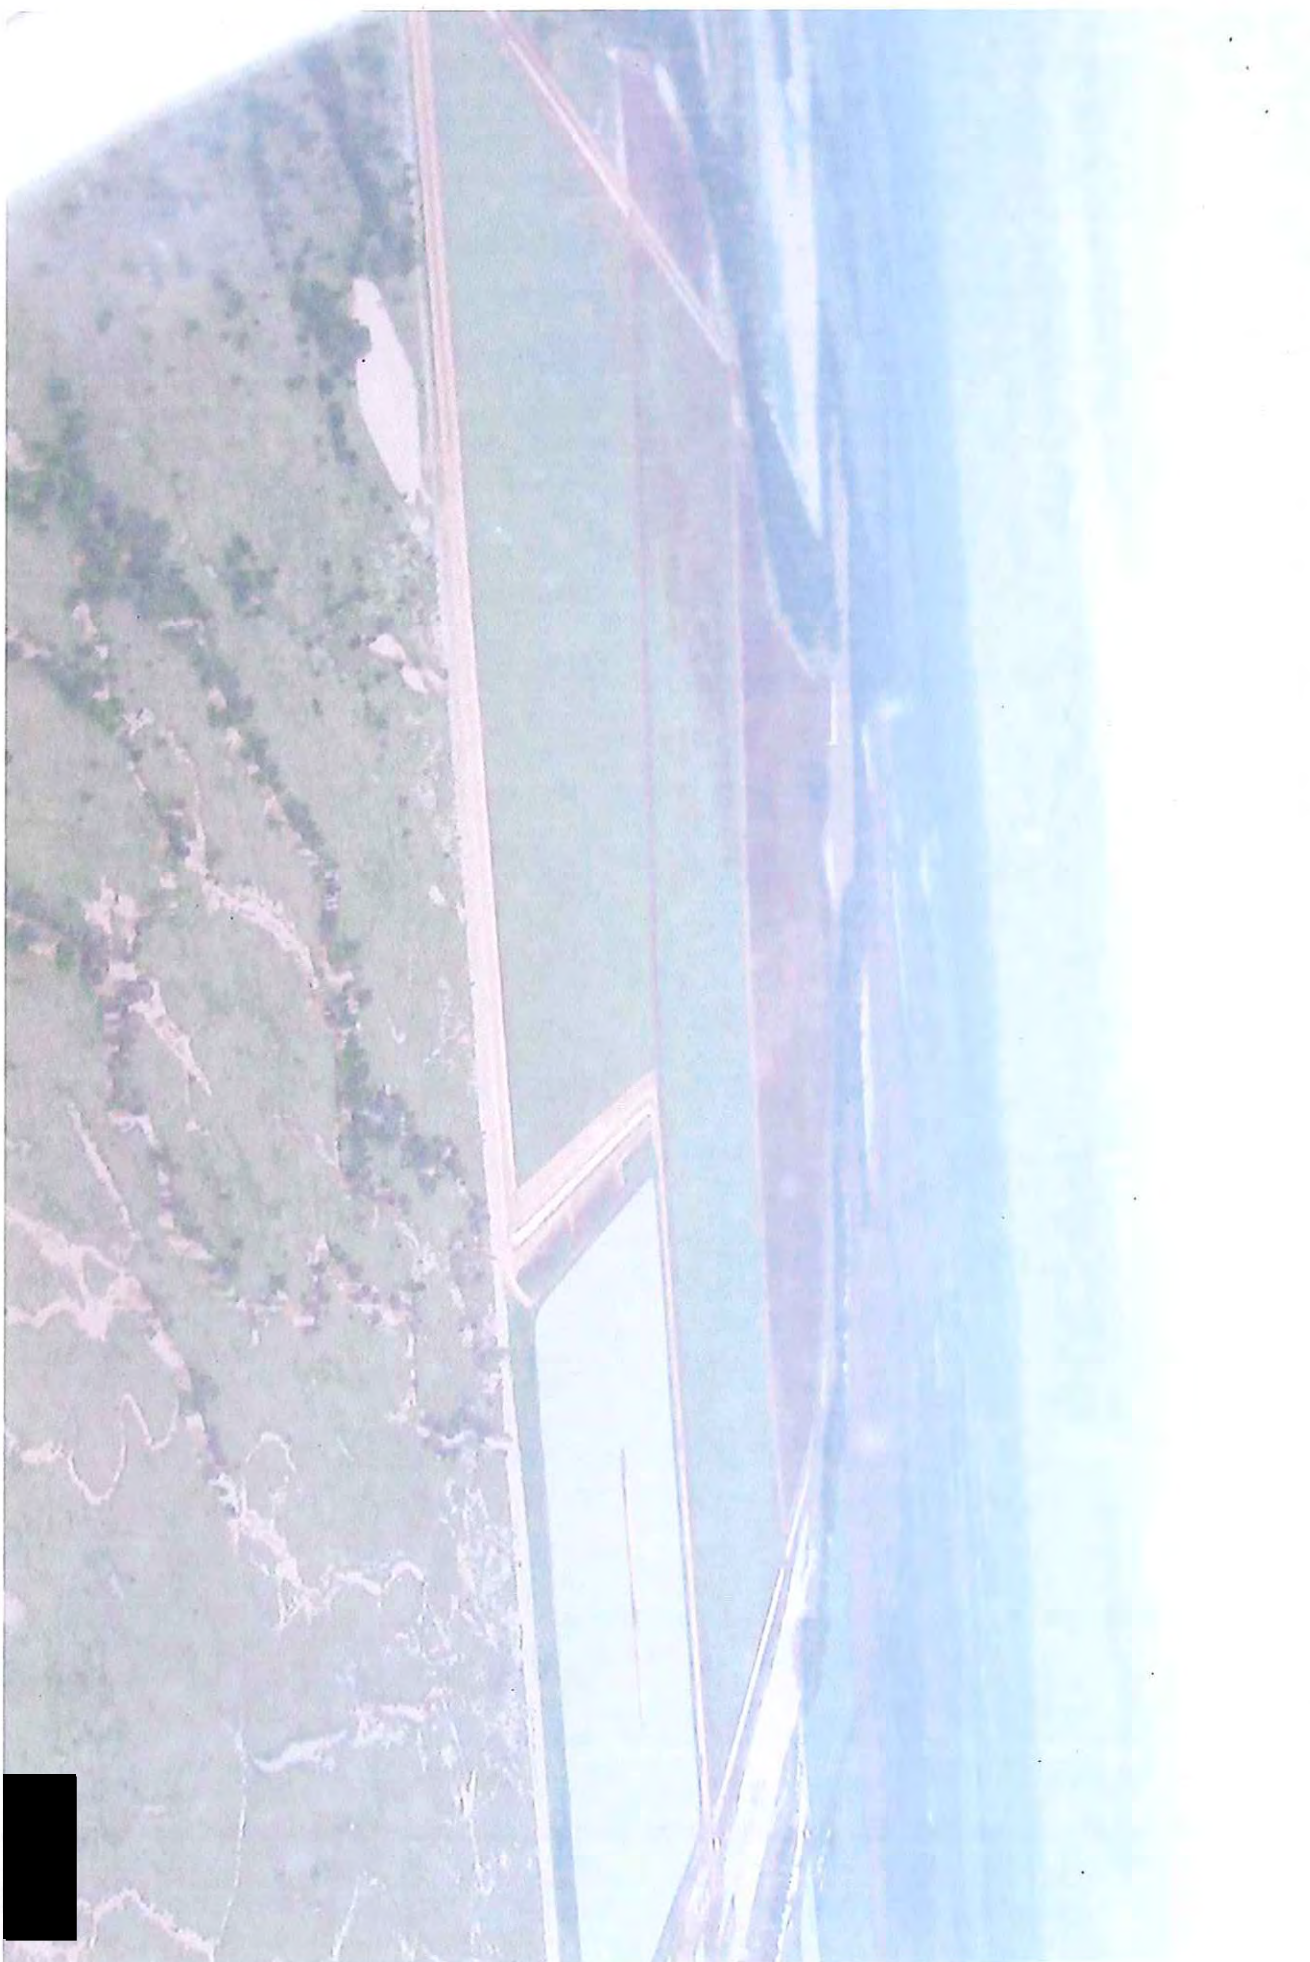
Robert ANDERSON – Photograph No. 5 – Depicts light flood in September 2010. Displays natural flood plain in lower part of the picture and levee bank running through the centre, cutting the natural flood plain.

13. Photograph number 5 depicts light flood in September 2010 and displays the natural flood plain prior to the development of levee's (bottom of picture). I am able to produce this photograph.

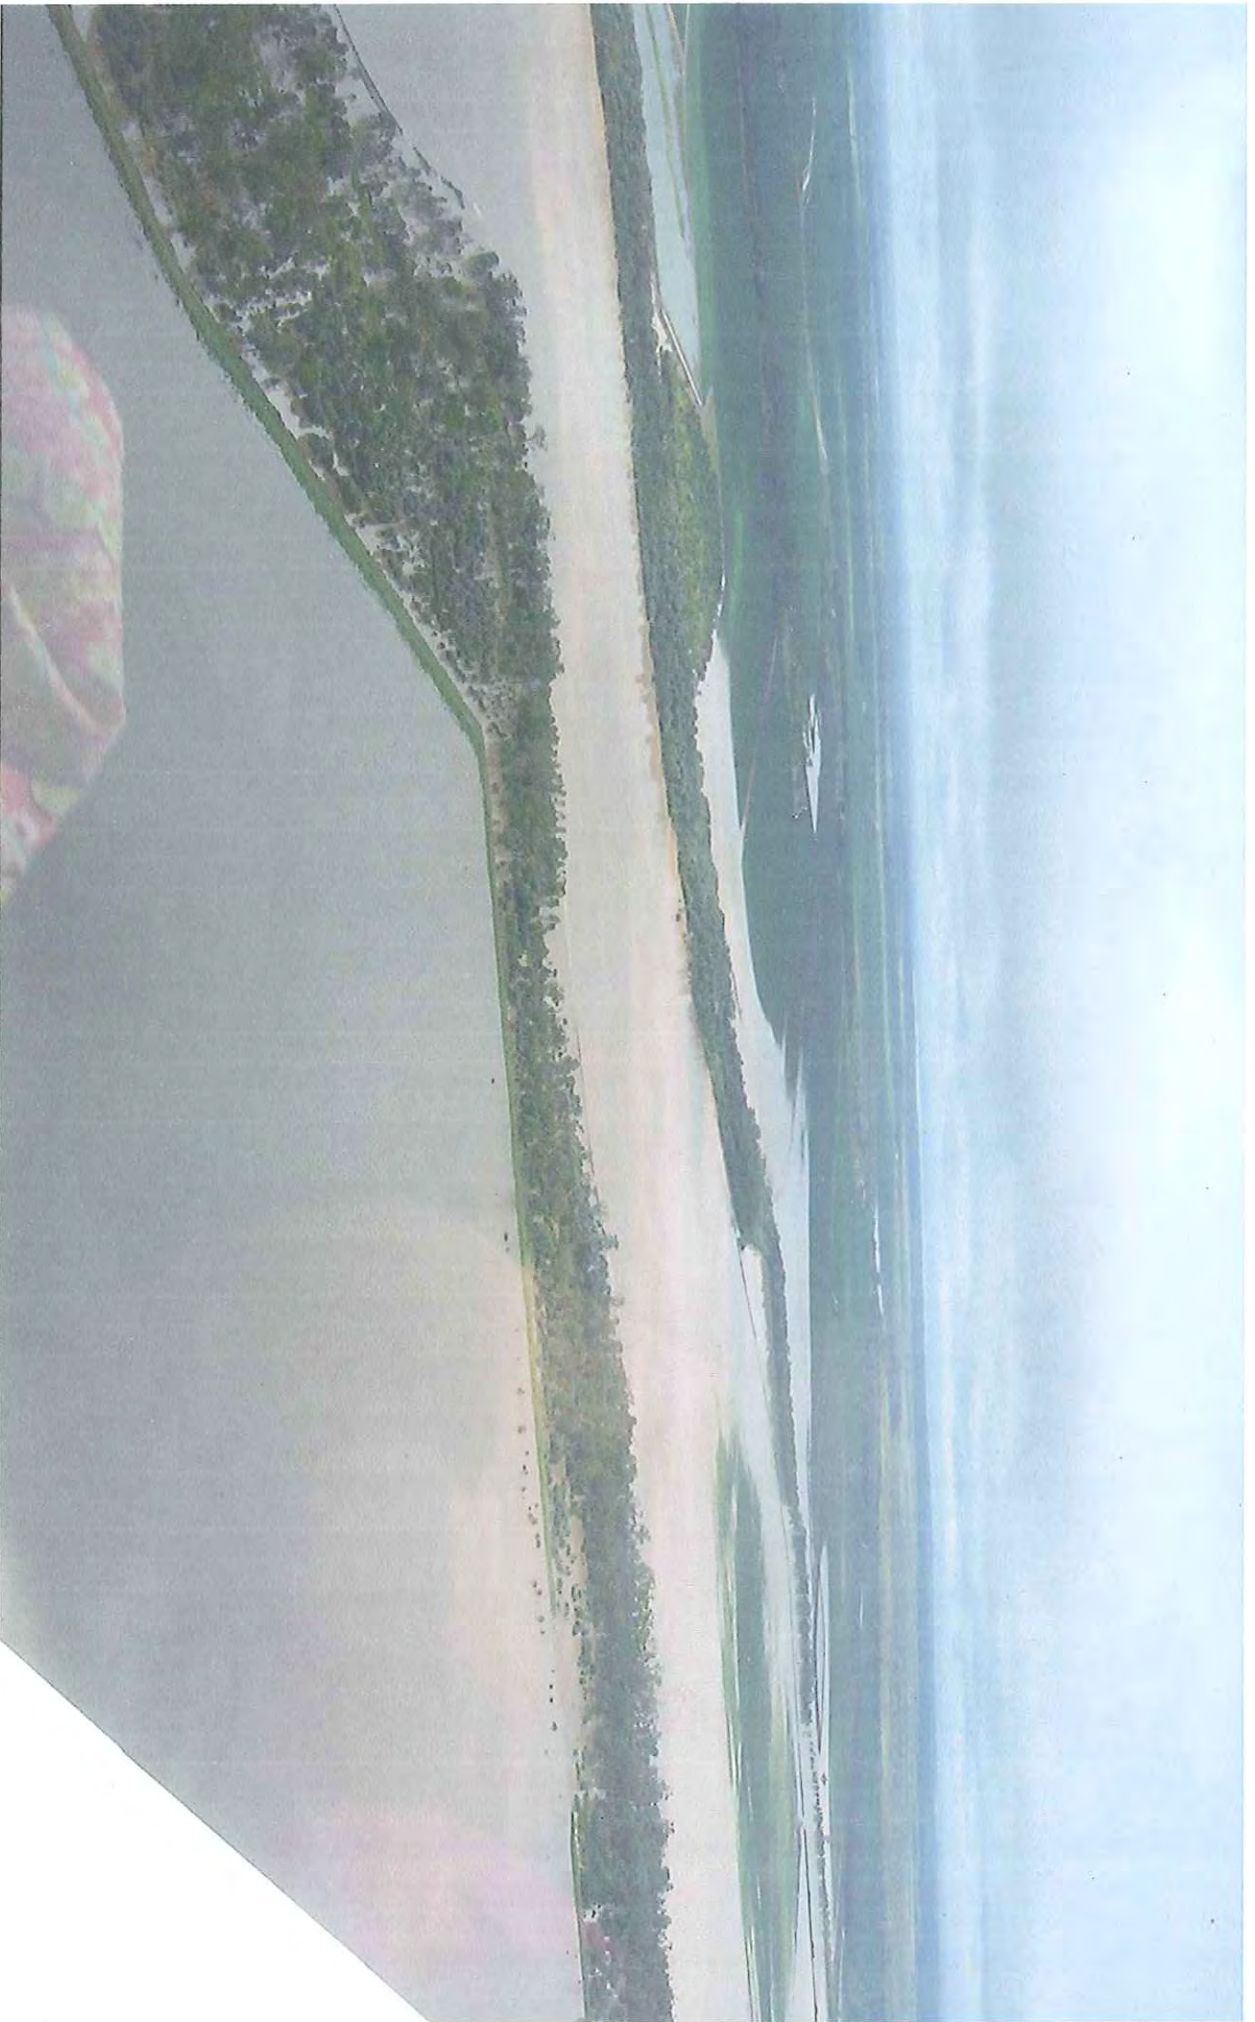
Robert ANDERSON – Photograph No.6 – Retreat creek restriction in December 2010 depicting the old and new flood plain after the levees had broke (they have since been re-built higher).

14. Photograph number 6 depicts the 200 metre restriction at Retreat Creek in the December 2010 floods. It displays the old and new flood plain after the levees had broken. I am able to produce this photograph.

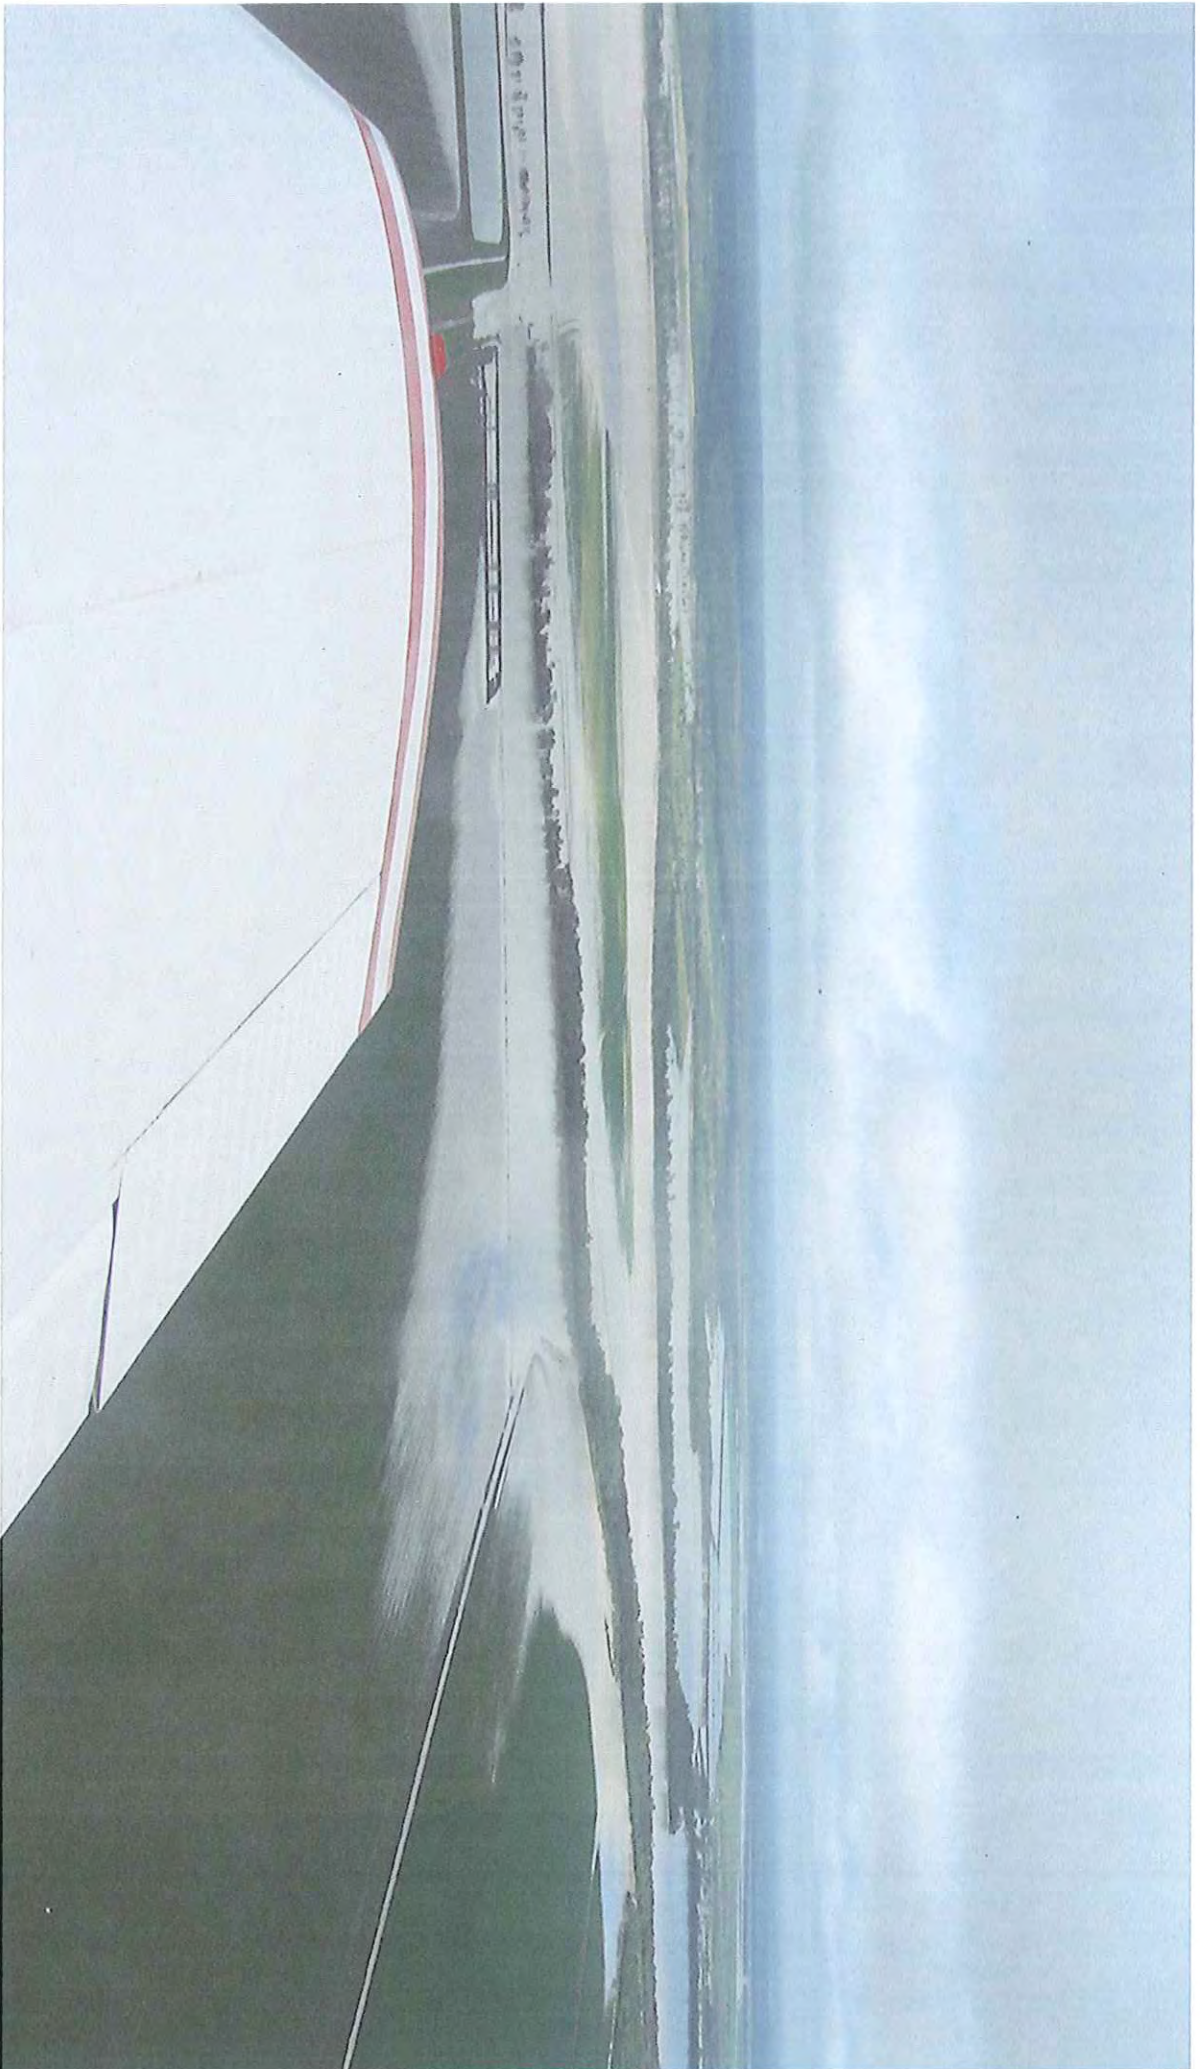
Robert ANDERSON – Photograph Number 7 – December 2010 showing 200 metre opening (just above leading edge on wing tip)

15. Photograph number 7 shows the 200 metre opening during the December 2010 floods. I am able to produce this photograph.

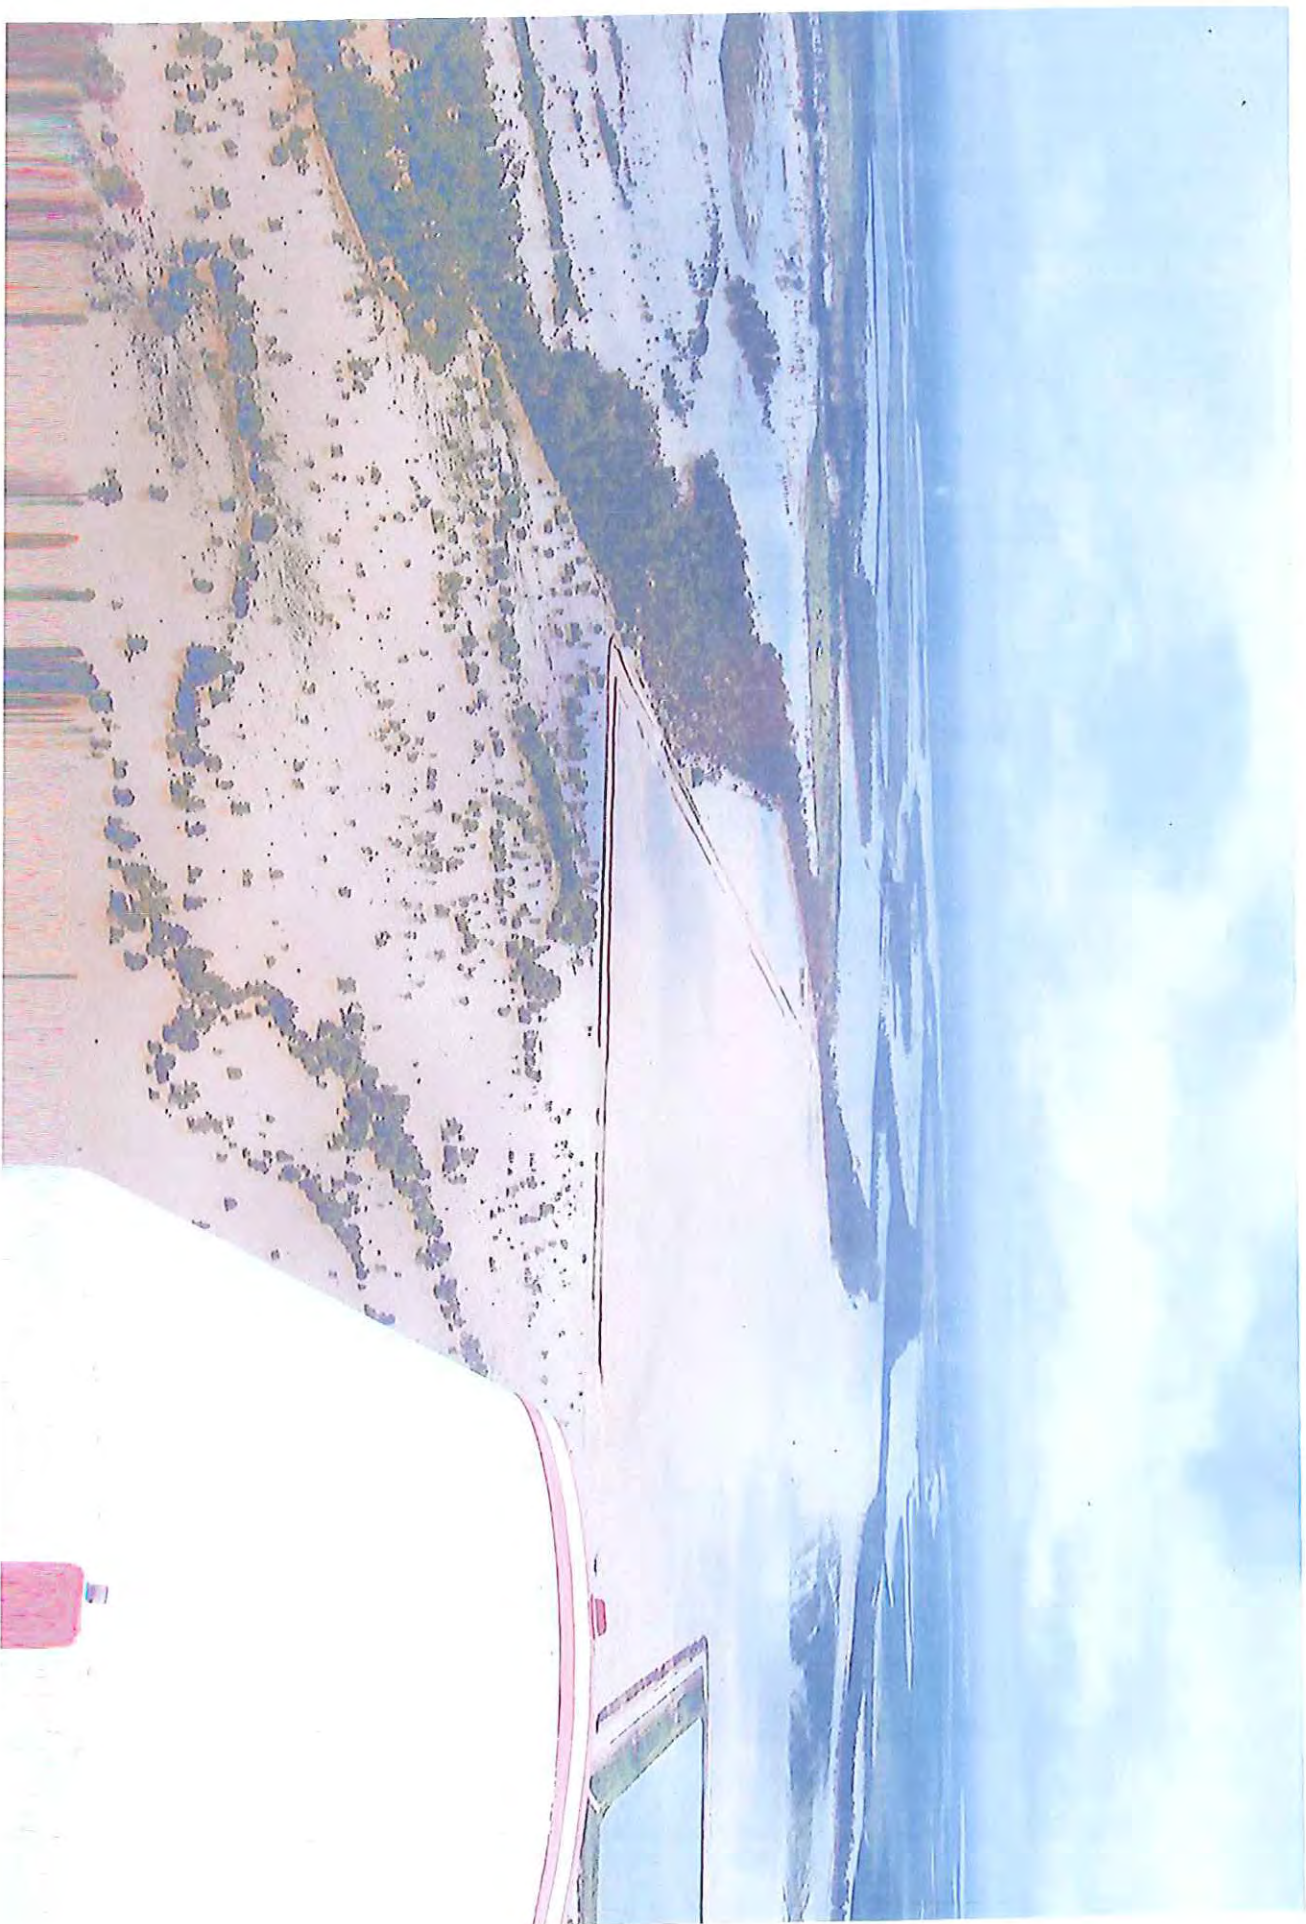
Robert AN DERSON – Photograph No. 4 – Depicts same area as mentioned in photograph 3 but during December 2010 flood (opposite side). Also shows current of water escaping from retreat creek into drain and then into Ford creek south of the dam.

12. Photograph number 4 displays flooding during the December 2010 flood within portion's [redacted] and surrounding properties. Flood has breached the levee banks and water is escaping into Ford Creek at the south of the dam. I am able to produce this photograph.

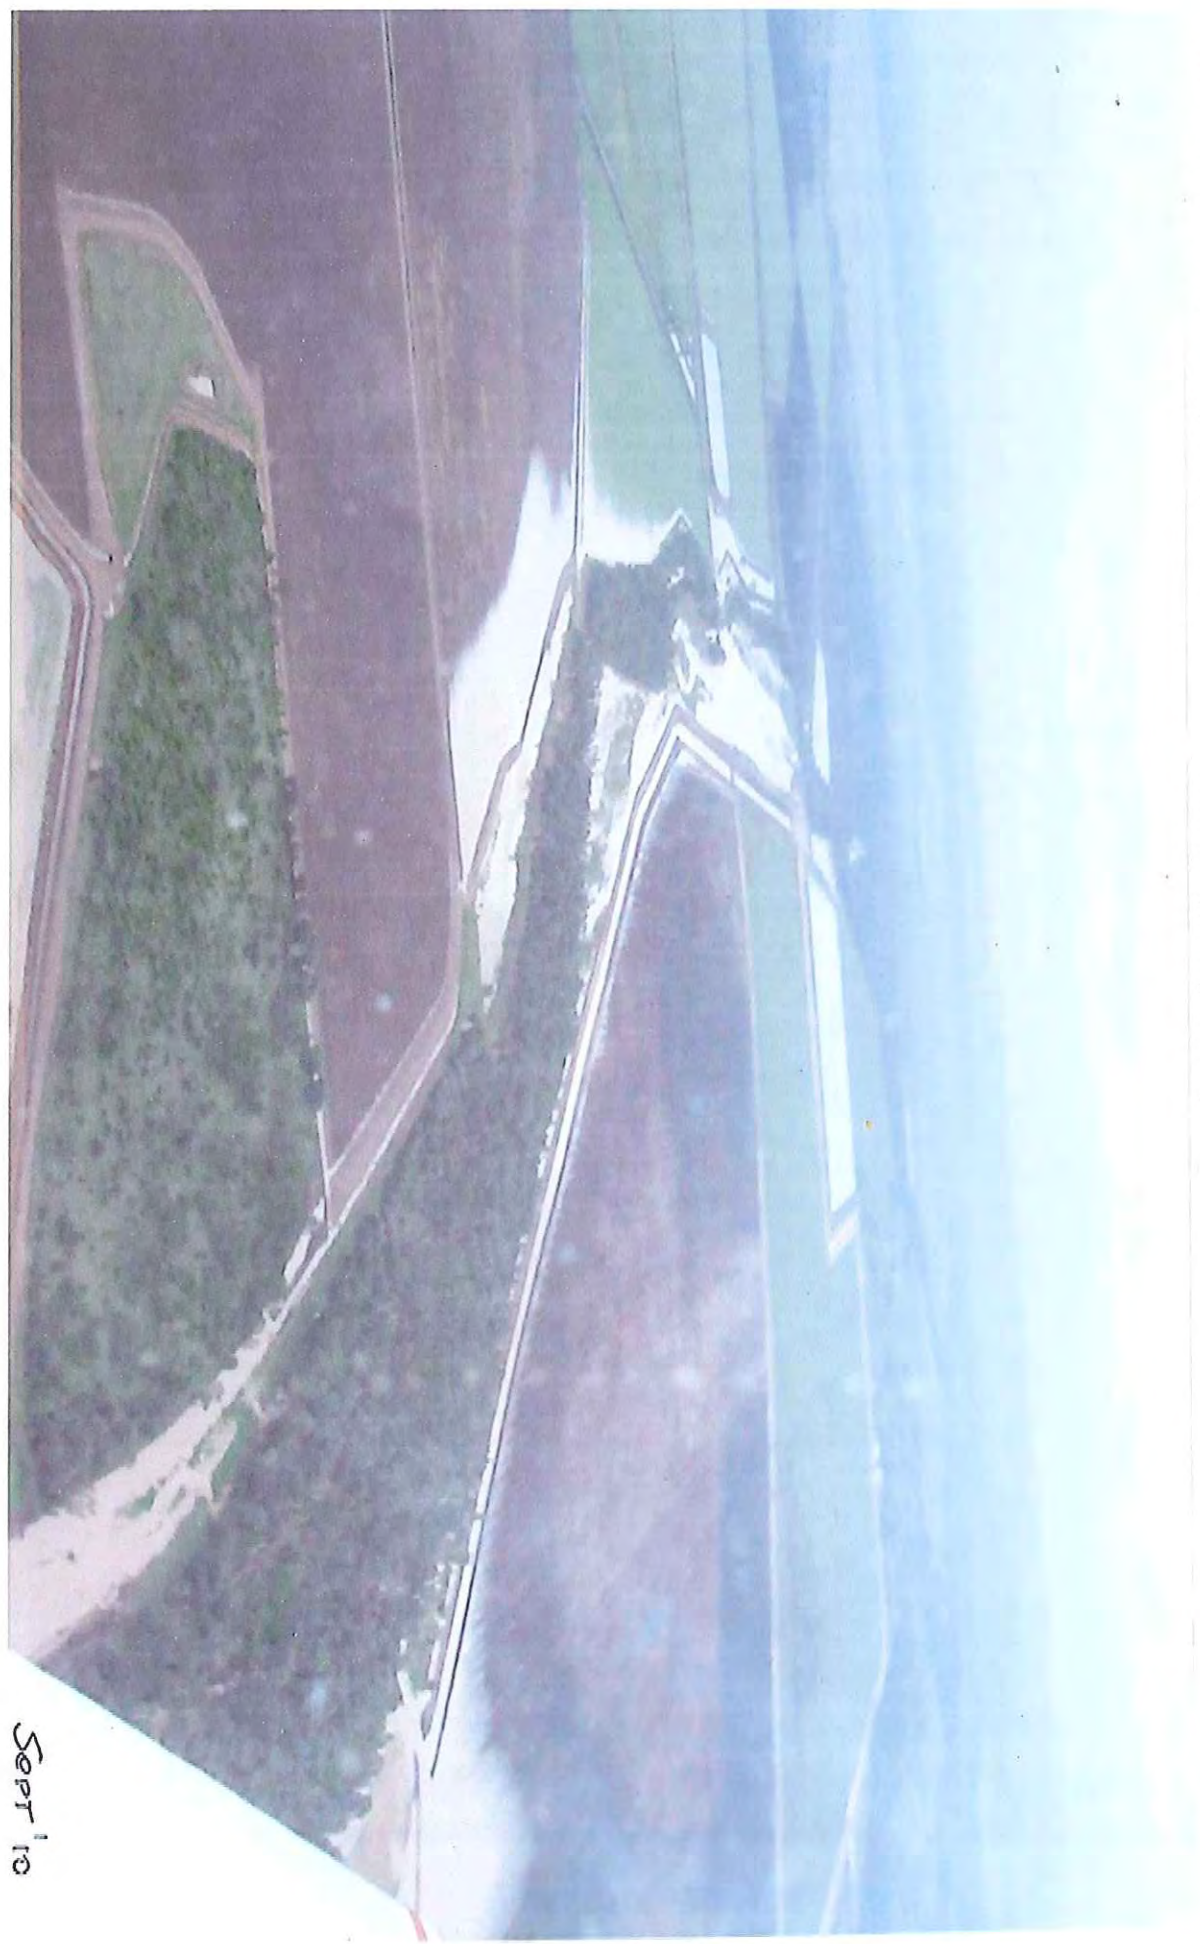
Robert AN DERSON - Photograph No. 3 - Depicts light flood in September 2010. Displays 8 m high western levee at top centre with dam to the left. Eastern levee bank (centre) forcing water onto to 157 and keeping flood plain high.

11. Photograph 3 is an aerial photograph depicting light floods in September 2010. It displays the levee wall on the western and eastern sides and the dam within portion's [redacted]. The levee has forced water onto portion [redacted]. I am able to produce this photograph.

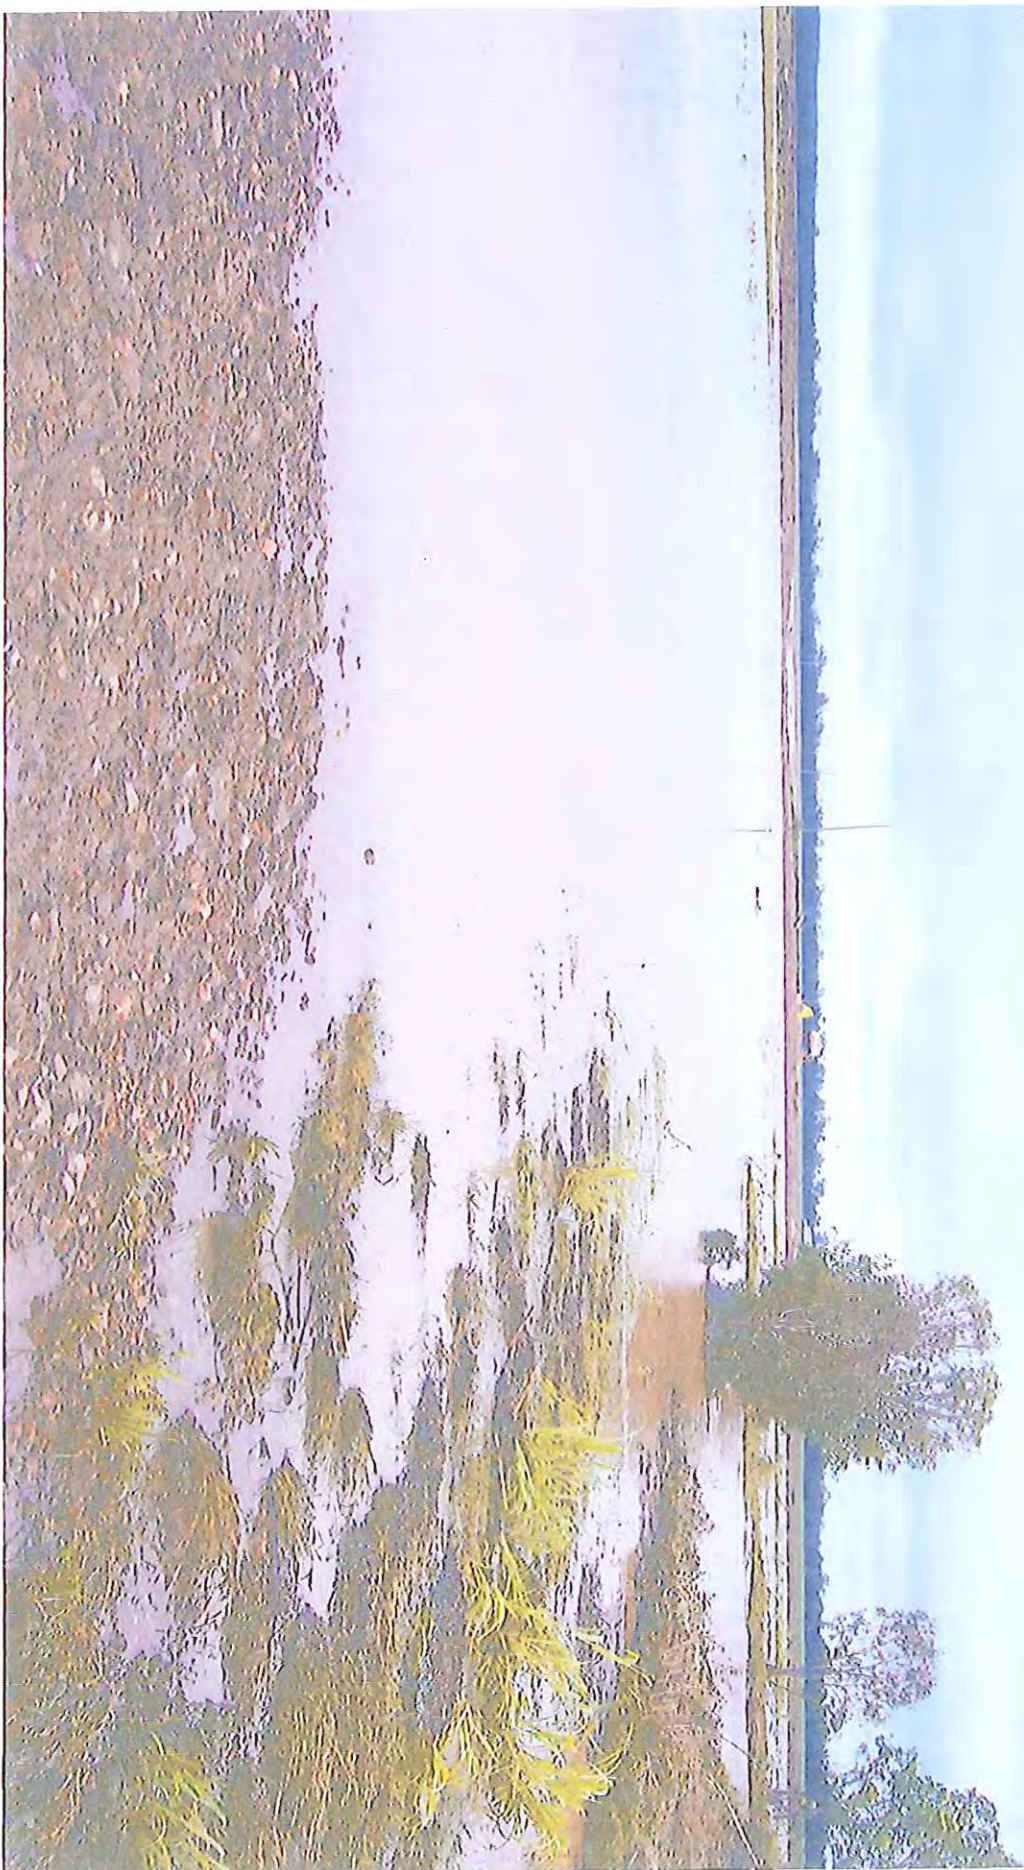
Robert ANDERSON – Photograph No. 2 – Looking across Ford Creek at the road opening and Eastern Levee Bank – across the 200m opening is a small dam on portion 158, on the left and just behind. Road opening has since been closed and filled to higher level of levee

10. Photograph number 2 displays the Eastern Levee Bank on portion [redacted] and Ford creek in the foreground. The 200 metre restriction between the dam on portion [redacted] and the levee bank is also visible. I am able to produce this photograph.

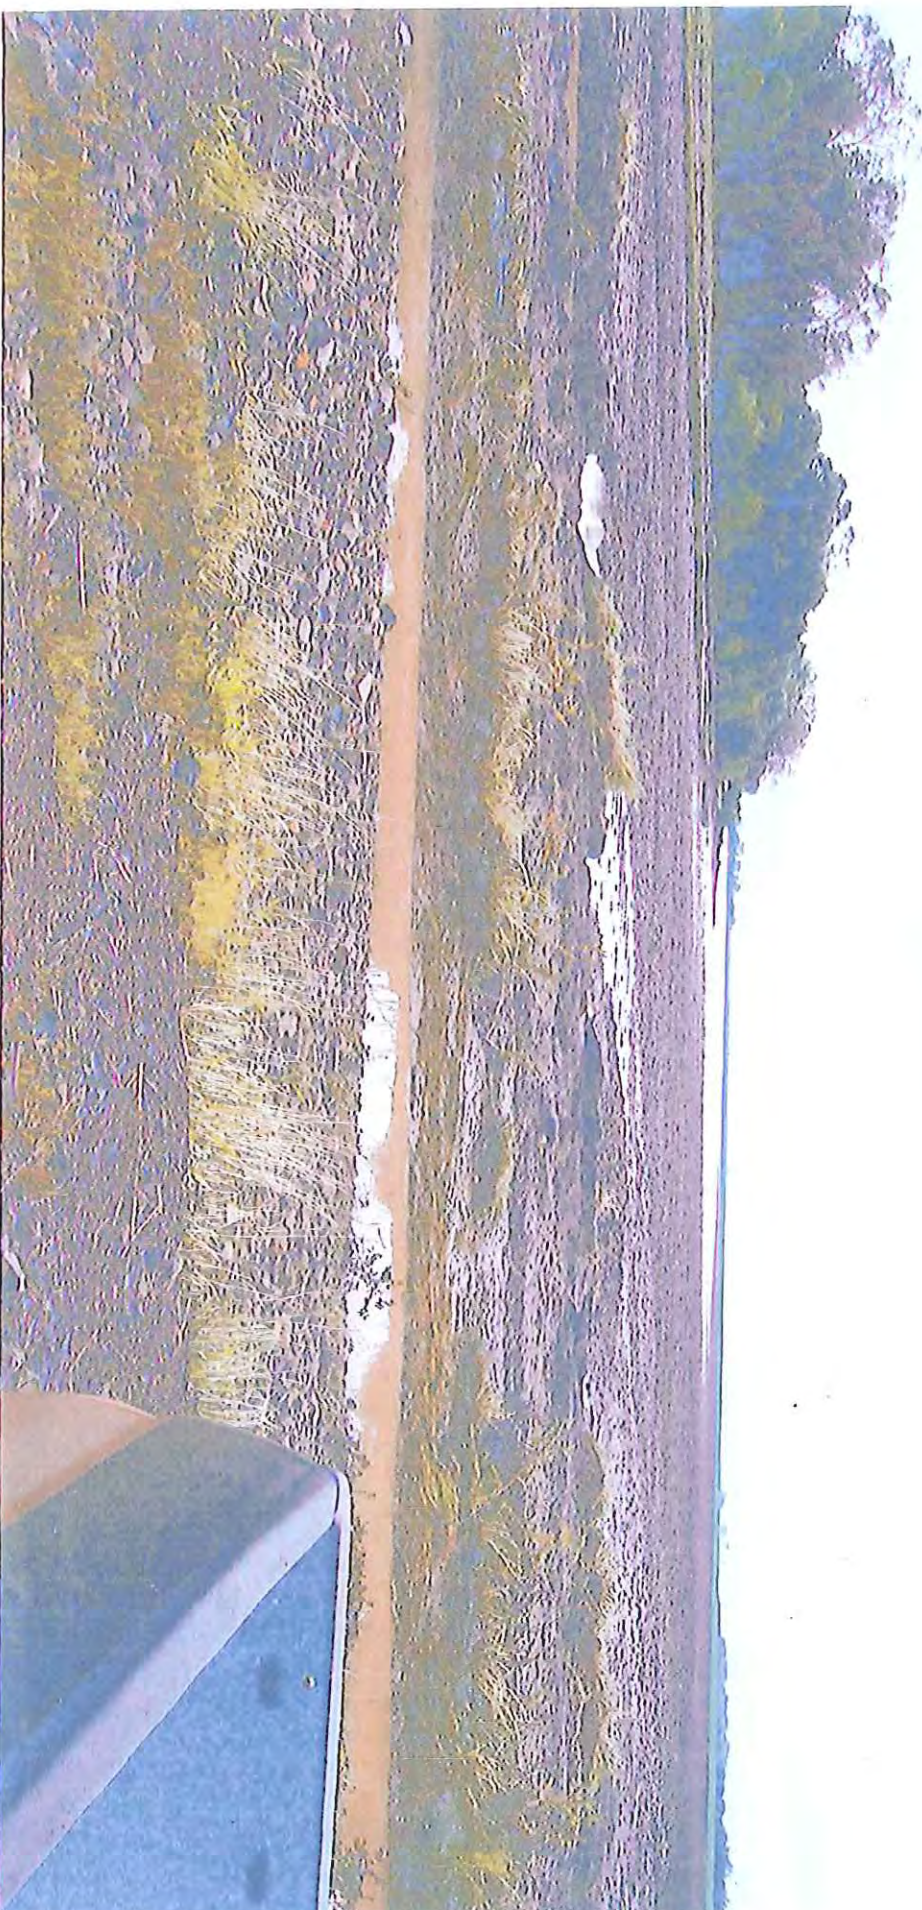
Robert ANDERSON – Photograph No. 1 – *Flood damage from swirling water at 200 metre opening after water had subsided considerably.*

9. Photograph 1 depicts flood damage caused to the ground at the site of the 200 metre restriction, portion [redacted], as indicated in Map 3. I am able to produce this photograph.
