QUEENSLAND FLOODS COMMISSION OF INQUIRY

Statutory Declaration

Sporting Clubs' Flood Damage Report

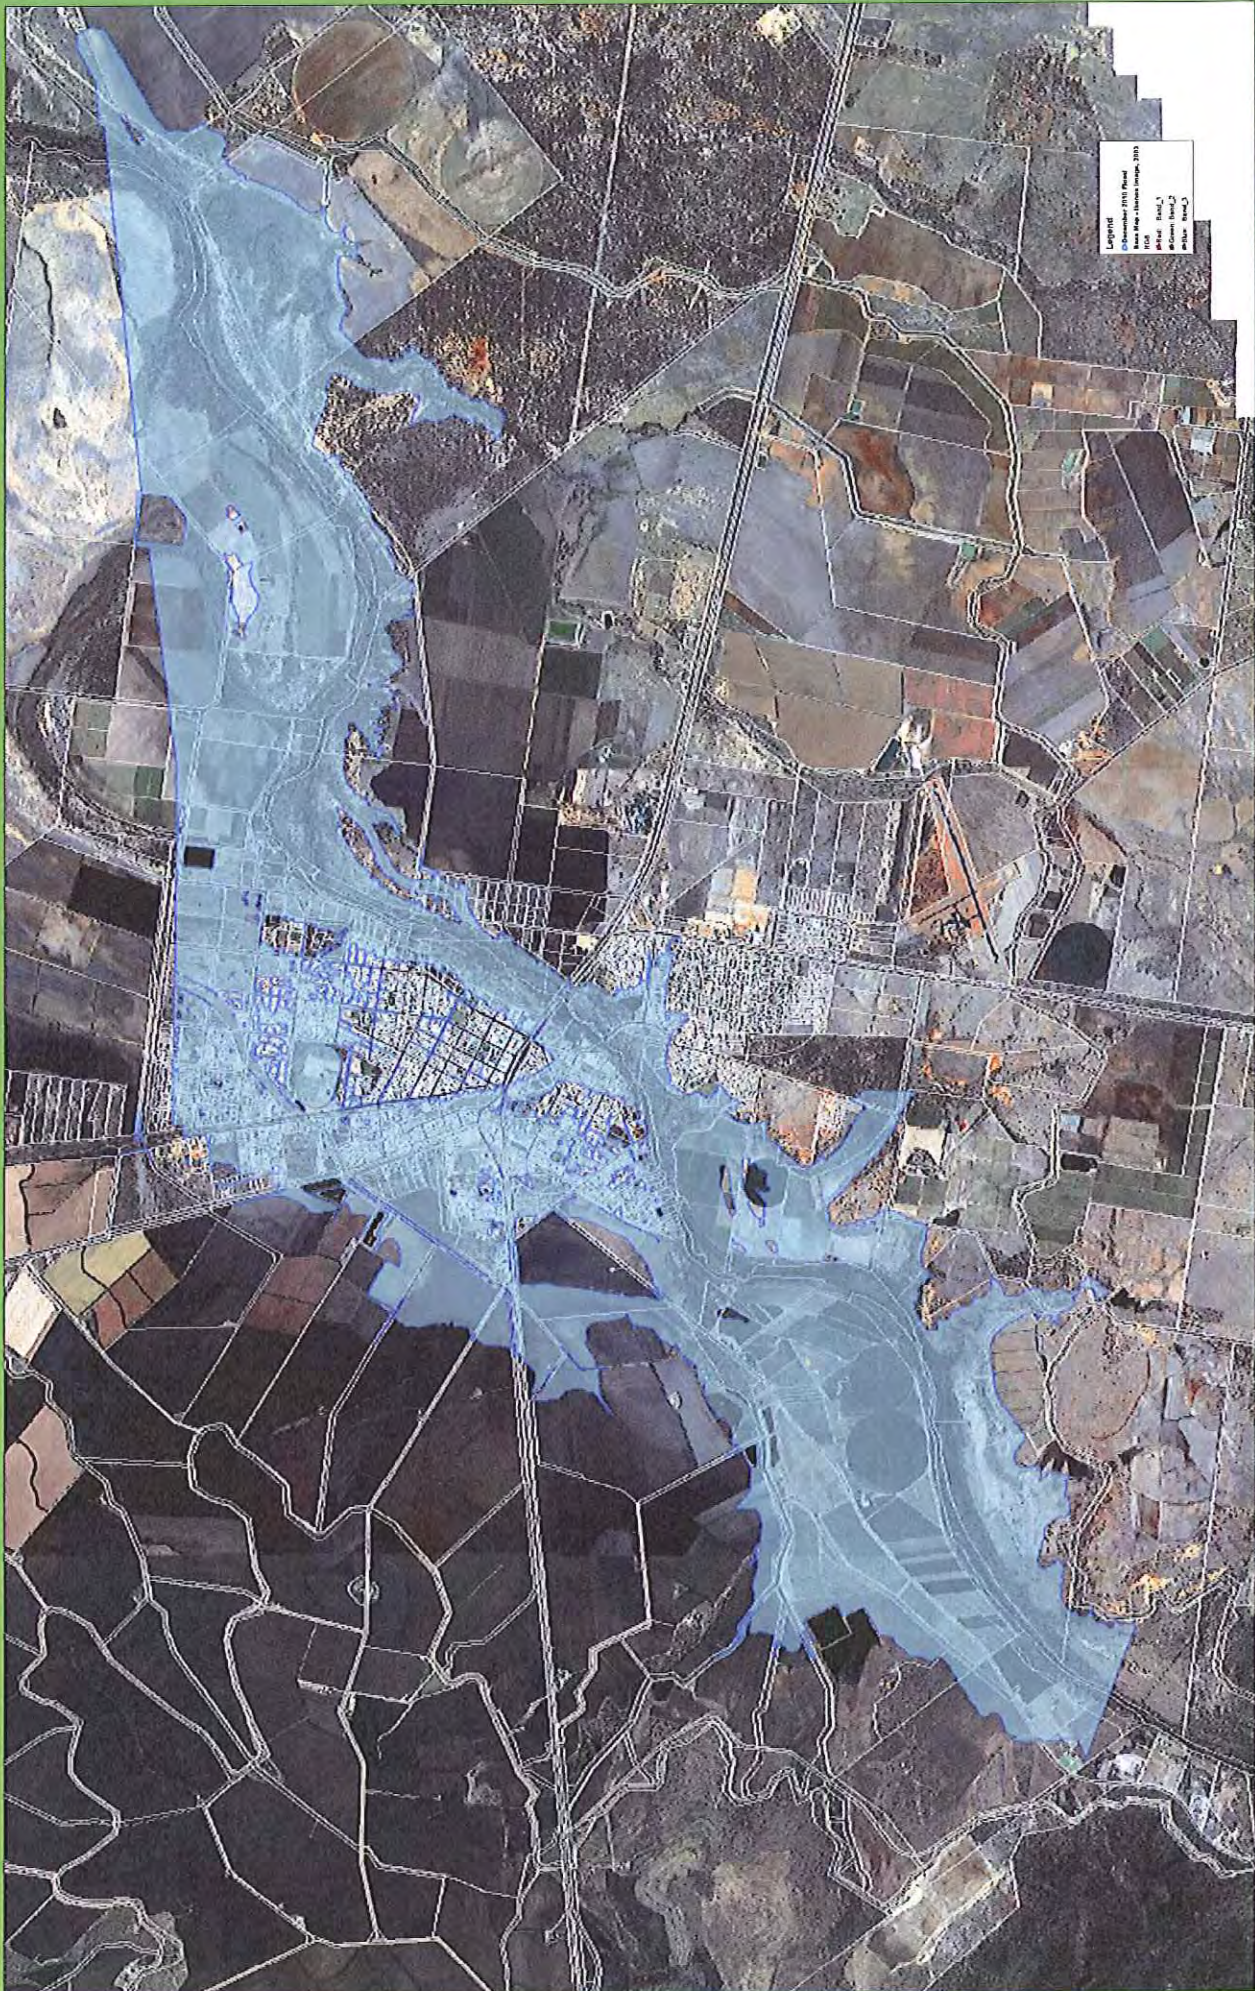
Land Inundation - 31 Dec 2010 Flood - Emerald

It should be noted that this plan shows the extent of water inundation only and gives no indication of water depth, water velocity, direction of flow or duration of inundation. All council infrastructure in the flood spread area was affected to varying degrees.

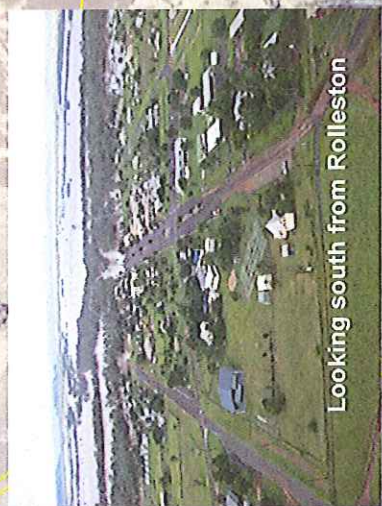
Rolleston - 28 Dec 2010 Flood Current Extent of Flood Mapping

All of the area to the south of the flood line was under flood water - see photo inset.

Looking south from Rolleston

- 8.5.1 **Flood Spread:** Attachment 6 shows the extent of the Flood Line with the water level being well above the highest level previously recorded.
- 8.5.2 **Sewerage Infrastructure:** Two pump stations located near the Comet River were flooded and suffered electrical damage.
- 8.5.3 **Water Infrastructure:** The Rolleston Water Treatment Plant, located alongside the Comet River, was inundated with about 500mm of water on the floor. Water from an emergency bore field was used to maintain the water supply to the township. As part of water supply security an in line chlorinator had been installed at the bore in anticipation of the need to use the bore field.
- 8.5.4 **Roads:** A few roads within the town were affected by flood waters but inundation was not long term and traffic loadings were generally light with little if any permanent damage being caused.

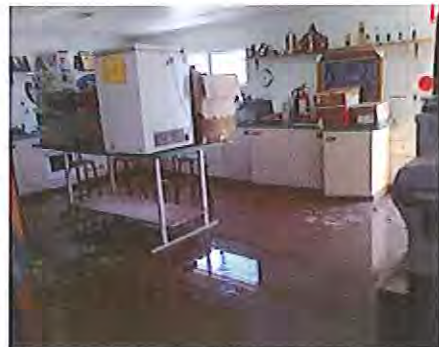
Damage sustained – *Infrastructure:* Concrete slab on clubhouse/equipment shed; seven doors in clubhouse and equipment shed; kitchen cupboards and benches; equipment storage cupboard and shed guttering; and possible sinkhole subsidence on fields to be confirmed.

Damage sustained – *Equipment:* Honda mower; 110lpm compressor; 3 fridges (TBC); 1 freezer (TBC); photocopier and fax machine; PA system; line marker; \$5000 junior jerseys; balls; bibs; 6 x first aid kits; miscellaneous office supplies; canteen stock; training cones; water bottles; flood lighting bulbs (were in storage); barbecue (TBC); and club records/paperwork.

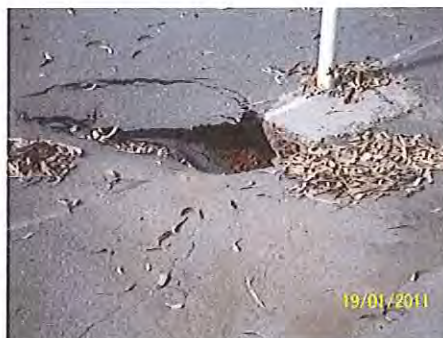
- **Emerald Netball Association**

Damage sustained – Infrastructure: Possible structural damage to clubhouse to be assessed (including stairs), significant subsidence on court 5 and further subsidence noted to the northern end of court 3 (yet to be confirmed but is covered with a large pool of water). Minor subsidence courts 1, 2 and 4.

Effect on ability to operate – Minor subsidence issues on courts 1, 2 and 4 needed to make them playable to enable season to get underway. Work on court 3 will be required as soon as possible if membership increases this season. Significant subsidence on court 5 poses public safety risk.

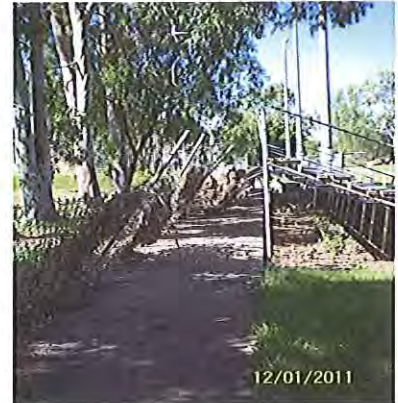
- **Emerald Brothers Cowboys RLFC, Emerald Tigers RLFC, Emerald Brothers Junior Rugby League and Emerald Junior Rugby League**

Damage sustained – Infrastructure: Significant damage to the clubhouse/canteen and fittings (doors, floor, lino, bar etc); dressing shed doors; perimeter fencing; clubhouse electrical wiring and storage donga (shared by four clubs). The maintenance shed was destroyed, seating on 13 grandstands, which were displaced by strong water current, will need to be replaced; and the light box for playing fields will need to be checked. Fields also lost recently applied top soil.

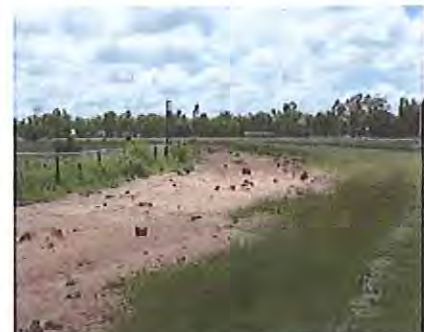
- **Emerald Jockey Club**

Damage sustained – Infrastructure: The road to the stables has been washed out in many places. The perimeter fence along Hospital Road has been flattened and severely damaged along Moody Street. The work track has sustained large washouts and this has made the track unusable. The work track will require a complete re-sanding.

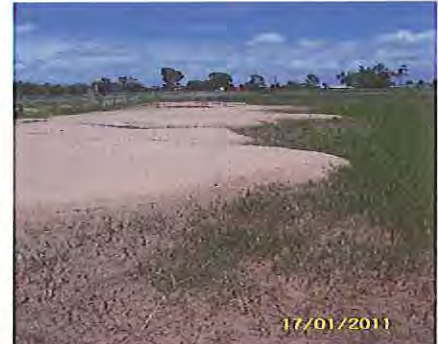
- **Emerald Polocrosse Club**

Description of water inundation – In the early stages of the flood event, the Club's fields were used for emergency helicopter landings and sustained damage as a result. The four fields were later inundated with floodwater for approx 24 hours.

Damage sustained – Infrastructure: Fields have deep wheel ruts from emergency vehicles/trucks and turf has been affected by helicopter fuel/oil in places. Damage to the field also resulted from the helicopter crash on site. There are also wheel ruts in the parking area. The fields are covered in a layer of clay silt, which will become extremely slippery for horses when wet, so facility will require topdressing. A significant amount of sand and crusher dust from the race track has been washed onto one field in large deposits. There are major issues with silt build-up blocking drainage, which will cause significantly more damage should more rainfall occur. Damage to irrigation set-up is possible but still to be determined.

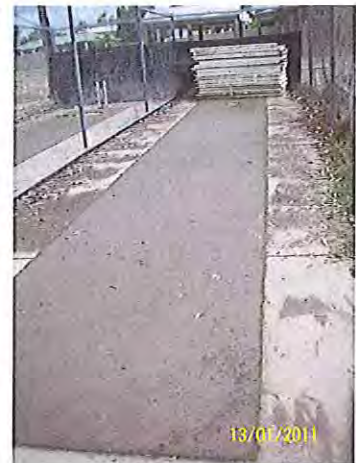
Damage sustained – Infrastructure: Possible sinking of and damage to artificial cricket pitch; possible damage to concrete in two cricket nets and cricket nets' carpet/pitch destroyed. Playing field may also need top dressing/levelling.

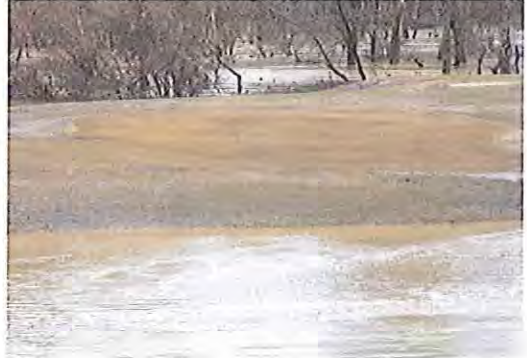
Damage sustained – Infrastructure: Two greens will need to be replaced and the rest require major repairs (sand, gravel, turf, tree/debris removal etc); pump has been submerged for a significant period (still to be checked) but associated pipes have been damaged; seven satellite receivers for the irrigation system destroyed; irrigation electricity supply damaged; boundary fence damaged; and tee signs and posts will need to be replaced.

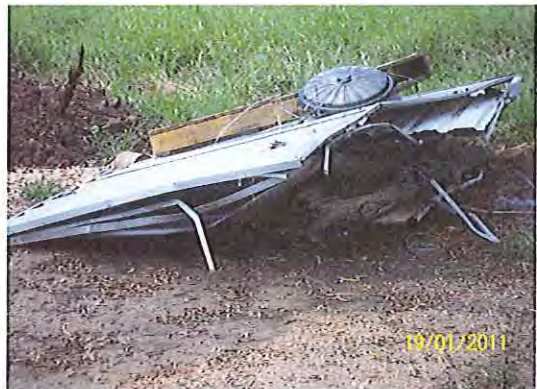
- **Emerald Horse and Pony Club**

Damage sustained – Infrastructure: Equipment/tack shed; Feed shed; sand/soil washed out of stables.

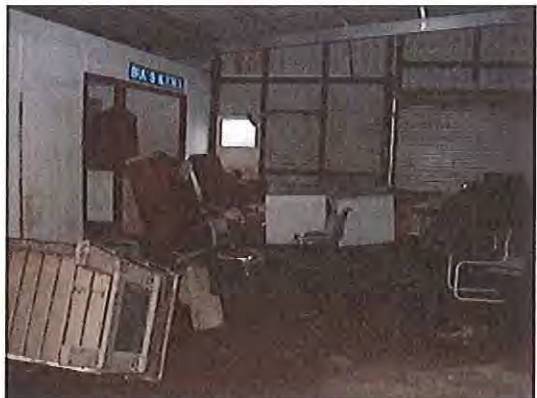
- **Emerald Pistol Club**

Damage sustained – Infrastructure: Damage was sustained to three ranges, clubhouse (including kitchen, workshop and office), toilet block, access road and 5000l tank.

Effect on ability to operate – Mounds on two ranges need to be fixed to operate at capacity according to Weapons Licensing legislation.

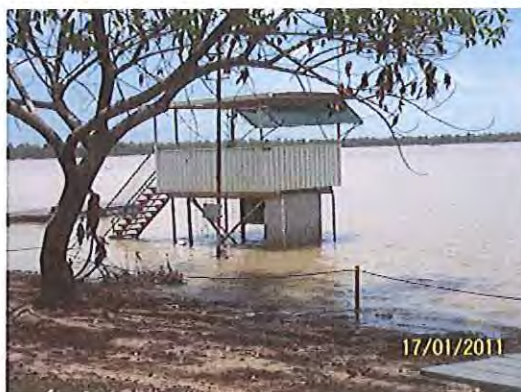
- **Maraboon Power Boat and Ski Club**

Description of water inundation – Facilities were damaged by a storm prior to Christmas 2010 and have been submerged by floodwaters for 6-8 weeks.

Damage sustained – *Infrastructure:* The judges' stand was totally submerged and remains partially under water. Possible damage to the stand's stairs and electrical work and possible erosion around concrete slab. The facility's undercover area may also require painting and repairs to benches.

Effect on ability to operate – Repairs will be required to be completed by next major event in August.

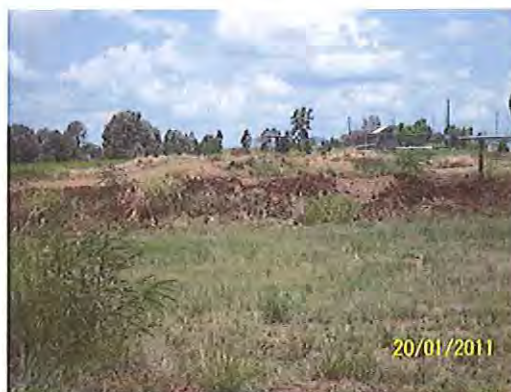
Description of water inundation – Heavy Christmas rainfall caused overflow from Council water treatment plant, which subsequently surged through club facilities, damaging track and bursting club's dam.

Damage sustained – *Infrastructure:* Dam wall blown out; damage to drainage and jumps; 2000-3000 m³ of sand washed from 1.8km track

Effect on ability to operate – Track can be used for practice runs but under licensing requirements, sand is required to be laid on the track for competitions.

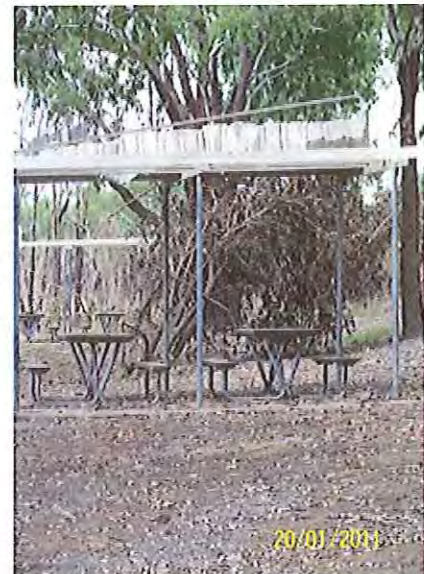
- **Blackwater Powerboat & Ski Club**

Damage sustained – *Infrastructure:* Significant damage to the ski clubs toilet block/equipment shed (roof, internal walls etc); switchboard, metre boxes and electrical wiring will need to be replaced. The rainwater tank was displaced by strong water current and will need to be repaired if possible or replaced. The shade shelters have sustained significant damage (rooves ripped off or torn) and will need to be replaced.

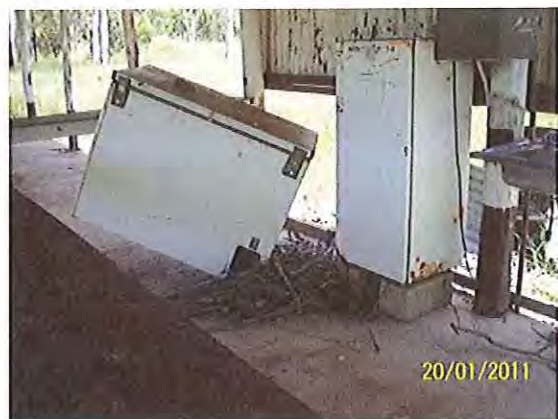
Damage sustained – *Infrastructure:* Possible damage to the storage container.

Damage sustained – *Equipment:* Fridge and freezer; two artificial pitches (roll-up); and miscellaneous cricket gear.

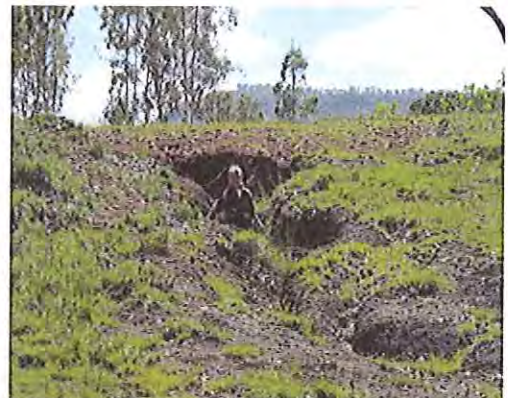
Description of water inundation – Heavy rain prior to Christmas caused breaks in the contour banks and water surged through grounds. The situation deteriorated with each subsequent rainfall event.

Damage sustained – *Infrastructure:* Areas of the contour banks have been destroyed; drainage damaged; deep water gouges through work area/arena; and access to the second area across the creek has further deteriorated.

Effect on ability to operate – Gouges to work area/arena have rendered area unsafe for use so club cannot function until it is fixed.
