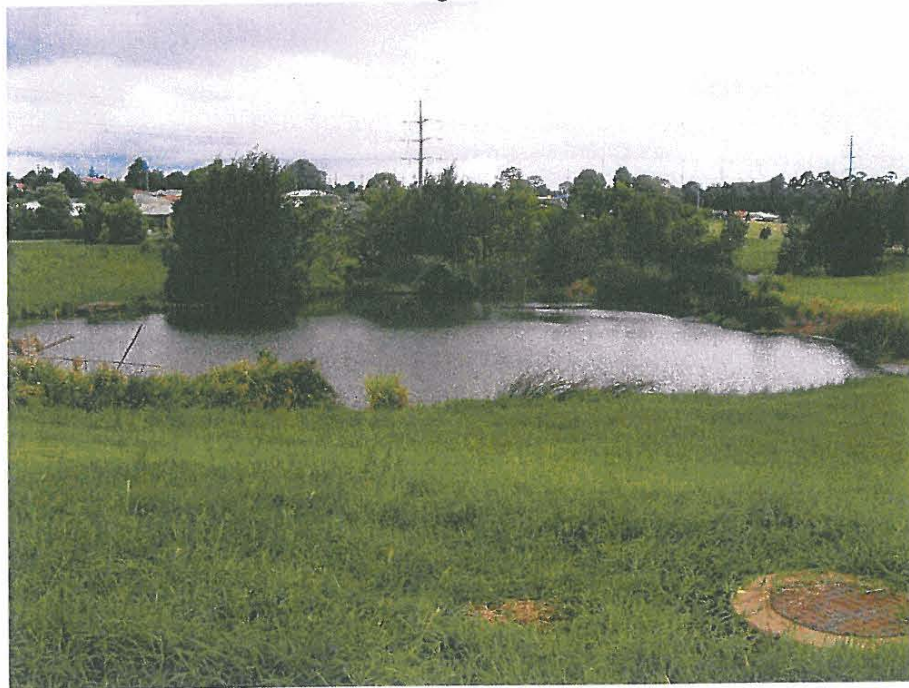
**Figure 67**

Many of the ponds and retention basins had overtopped during the storm with erosion initiating at several containment embankments, usually on the downstream batters (Figures 67, 88, 89 & 99). In some instances crushed rock paving material on the crest walkways had eroded preferentially (Figure 86).

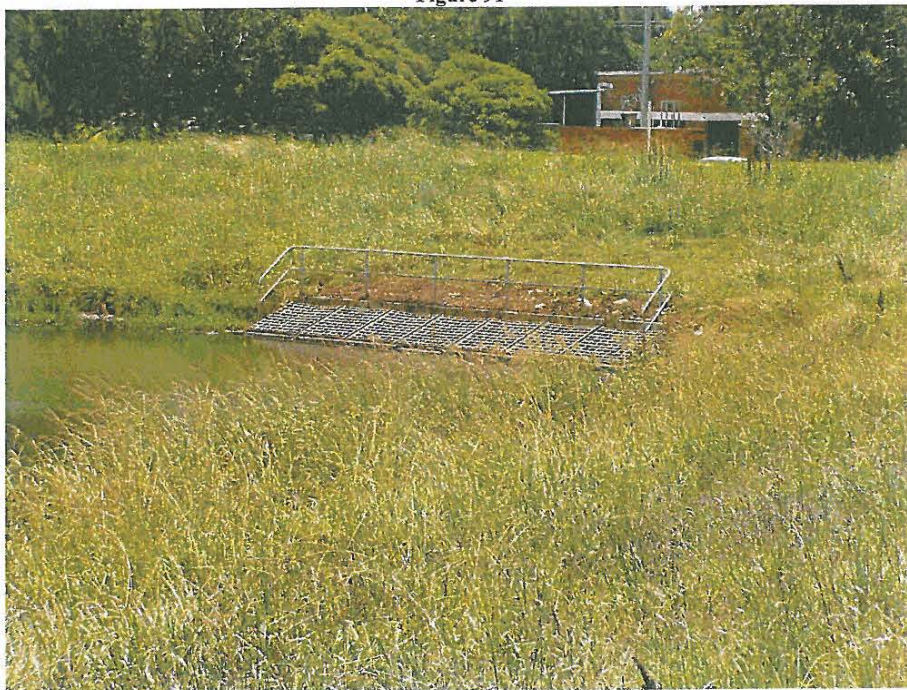
**Figure 91**

One embankment (Figure 91, 95 & 98) had the appearance of severe erosion but later inquiries found that the land form was the result of earthworks carried out by TCC workers the day after the flood.

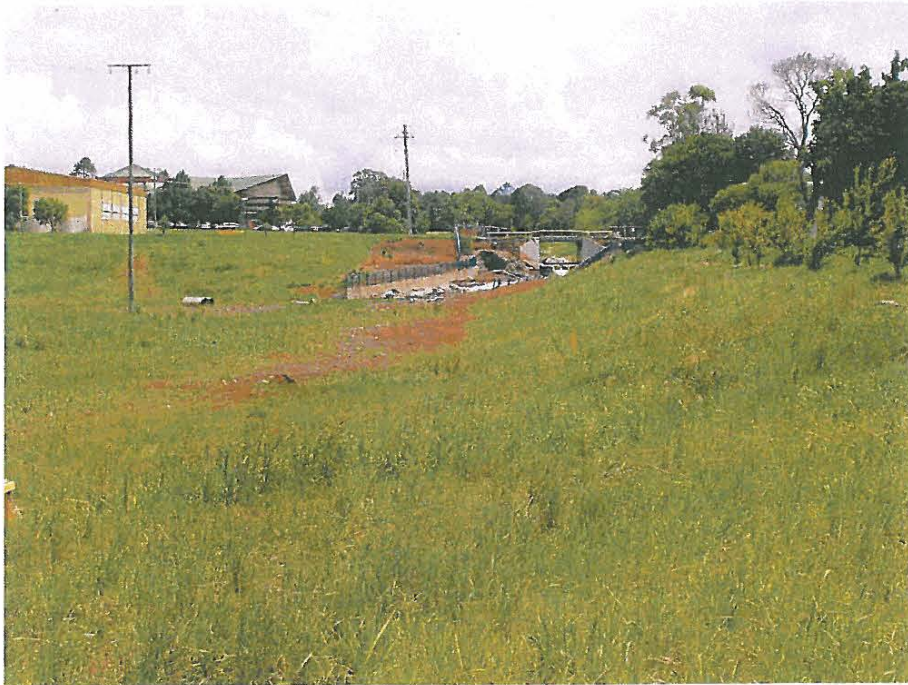
**Figure 106**

The outlet to the Long Street Retention Basin – WC14 (Figure 106 & 109) is small and the overtopping of this embankment in particular would probably result in a large increase in flow for a small increase in pond depth. Most of the severe channel erosion occurred downstream of this retention basin. (Figures 118 to 121). The embankment did overtop.

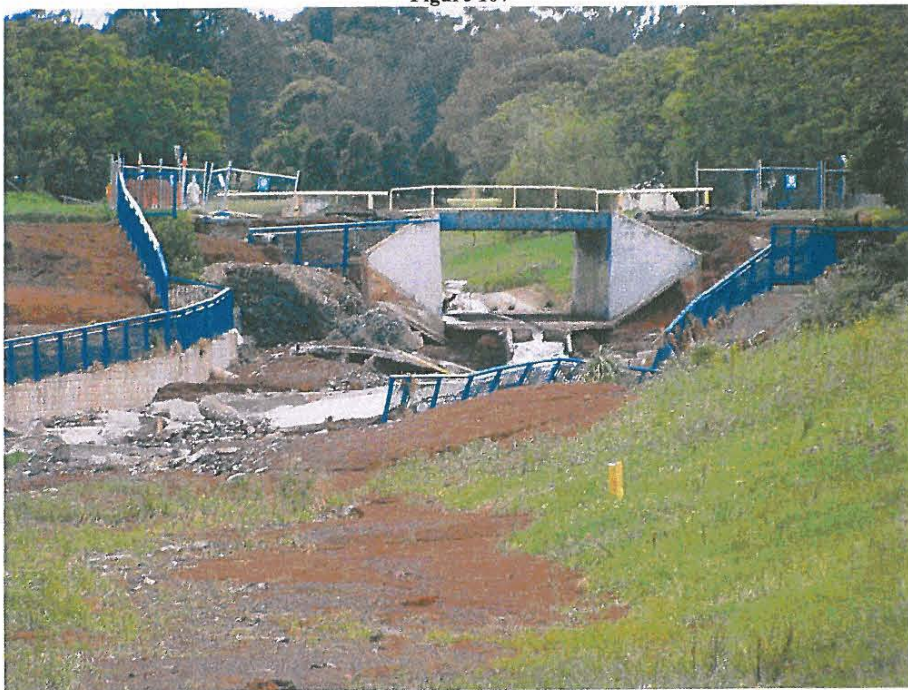
Figure 107

The only control structure to partially fail was the inlet to the Long Street Retention Basin – WC16 (Figures 107 & 108). This controlled flow in a formed drain from the pond upstream. It is unlikely that the volume released by the failure of the entrance control would be significant enough to have caused a surge downstream. The flow into the Alderley Retention Pond had overtopped the road over the inlet control.

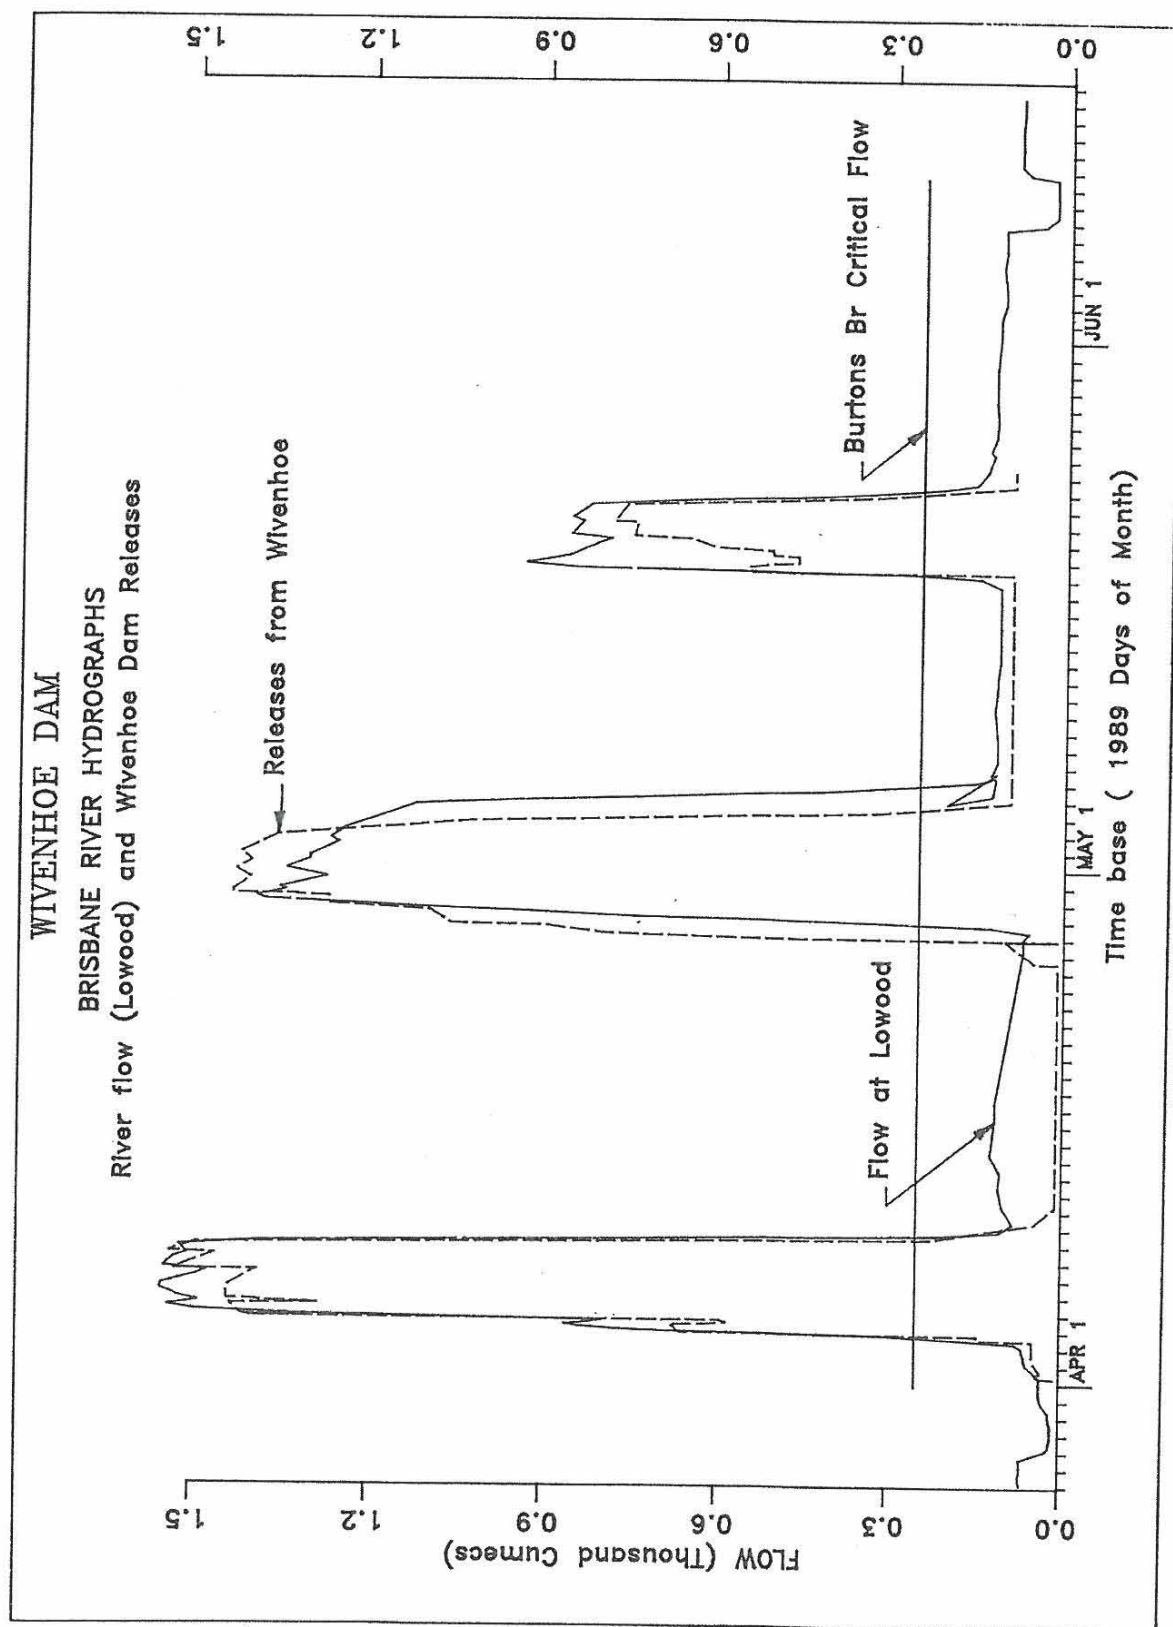
FIG. 1

Three periods of major storms occurred over the April-May period (Figure 1).

Sustained rainfall over several days from 2nd April to 8th April, 1989 caused significant storage rise above full supply level in both Wivenhoe and Somerset Dams.

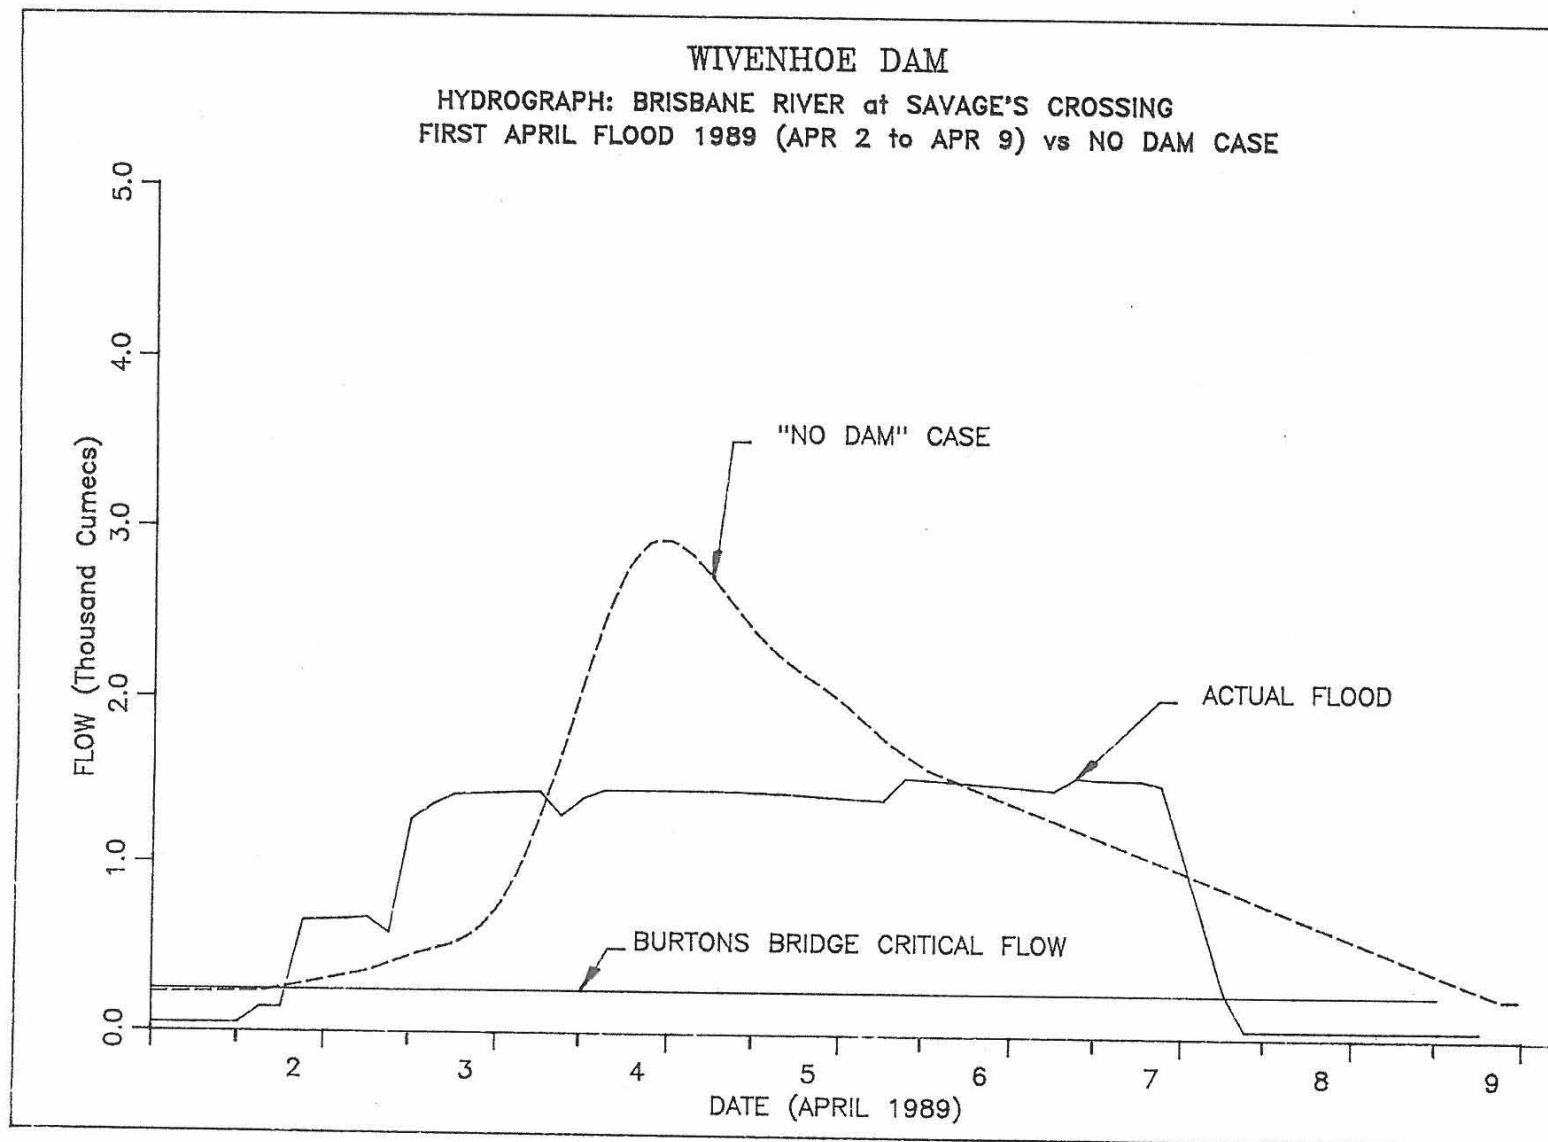
FIG. 2A

Figure 2A shows the recorded flood hydrograph at Savages Crossing (with dams) and the derived hydrograph for the "no dams" case. As can be seen, without Wivenhoe Dam, the flood would have peaked at nearly 3 000 cubic metres per second. The flood was of relatively long duration with a total volume of runoff approaching 600,000 megalitres.

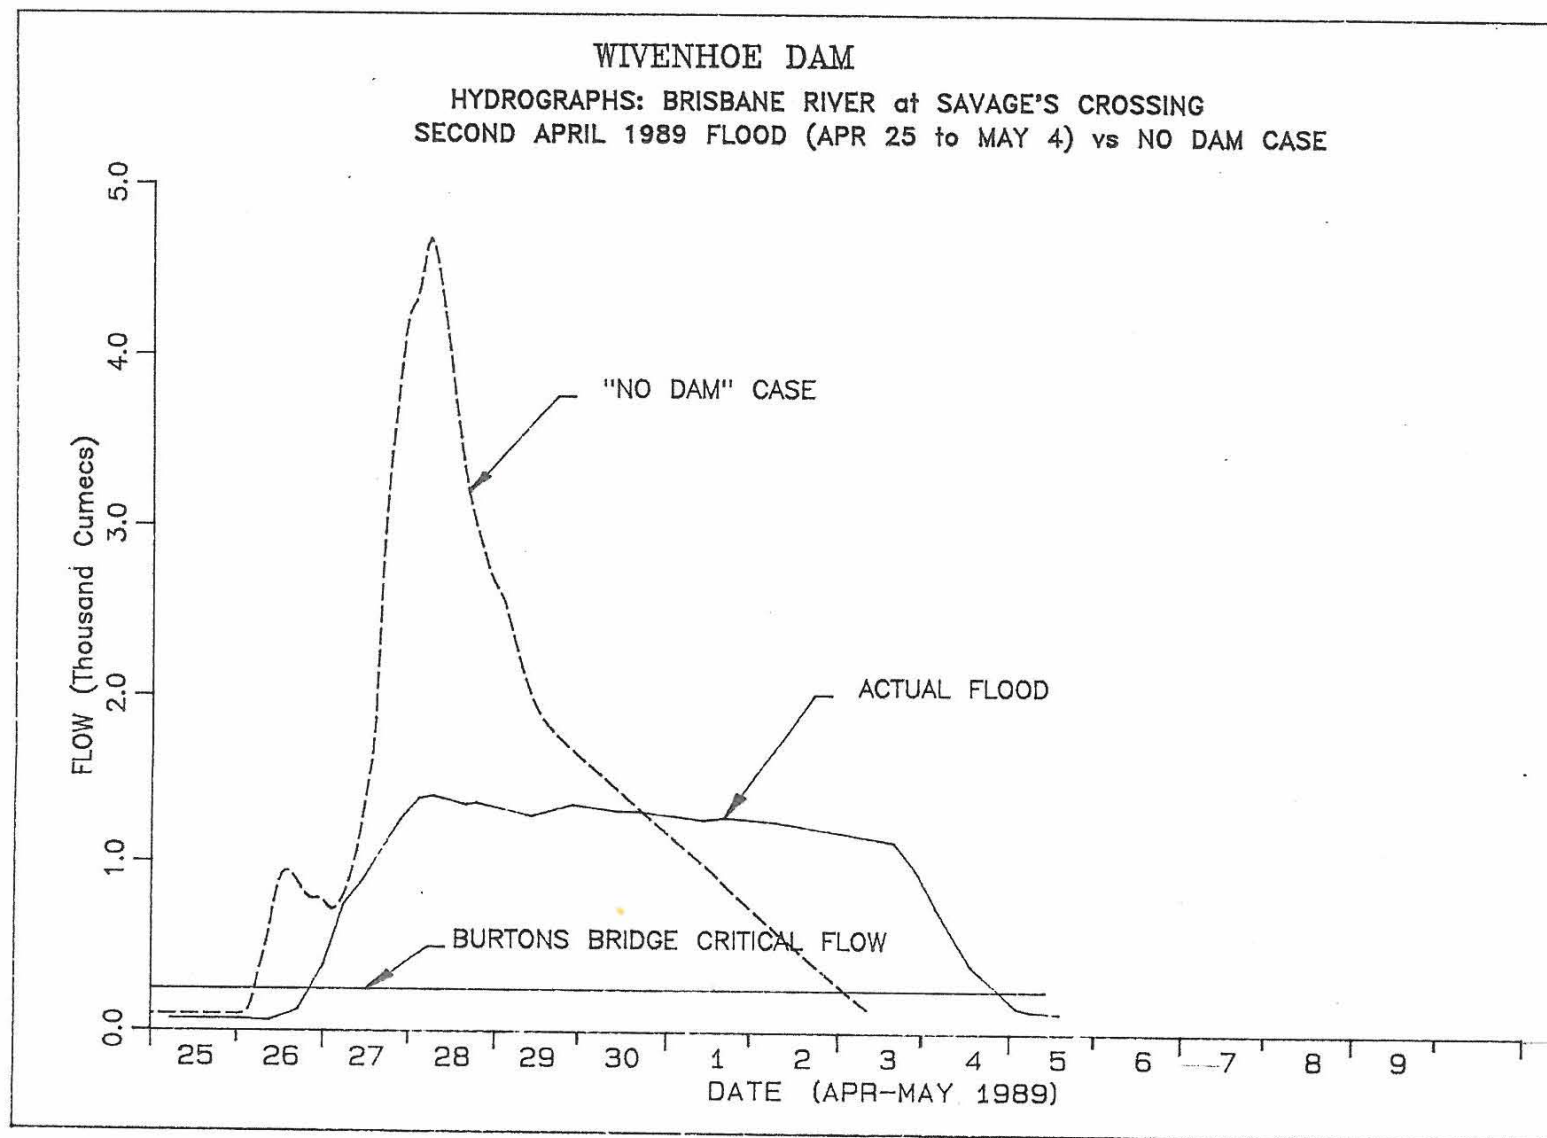
FIG. 2B

The second April flood resulted largely from an intense storm event on the evening of 25th April. Figure 2B shows, again, the recorded flood hydrograph at Savages Crossing (with dams) and the derived "no dams" hydrograph. This second flood was of shorter duration but would have peaked at some 4 600 cubic metres per second had Wivenhoe Dam not been in place. The total volume of runoff in this second flood approached 1 million megalitres.

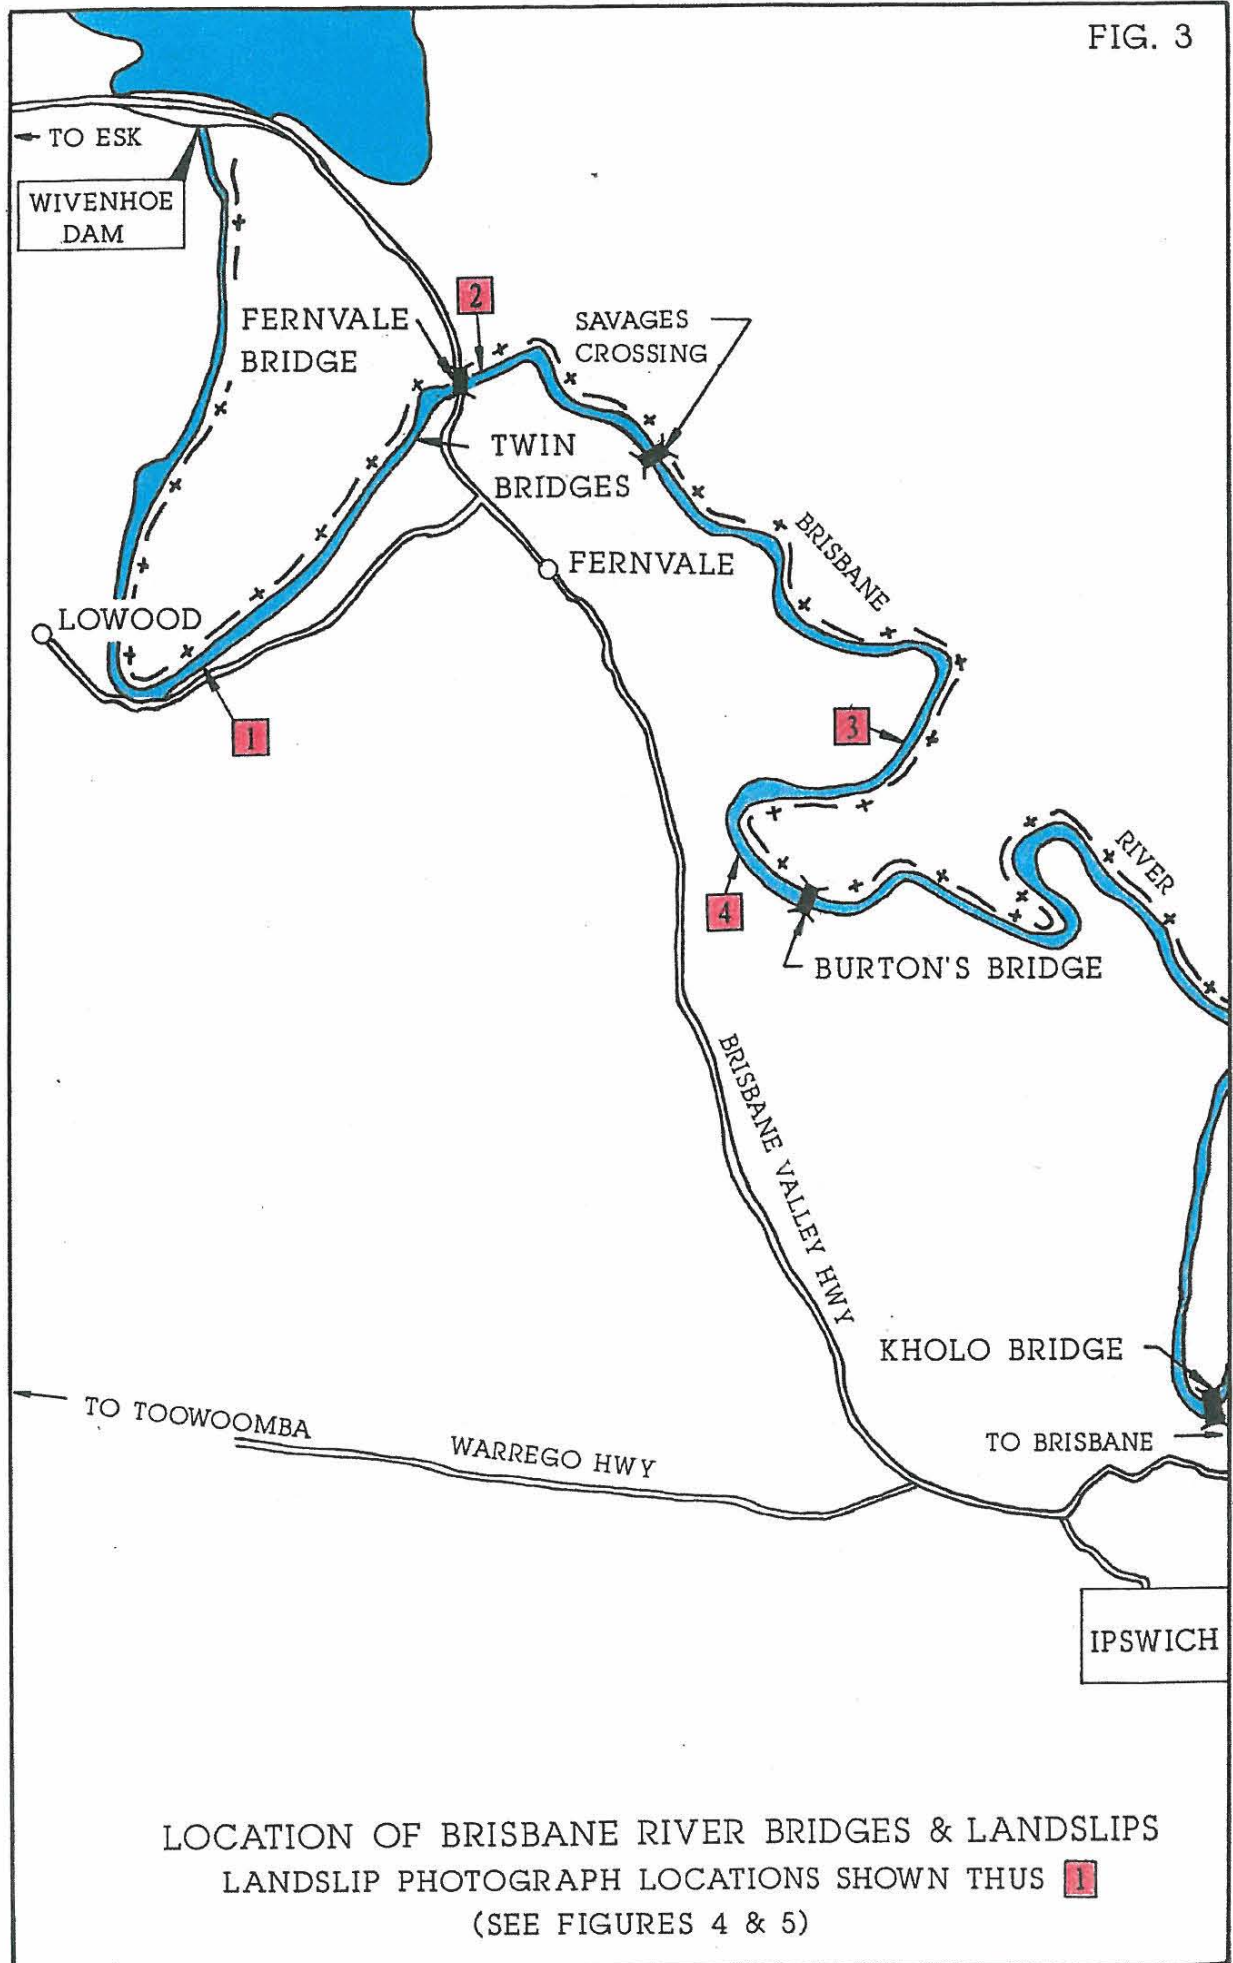
FIG. 3

Many bank slips were reported after the first gate closing at Wivenhoe Dam. All slips reported were located, inspected and photographed. Slips were mostly in the areas indicated on the attached Figure 3.

Brisbane River flooding downstream of Wivenhoe Dam affects six bridges as detailed hereunder and whose locations are shown in Figure 3. For each bridge, the flood flow at which the bridge is inundated (flood immunity) is also shown.

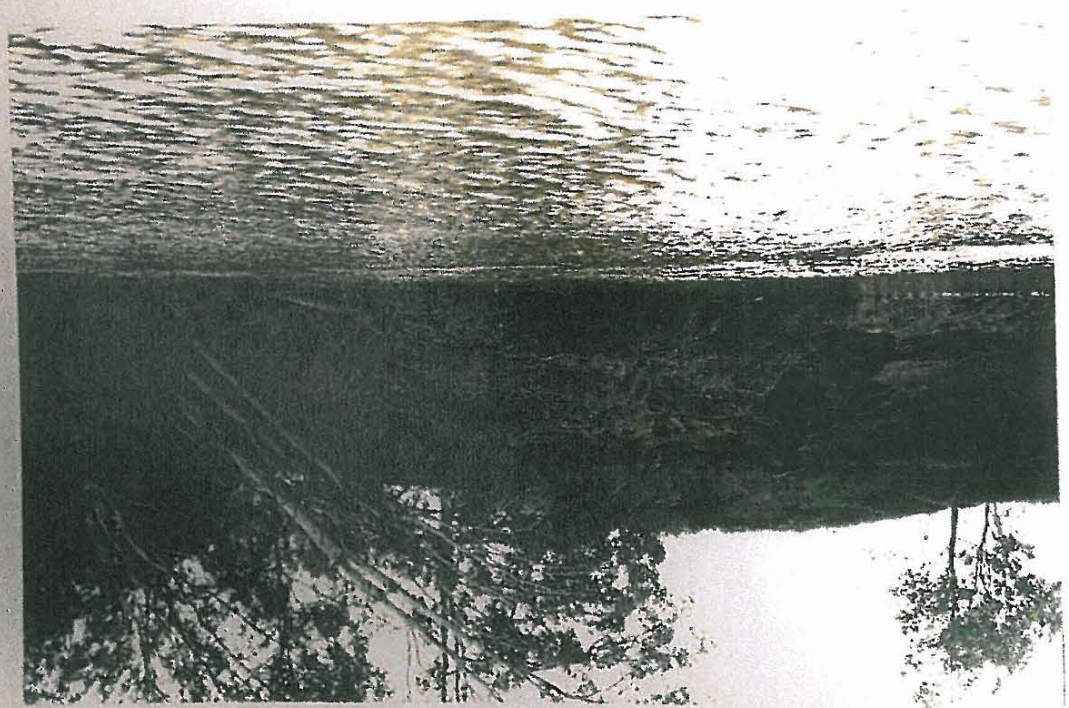
FIG. 5

For the most part, slips were 30 to 50 metres long and quite shallow. Although the slips are certainly unsightly 'scars' along the banks, little useable land above the high bank has been lost. Photographs of a number of typical slips are attached as Figures 4 and 5.

- . river bank slips downstream of Wivenhoe Dam were a result of several factors. The rate of gate closure at the dam was possibly a contributory factor but only one of the factors.
- . the Water Resources Commission should continue to investigate reports of bank slumping as and when they may occur and if desirable, review further variations to the gate operating rules.
- . based on a preliminary study, the effect of Wivenhoe Dam operation on flood immunity of the various downstream bridges was minimal.
- . the Water Resources Commission should in conjunction with authorities responsible examine more exhaustively the effect of Wivenhoe Dam on the downstream bridges.
- . a review of the flood operation manual should be undertaken as planned this year taking into account the issues identified in this report as being worthy of further consideration.

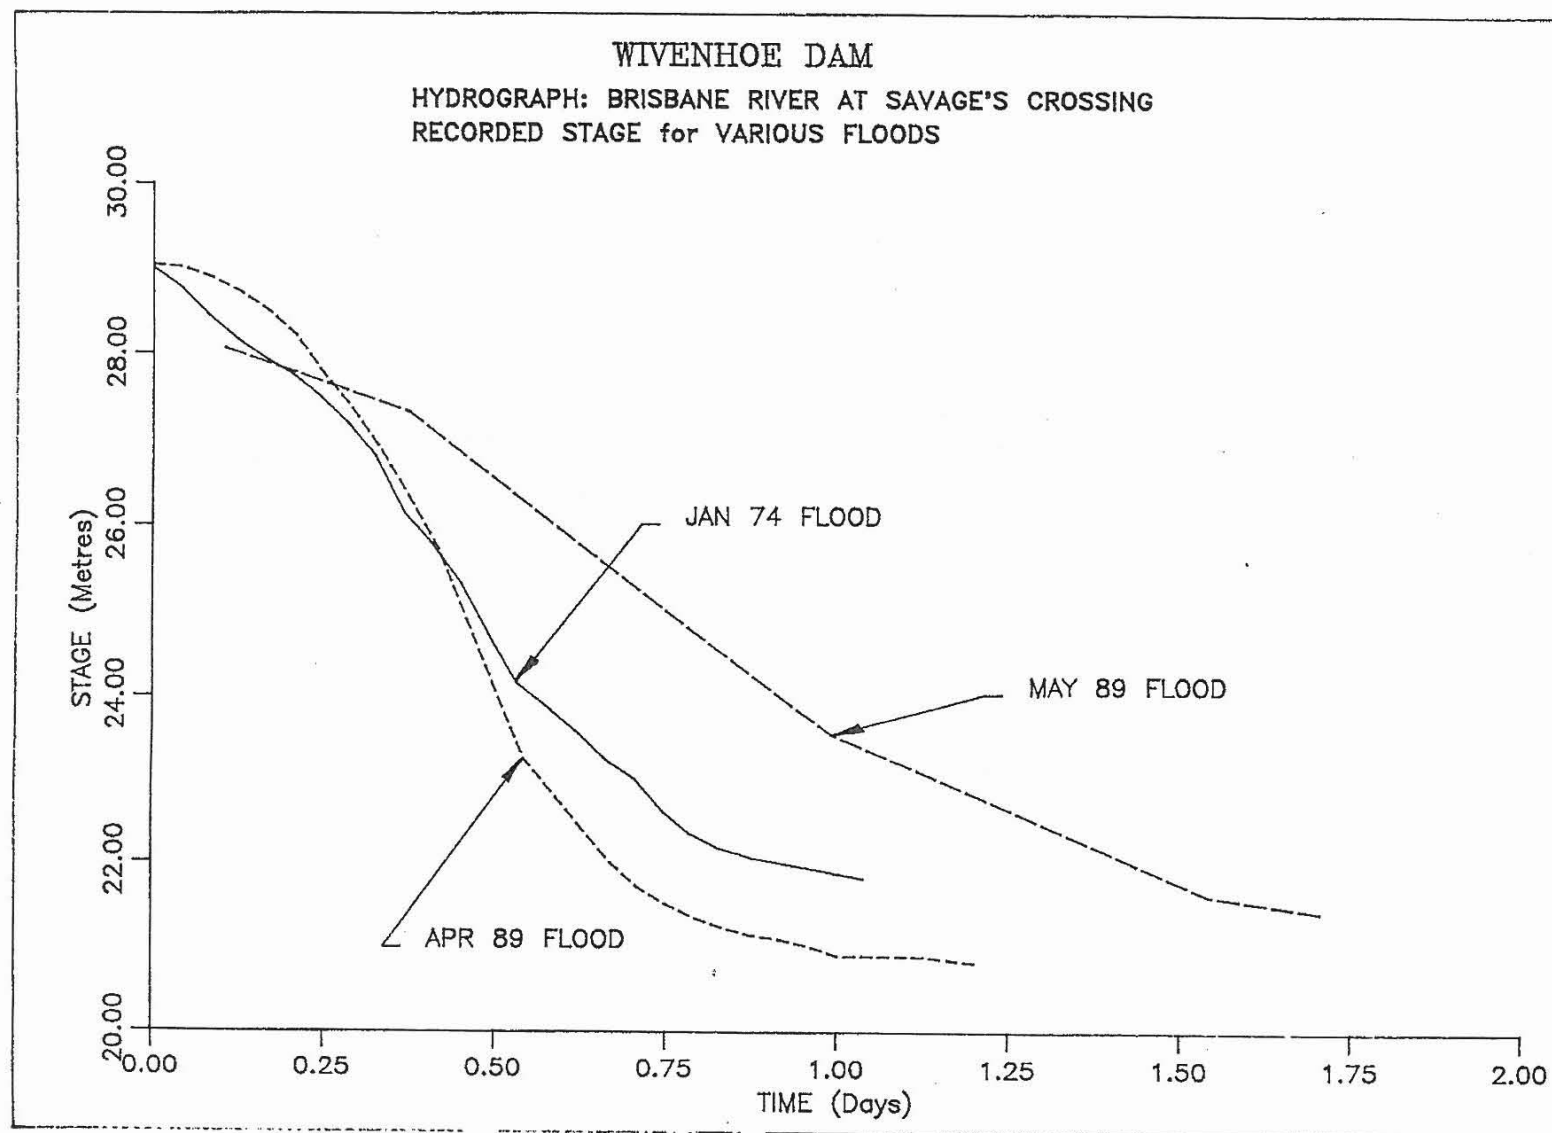
FIG. 6

After an urgent review of the gate operating rules and of water level records along the river, it was concluded that the rate of gate closure should be slowed, although clearly, this would increase the period of inundation of the lower level bridges downstream. A slower rate of gate closure (see Figure 6) was used after the second flood. No new bank slips were reported.
