WIVENHOE DAM

RADIAL GATE TRUNNION BEARINGS

PEER REVIEW

MAY 2006

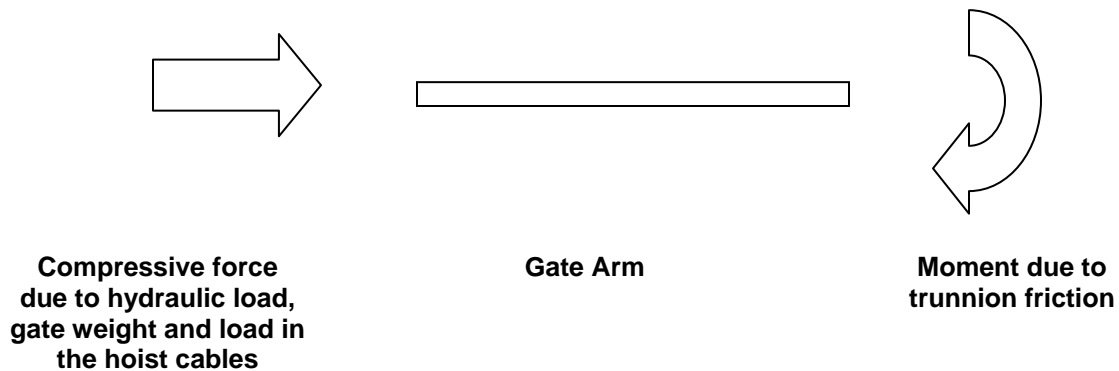
**FIGURE 1
LOADS ON ARM BEAM**

The gauges measure strains due to water loading which is a compressive strain, and strains due to trunnion friction which is a cyclic compression and tensile strain (see Figure 1). During gate raising the upper fibres are in compression and the lower in tension; during lowering this pattern is reversed. The variation is an indicator of the strain induced by the bearing moment due to friction.

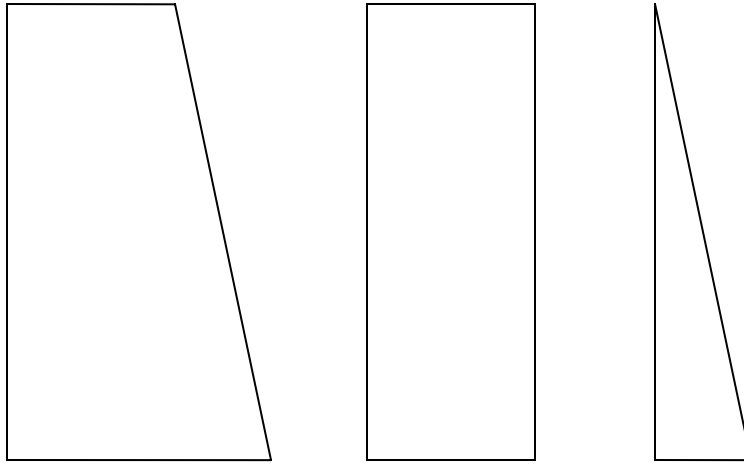
**FIGURE 1
SHOWING MEASURED STRAIN FOR WATER LOAD
& TRUNNION FRICTION MOMENT**

Inputting the strain results into the structural analysis allows the bearing friction to be determined. Also from the structural analysis the strain value that will result in structural failure can be determined. This strain value then sets the upper limit for bearing friction. Regular checking of bearing friction will allow the bearing condition to be monitored and bearing replacement to be predicted.

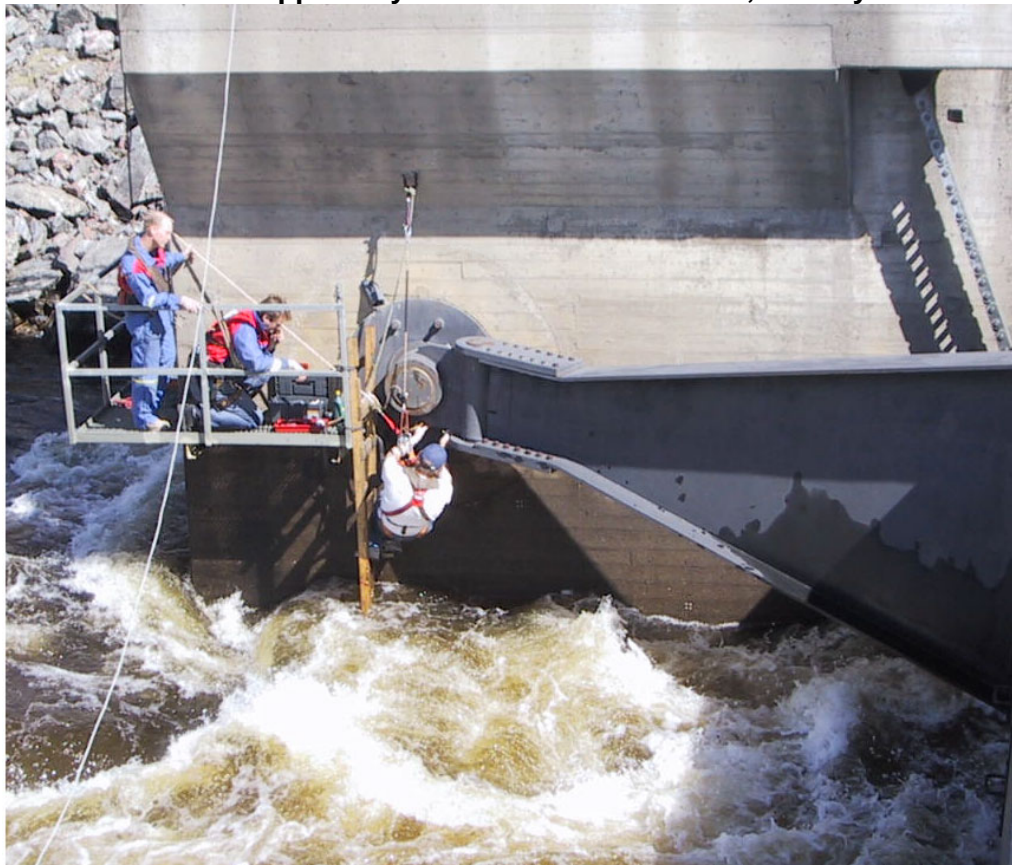
Photo 8

**Gate Failure: Liwonde barrage, Malawi, Africa
Photo Supplied by H. Fosker of Norconsult, Norway**
