**IN THE MATTER OF  
THE QUEENSLAND FLOODS COMMISSION OF INQUIRY**

**THIRD STATEMENT OF TERRENCE ALWYN MALONE**

2. This statement addresses only the matters raised by Mark Babister in paragraphs 46-48 of his report "*Brisbane River 2011 Flood Event – Flood Frequency Analysis*" dated 18 September 2011. In summary, Mr Babister has suggested that there may have been mechanical failure with Seqwater's City gauge during the January 2011 Flood Event.
3. I do not make any comment on the remainder of Mr Babister's report.

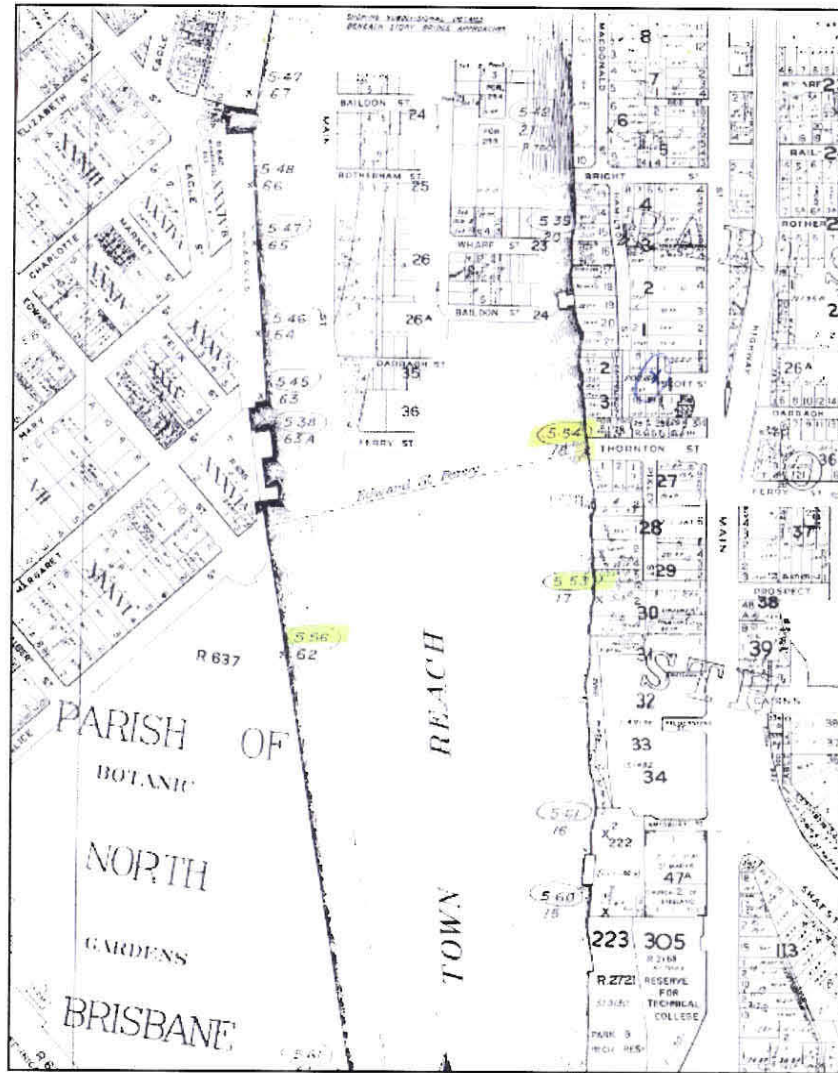
Figure 6 Peak Water Levels in Town Reach Jan 1974

38. The surveyed levels shown in Figure 5 clearly show the impact of superelevation with peak water levels on the outside of the river bends being higher than those on the inside.
39. However, the MSQ Port Office gauge and the Seqwater Brisbane ALERT are located in a relatively straight section in the Town Reach of the Brisbane River.
40. Survey records from 1974 confirm that there is not a large difference in peak water levels between the left and right banks in the vicinity of the Port Office gauge with the difference less than 30mm in January 1974 as shown in Figure 6 below.
41. As a result, my opinion is that superelevation can be discounted as a possible cause of the difference in peak water levels.

42. My opinion is that slope is also unlikely to account for the difference as the Seqwater Brisbane ALERT gauge is about 200m metres downstream and the peak at the ALERT gauge is higher than the MSQ Port Office gauge. Under flood conditions the downstream water level is normally lower than the upstream water level.
