Statement of Witness

Queensland Floods Commission of Inquiry

FIRST REPORT – FLOOD DAMAGE CLAIM

3 SITE INSPECTION

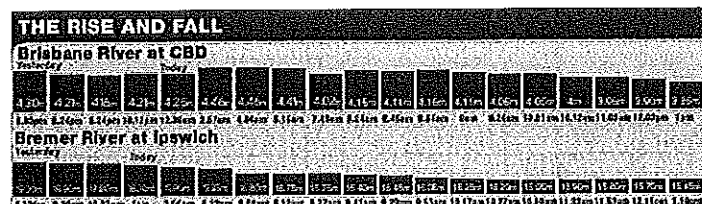
- Unit 13 had approximately 330mm of water through the ground floor at the highest point at approximately 10pm January 12th. This would place the water level at approximately 13.1m AHD in this area at that time.
- Unit 5 had approximately 700mm of water through the ground floor, at the highest point at approximately 10pm January 12th. Confirming water level at 13.1m AHD. Water started entering units 1 to 5 around 6am January 12th, 2011.
- Photographs taken at the site on January 13th suggest the water levels receding from a January 12th peak, though BOM advised that the Brisbane River was yet to peak. This peak information was confirmed in the image published by the Courier Mail (13th January 2011) shown below.

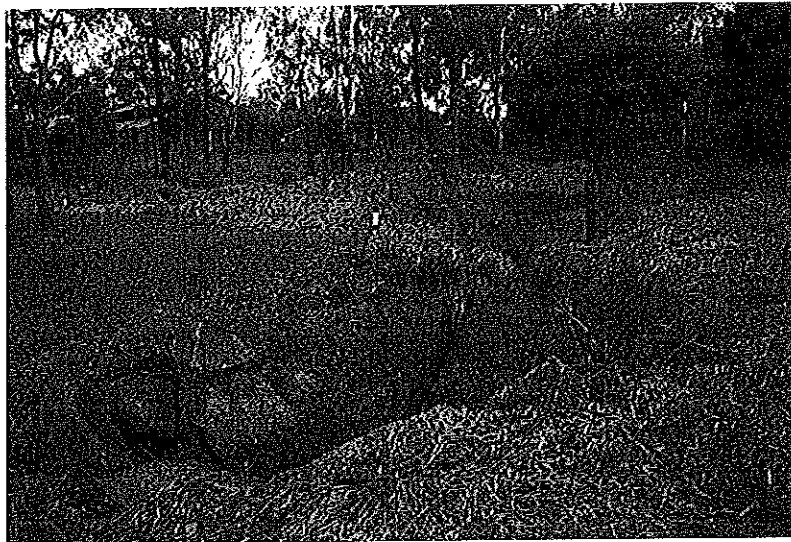
- d) An inspection of the drainage system in the waterway along the western site boundary conducted by a DEC representative at 1:30pm on 11th January 2011 confirmed flows were continuing to be received down the drainage network from the upper Middle Park catchment. These flows were occurring in both the drainage pipes and overland flowpaths. This flow was engulfed by the tailwater conditions present in the MacLeod Golf Course. A photograph of the waterway after the water had receded is below, showing the vegetation has been compressed in the direction of flow downstream.
