Name of Witness	Lynn De Lange
Date of Birth	[REDACTED]
Address and contact details	[REDACTED] Albert Street, Brisbane (Ph: [REDACTED])
Occupation	Retired
Officer taking statement	Detective Sergeant Stephen Platz
Date taken	13/09/2011

**Exhibit; Engineers report on basement inundation at Festival
Towers apartments by Sheehy & Partners Pty Ltd**

Festival Towers Apartments – Basement Water Inundation

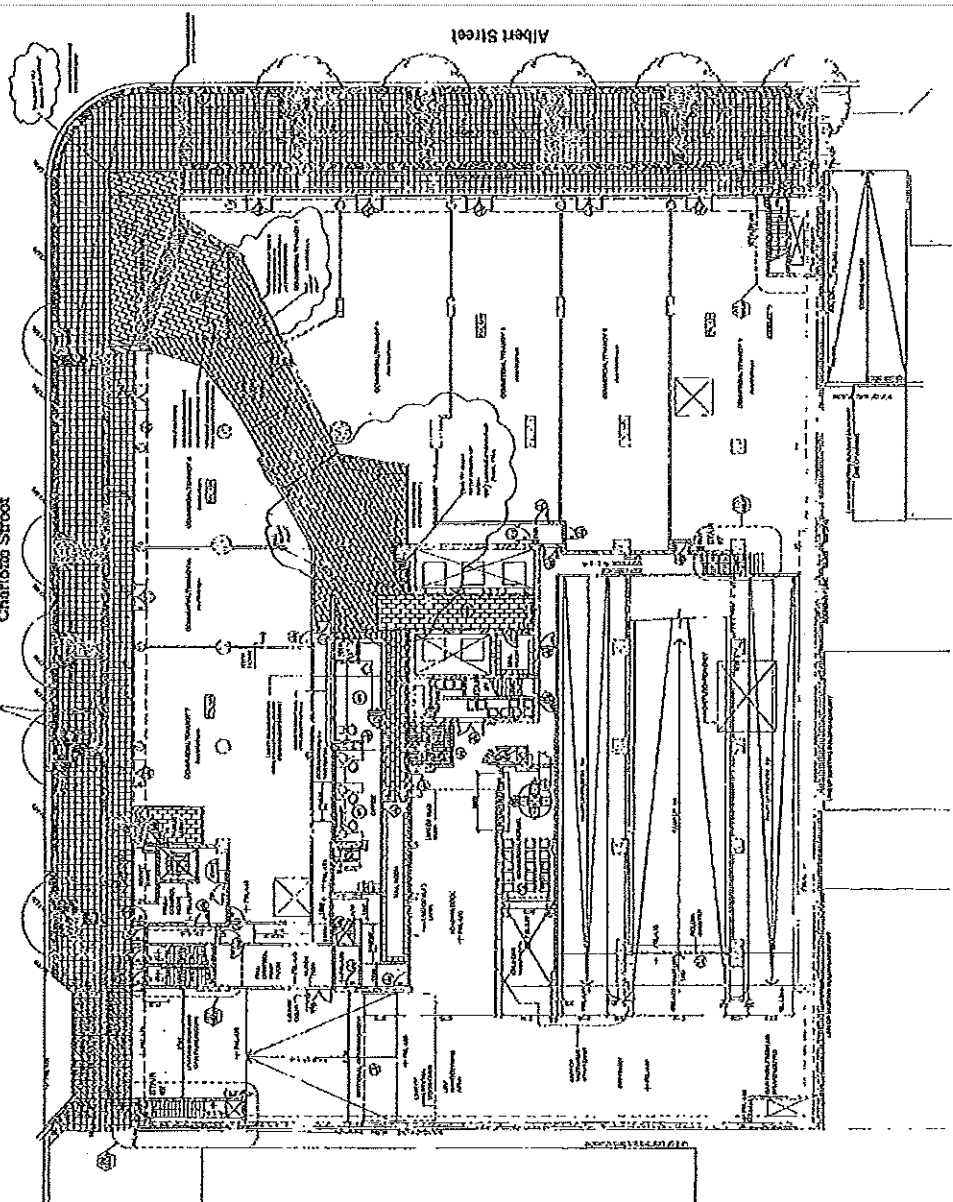
LOCATION OF SWEEP PITS IN STREET

The source of the water inundation is believed to be at the incoming electricity mains to the building on the Charlotte Street Frontage. Marked up drawings are attached and photographs follow for identification of this primary water inundation source. A "waterfall" from this location was observed by staff on site during the event. The water staining on the vermiculite encasing of the incoming conduits and failed fire proofing of the entry location boxing soffit also confirm the likelihood of this location being the main source of water entry into the basement.
