STATEMENT OF DR BRUCE ABERNETHY

Brisbane River Flood, January 2011

REPORT ON RIVER BANK EROSION

- Final
- 6 October 2011

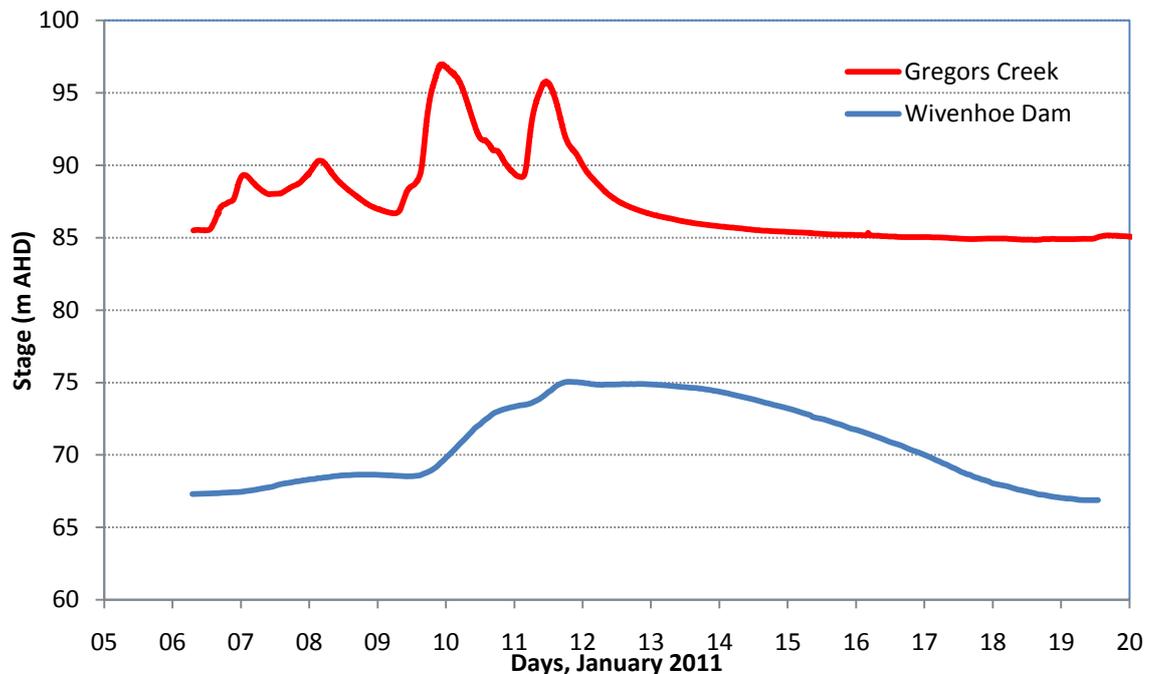
Figure 4: Stage heights at Gregors Creek and Wivenhoe Dam gauges.

Harlin is upstream from the Gregors Creek gauge which in turn is some 83km upstream from the Wivenhoe Dam wall. Base flow at the Gregors Creek gauge is some 10m higher than the peak water level recorded at the dam in January. Regardless of the processes of channel change, the hydrographs presented in Figure 4 show clearly that flow in the River at Harlin was controlled by local channel conditions alone and was not under the influence of Wivenhoe Dam. Between 9 and 13 January, the river stage at the Gregors Creek gauge rose and fell, completely independently of the steady rise in stage in the Wivenhoe Reservoir. In other words, operation of the dam during the flood had no bearing at all on the flow behaviour of the river at Harlin.

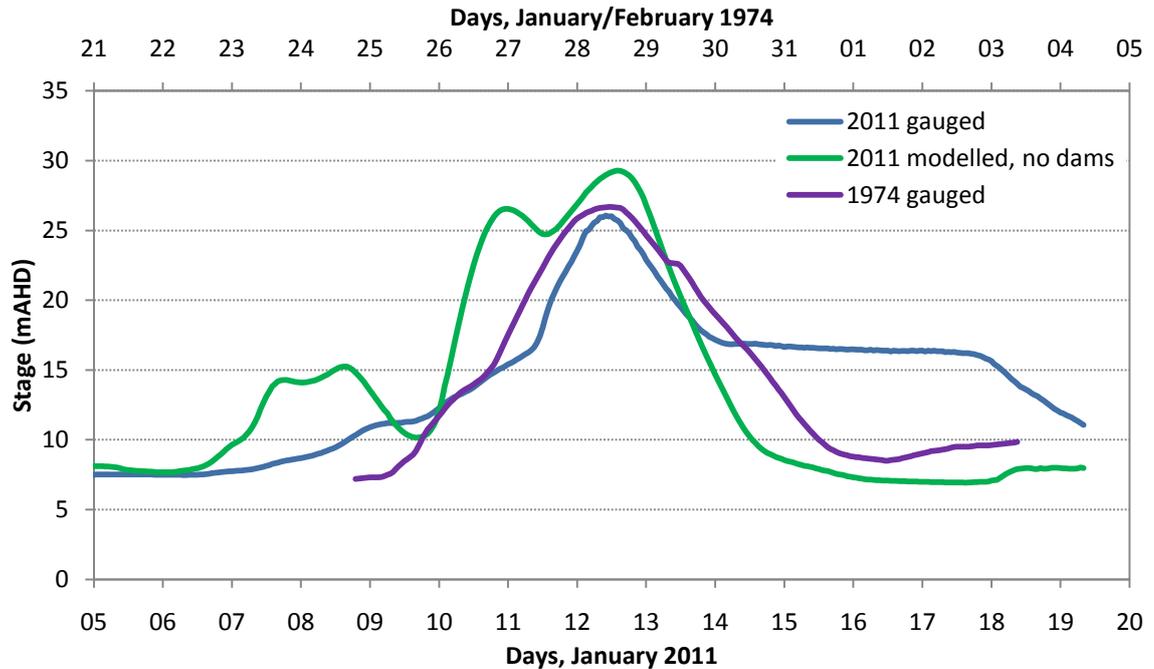
Figure 9: Modelled and gauged hydrographs at Mt Crosby Reservoir.

The hydrographs presented in Figure 9 show that, in comparison to the 1974 flood, the January 2011 flood had quite different attributes. Although the peak stage was similar, at 26.1mAHD compared to the 1974 peak of 26.7mAHD, the floodwaters remained above 18mAHD for 75 hours and 55 hours in 1974 and 2011 respectively. This against a potential peak (modelled) of 29.3mAHD at the Mt Crosby Weir gauge and high floodwaters, above 18mAHD, for 82 hours if the dams weren't used to moderate the downstream flow.

In 2011 river stage was maintained above 16.5 m at Mt Crosby Weir (level prior to a second drawdown) for 106 hours. In 1974, the river remained above 16.5 m for 85 hours. And according to SKM’s (2011) modelled scenario would have stayed up above 16.5 m for some 87 hours if Wivenhoe and Somerset Dams had not existed during the 2011 flood. Hence dam operations kept the stage at that point for some 20% longer than might have happened without them.
