STATEMENT OF PETER GEORGE UNWIN IN RESPONSE TO REQUIREMENT TO PROVIDE INFORMATION ISSUED TO SUNCORP INSURANCE DATED 2 NOVEMBER 2011

Property Claim – First & Final

[REDACTED] Fairfield, QLD, 4103

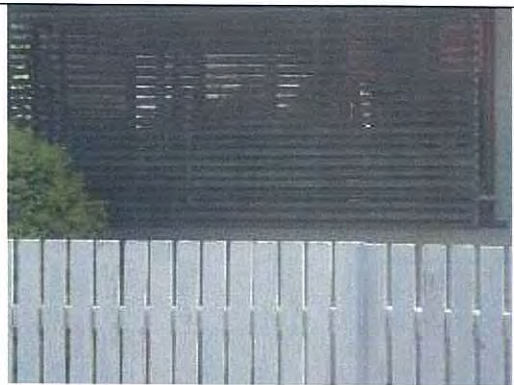
Photo #2 : Side View of Property

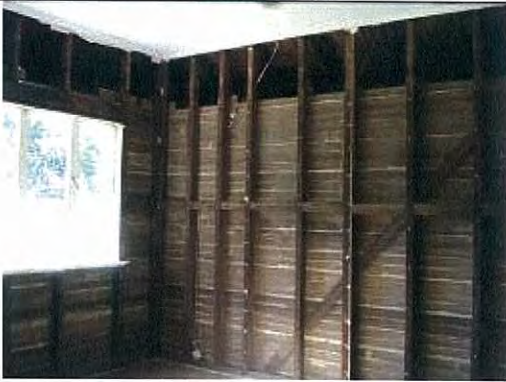
Photo #3 : Interior Walls

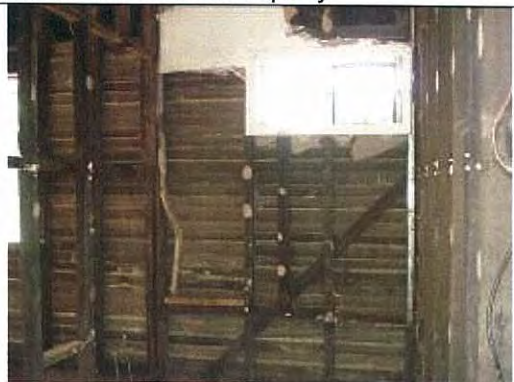
Photo #4 : Interior Walls

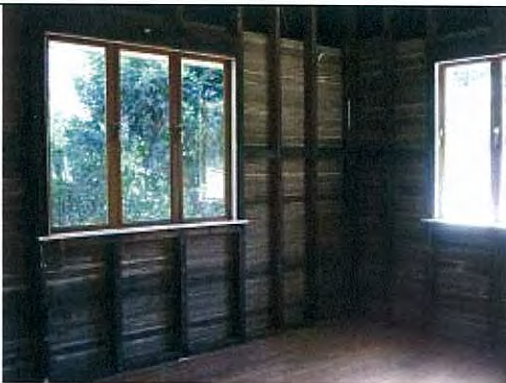
Photo #5 : Interior Walls
