17 Other dam issues

17.1 Longer term review of the Wivenhoe and North Pine manuals

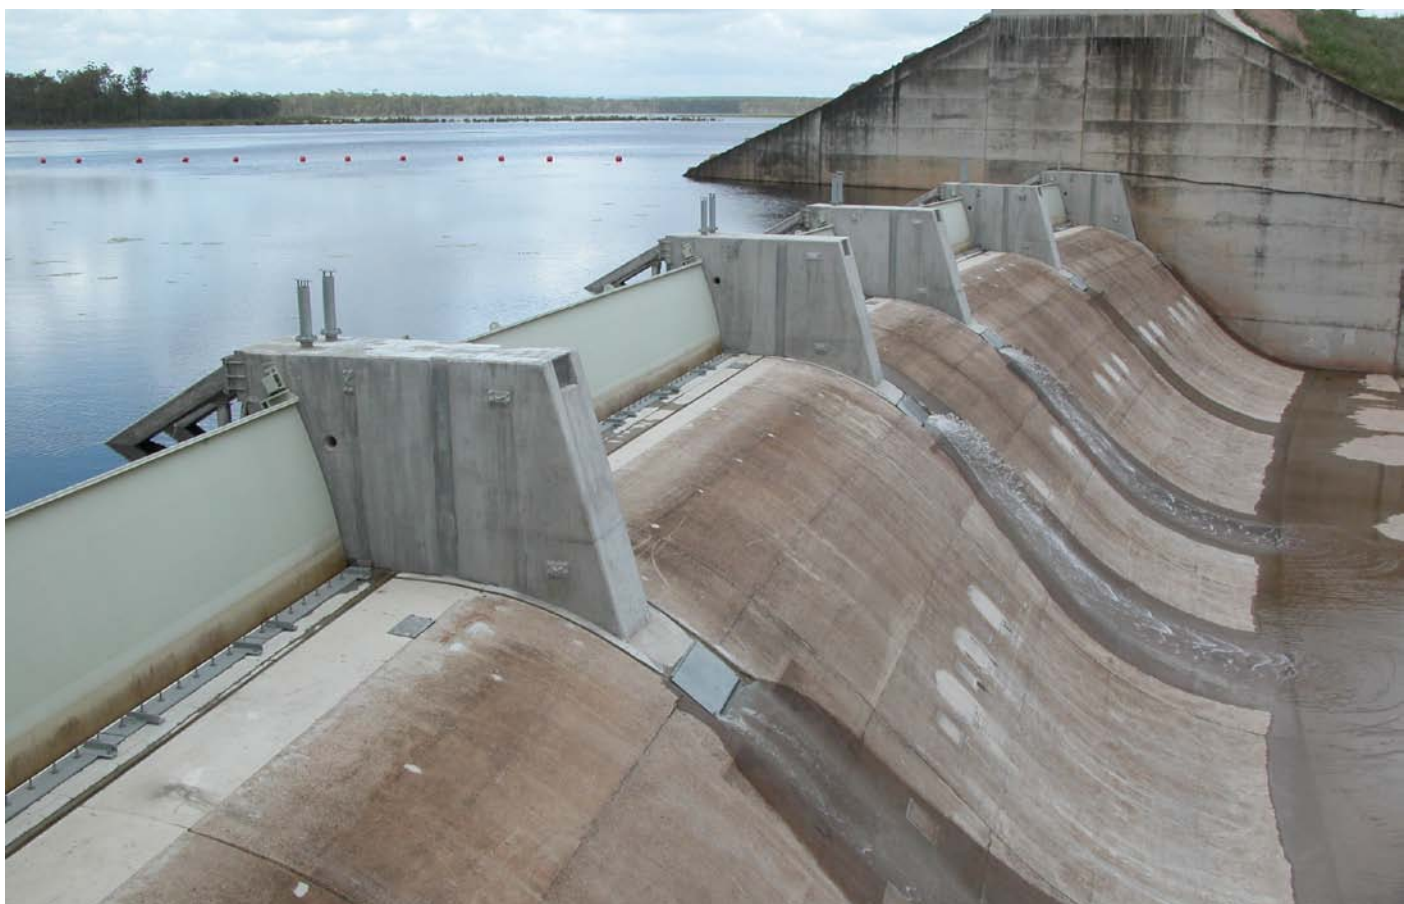
Crest gates on the spillway of Lenthalls Dam (photo courtesy Wide Bay Water)

The failure of most of the gates to operate as designed during the flood worsened flooding upstream of the dam.³⁰²

Unsuccessful attempts were made to open both gates 1 and 5 manually by opening their inlet valves on 6 March 2010.³¹² Gate 1 was opened with the use of a hydraulic jack that day, and was opened manually by using the inlet valve on 7 March.³¹³ All attempts to open gate 5 failed.³¹⁴

The trigger event of 26.10 metres was reached early on 12 December 2010.³¹⁵ At this time, attempts to open gate 5 manually, first by using the inlet valve, and then with a hydraulic jack, failed.³¹⁶ Gate 1 was manually opened that morning, although it closed for a few hours when the dam level was 550 millimetres above full supply level, and opened again as the dam levels continued to fall.³¹⁷ According to Wide Bay Water, gate 1 should have stayed open until the level of the dam reached 350 millimetres above the full supply level.³¹⁸
