**QUEENSLAND WATER RESOURCES COMMISSION  
TOWN WATER SUPPLY AND SEWERAGE BRANCH**

**HISTORY AND CAUSES**

**OF FLOODING IN FLAT ROCK CREEK**

**JOB No. F.M. 242**

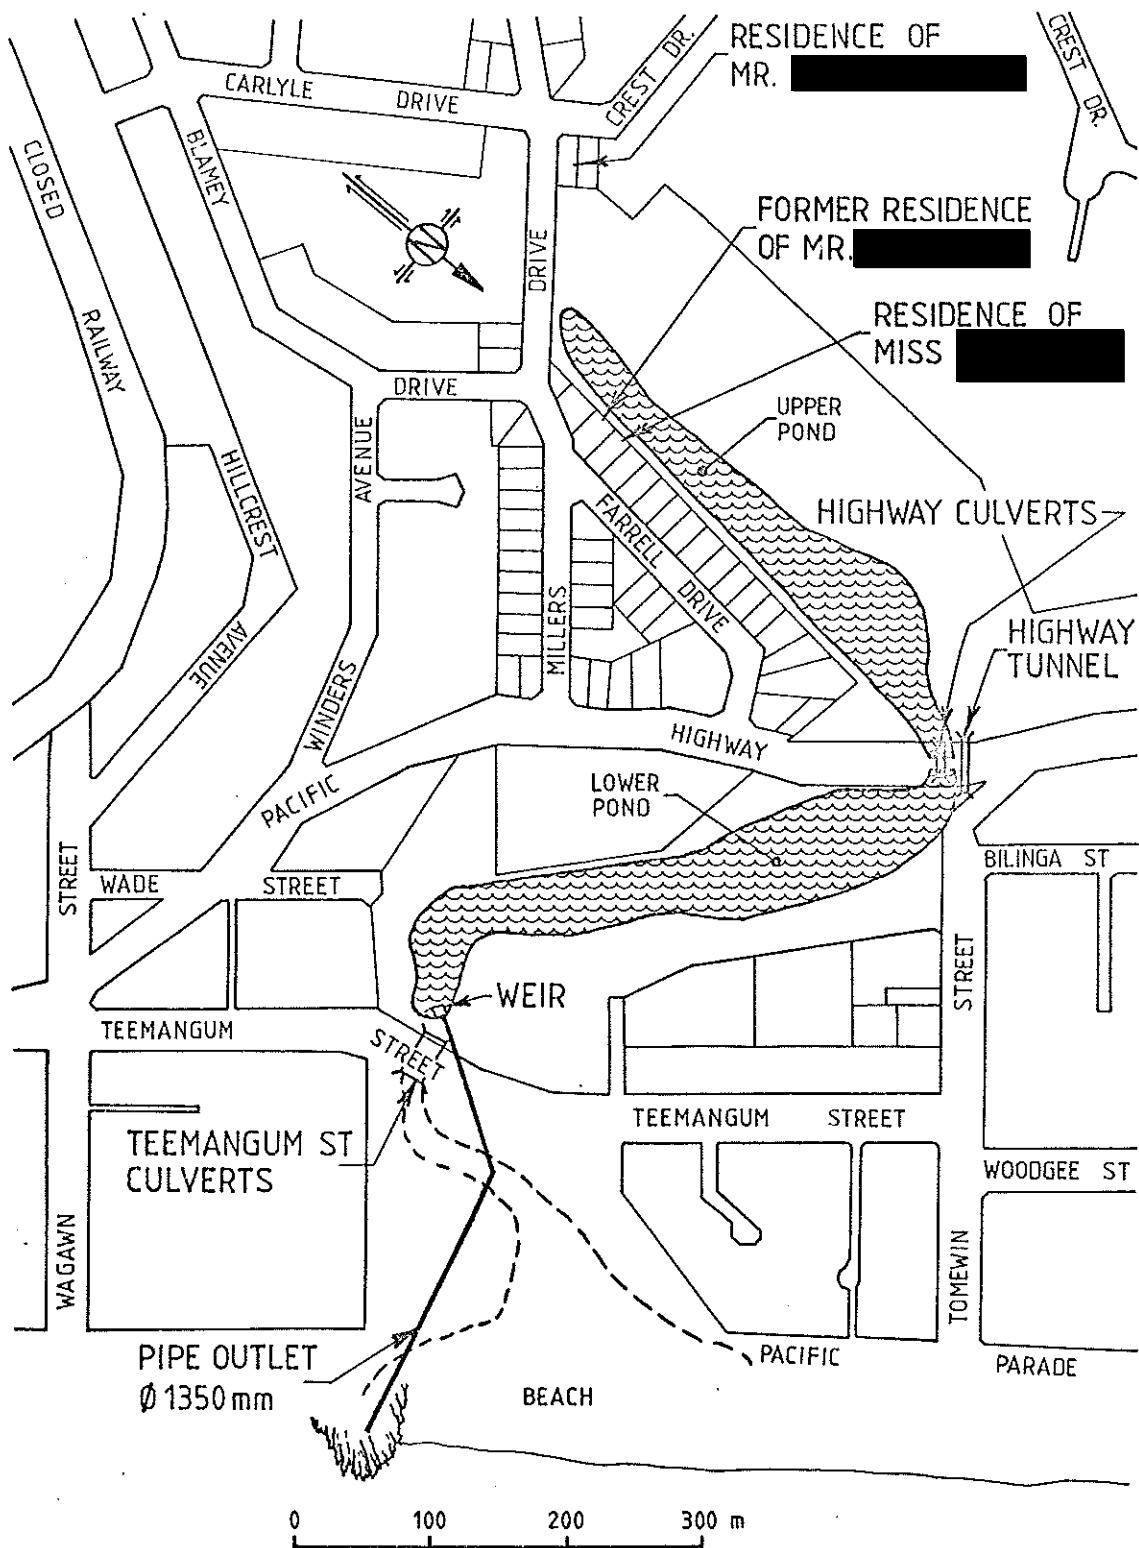
FIGURE 1: FLAT ROCK CREEK LOWER CATCHMENT

The flooding problem in Flat Rock Creek occurs in that reach of the Creek flanked by the Currumbin Bird Sanctuary. This reach consists of two ponds or lakes, the upper ("upstream" or "western") pond and the lower ("downstream", "eastern" or "Sanctuary") pond, which are separated by the Pacific Highway. The lower pond is separated from the Pacific Ocean by Teemangum Street and Currumbin Beach. Figure 1 is a plan of the area.
