Submission to the Queensland Flood Enquiry

Richard and Evelyn Robins

West End 4101

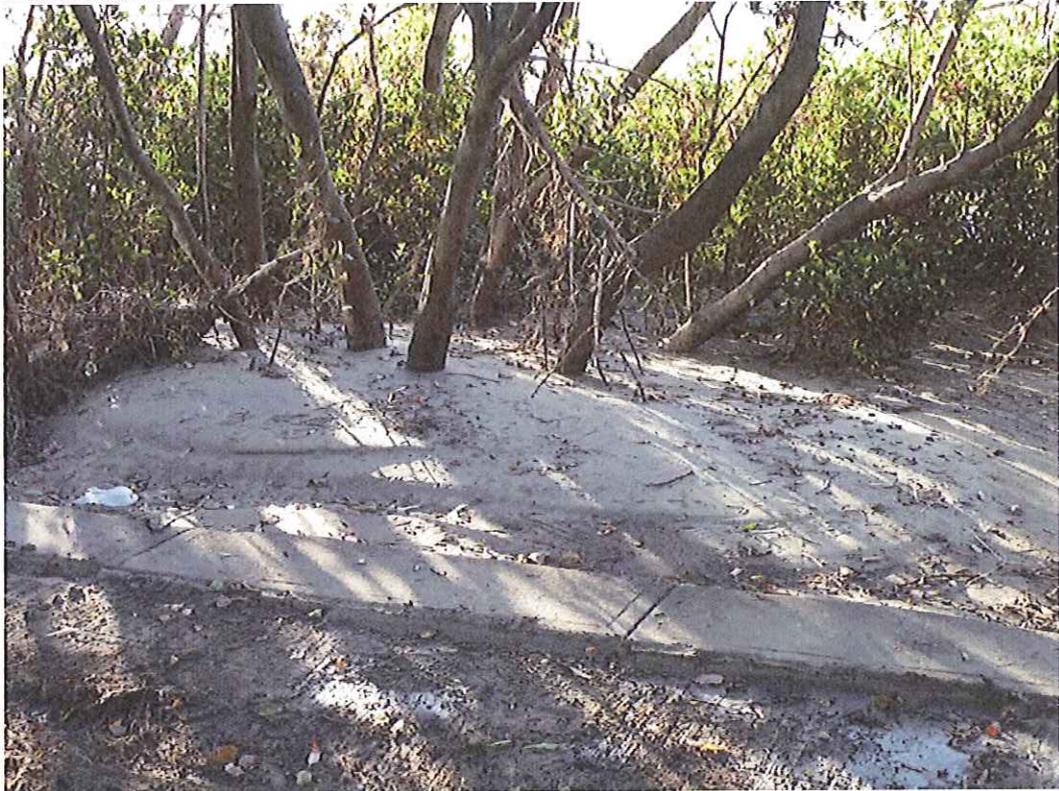
Figure 1: Mud and sand deposited amongst mangroves, Riverside Drive, West End

The explanation for this discrepancy could be that since the 1974 flood, the construction of bridges, walkways, buildings and the growth of mangroves along the river has contributed to a restriction of the flow of flood waters, thus causing a bottleneck for floodwaters and an increase in flood heights in particular areas. Attached photographs show a massive build-up of sands and mud in the mangroves along the edge of Riverside Drive. In places these deposits extend out some 15 metres into the river. The deposition of these sediments is indicative of an impediment reducing the velocity of the flood flow at that point resulting in the dropping of the rivers sediment load. Such impediments (and mangroves are only an example), could have had a damming effect resulting in localised increases in flood heights.

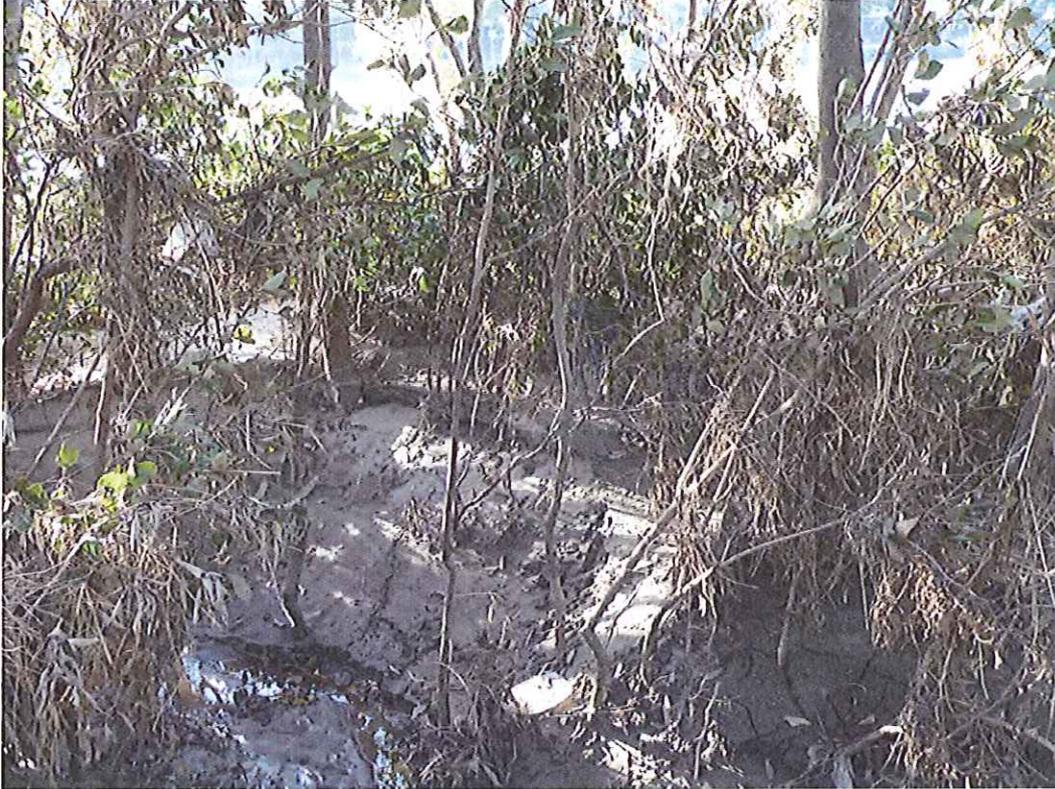
Figure 2: Mud and sand deposited amongst mangroves, Riverside Drive, West End
