Queensland Bulk Water Supply Authority SEQWater

WIVENHOE DAM COMPREHENSIVE INSPECTION JULY 2006

SURVEILLANCE REPORT **FINAL REPORT**

Report No: DC07063

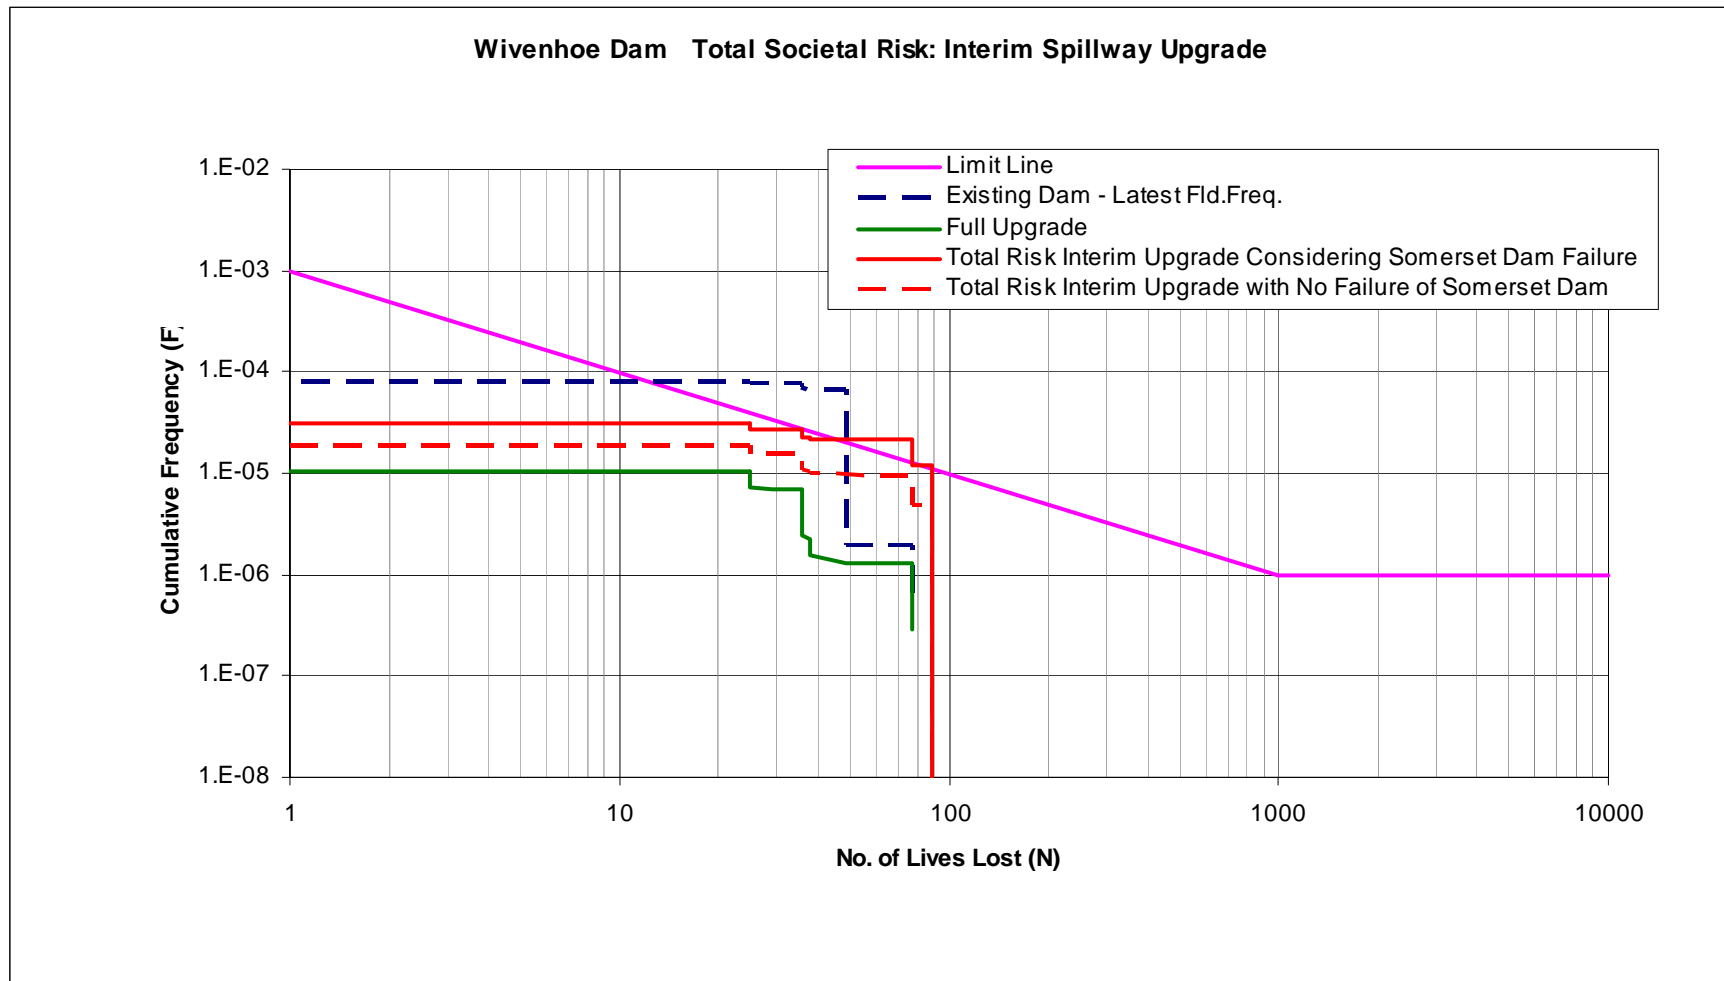
Figure 4-1 - ANCOLD Total Societal Risk Assessment – from Wivenhoe Alliance, 2004

The Wivenhoe Alliance further revised this work to incorporate the risks associated with a Somerset failure. The FN Charts for total loss of life is shown at Figure 4-1 and indicates that:

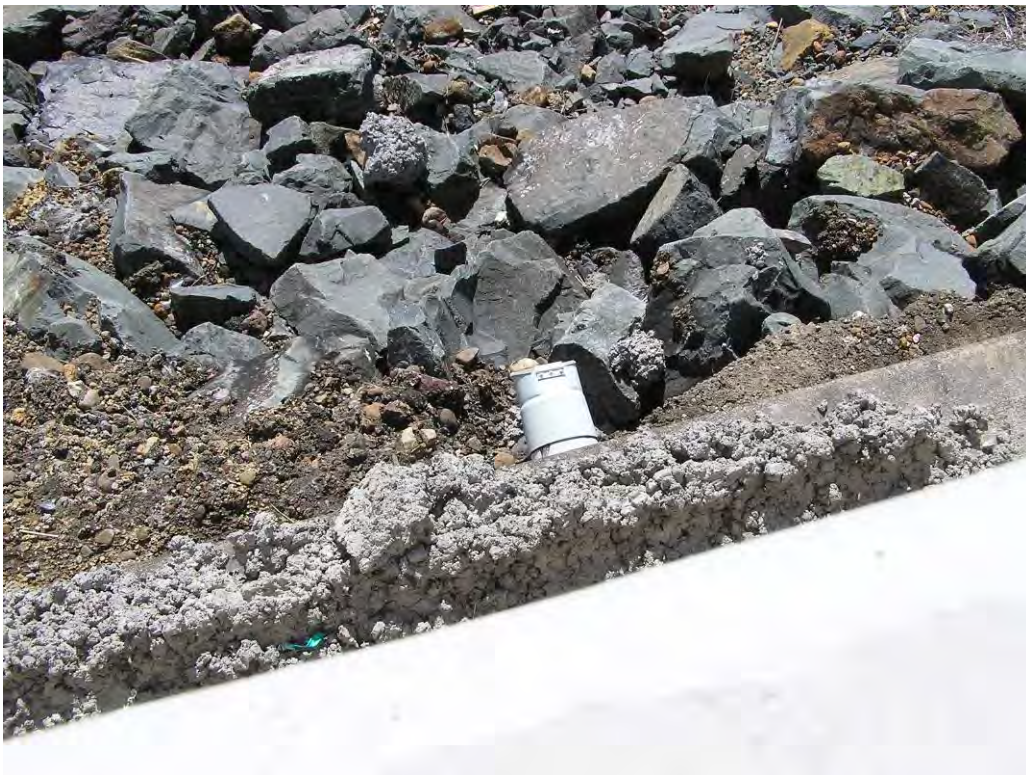
Photograph No. 8: Main Embankment - Road Drains Discharging to U/S Side Showing Flap Valves

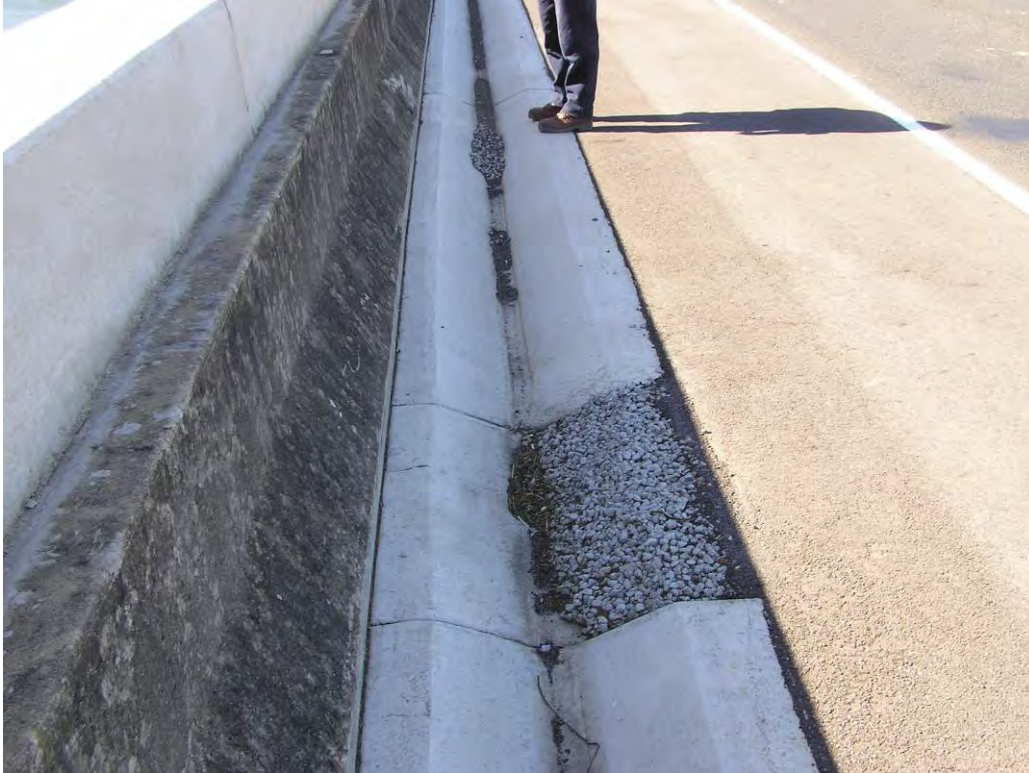
Photograph No. 9: Main Embankment U/S Road Drain Showing 'No-fines Concrete' Around Drainage Discharge Point

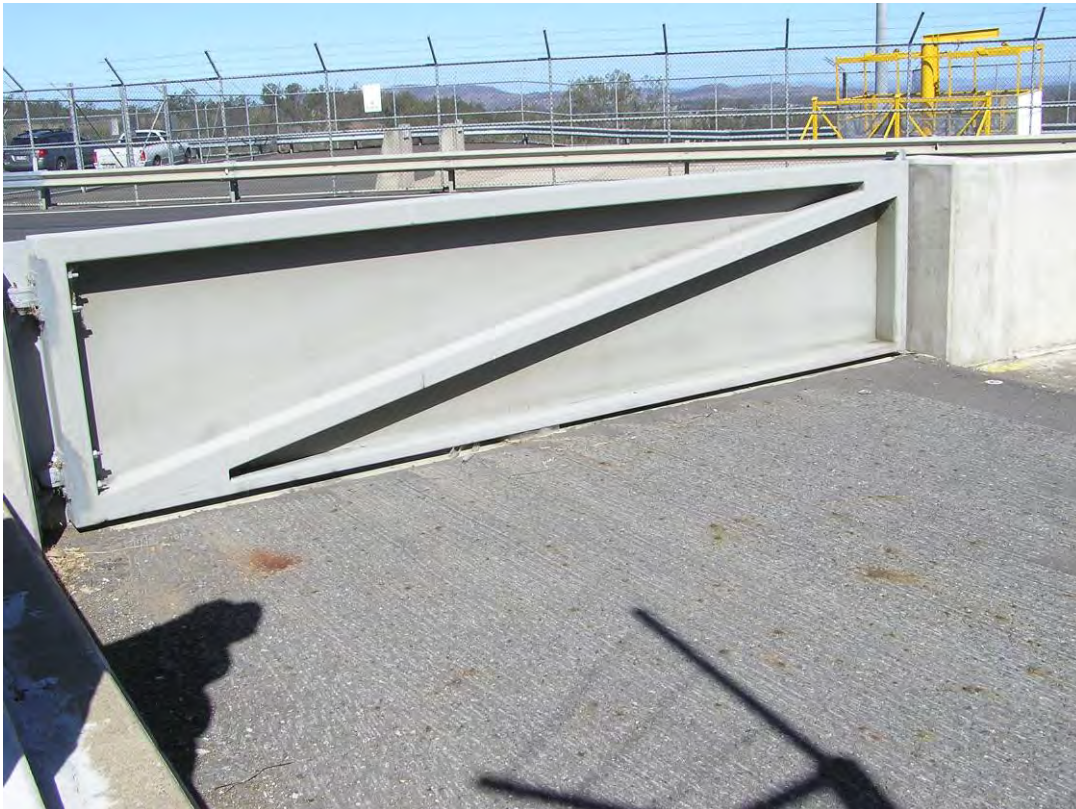
Photograph No. 10: "Watertight" Gate Adjacent to Spillway - Requires Rubber Seals

13. Repair rubber seal(s) as appropriate on “waterproof” gates installed in left embankment wave wall. Refer to Section 7.4.
14. Remove overgrown vegetation along the drainage channel downstream of the left embankment toe. Provide clearance under seepage pipe to allow placement of measurement container. Refer to Section 7.4.

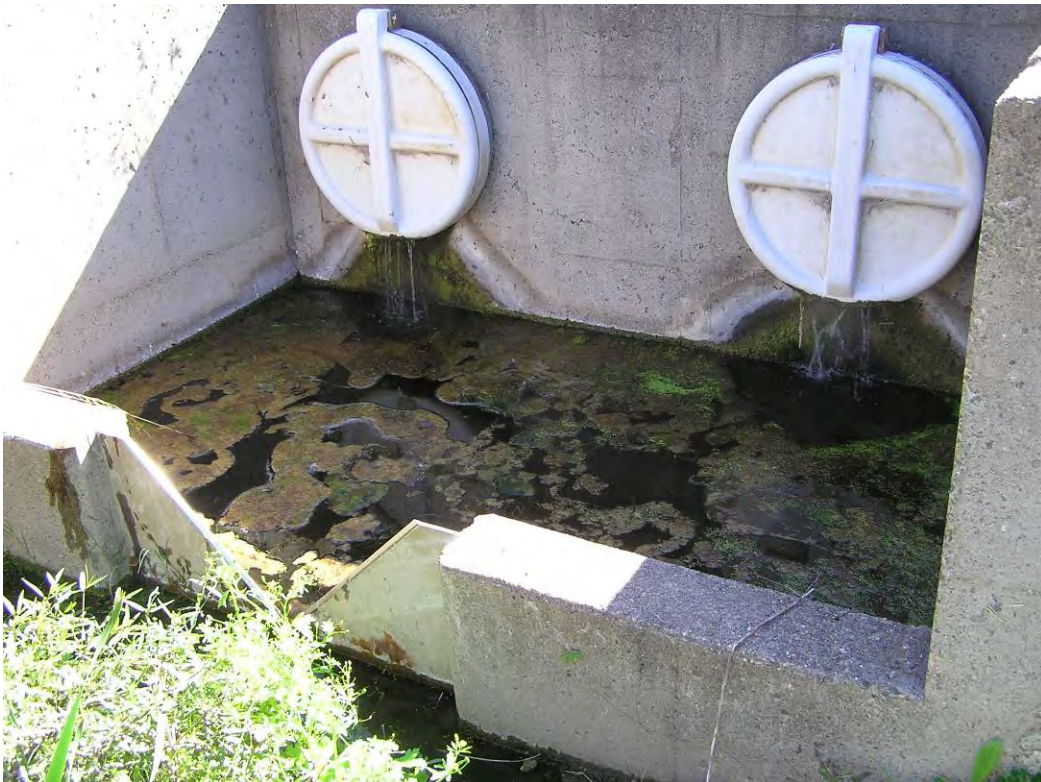
Photograph No. 14: Drainage/Seepage Collection D/S of Right Embankment
